# National Register of Historic Places Registration Form

Historic name: Beckstead-Butterfield House

Street & number: 13032 South Redwood Road

City or town: Riverton State: UT County: Salt Lake

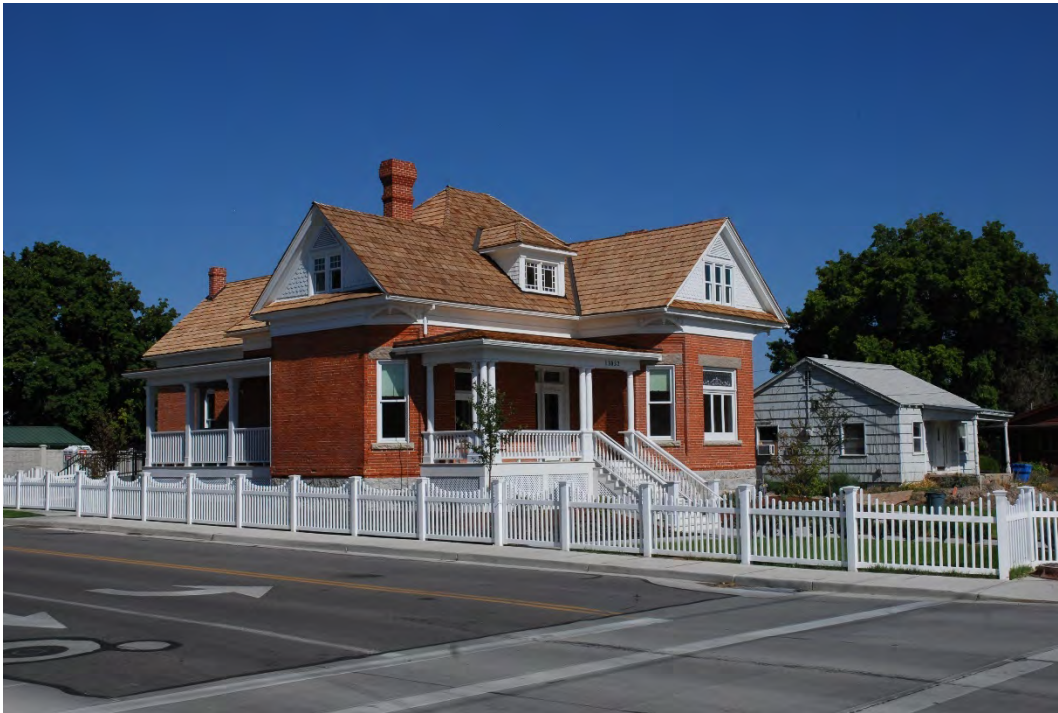
**Photograph 1**

East and south elevations, view of site with non-contributing house on right. Camera facing northwest.

The façade (east elevation) faces Redwood Road [Photographs 1-2]. The façade is asymmetrical in the typical Victorian Eclectic style. The north half of the facade is a projecting octagonal wing with a simple gable roof. The central window is a fixed-frame wood sash window with a flat sandstone lintel and sill. The original large window was replaced by a tripartite window separated by two wood mullions (circa 1970s) [Figures 1-2]. The dentiled transom bar and the leaded-glass transom are original. The glass is colored with a floral-ribbon and diamonds pattern [Photograph 7]. These windows were retained and repaired during the rehabilitation. The flanking windows are one-over-one double-hung replacement windows that match the originals, which were in poor condition. The replacements are wood windows that are aluminum-clad on the outside and wood on the inside. The sandstone sills and lintels were repaired or replaced as needed. The original wood cornice is divided into two sections. There are jig-saw-cut brackets and lathe-turned pendants in the bay's angles. Above the full cornice return are three narrow one-over-one windows. The windows are replacements, but the surround of fluted wood and paterae was retained. The gable trim is sheathed in the original alternating octagonal and fish scale shingles.

At the southeast corner is an angled wall with a double-hung replacement wood window and features similar to the east bay [Photograph 1]. This angle is connected to an unusual square bay with no openings facing south [Photograph 3]. Above the south bay is a simple gable with a full cornice return. The gable features a pair of six-over-one single-hung windows with Queen Anne-style glass in the upper sash, which are a

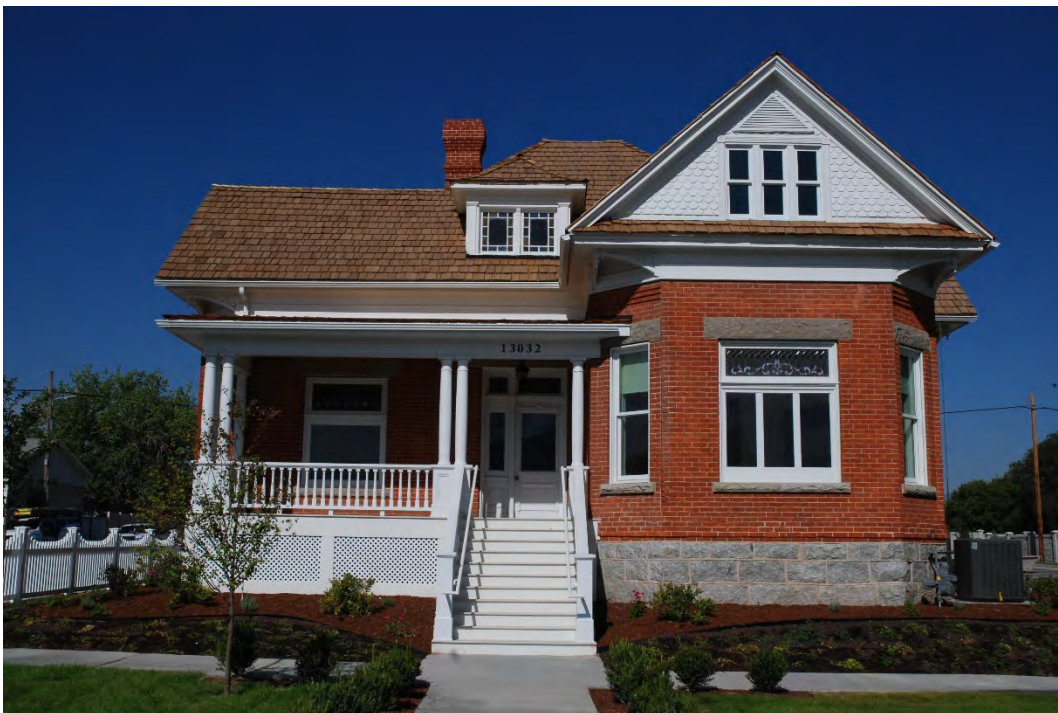
**Photograph 2**

East elevation. Camera facing west.

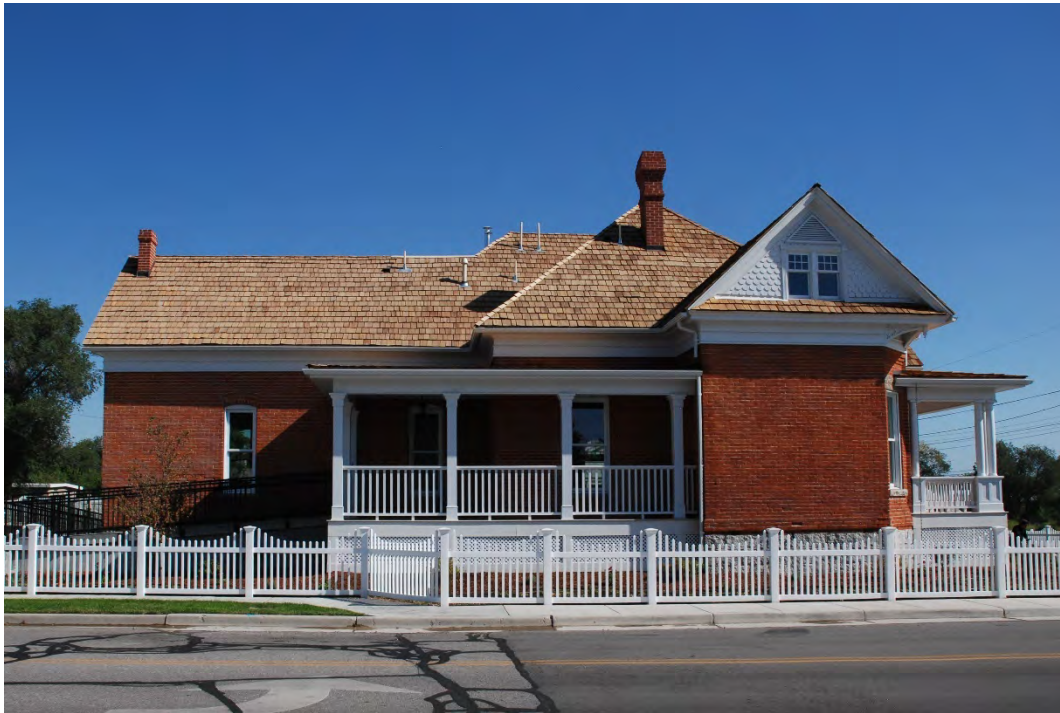
**Photograph 3**  
South elevation. Camera facing north.

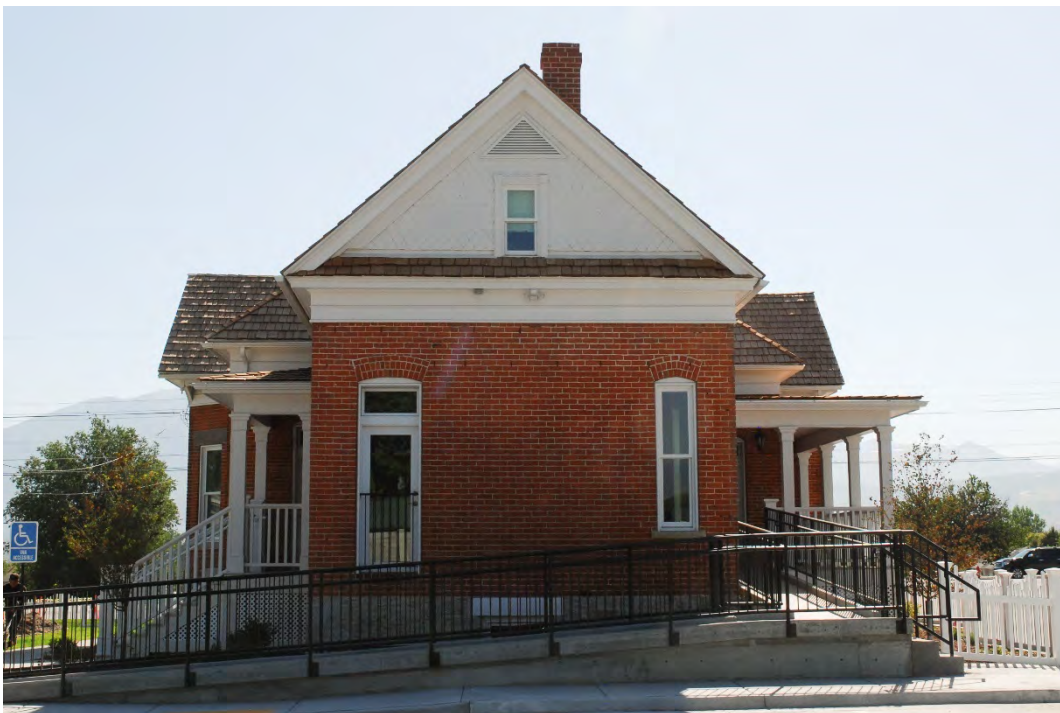
**Photograph 4**  
West elevation. Camera facing east.

The west elevation of the addition has two openings, a narrow window to the south and a doorway to the north, both blocked prior to the rehabilitation [Photograph 4]. The openings were replaced with a compatible window and door; however, the door opening is current inaccessible and blocked with a wrought-iron rail because of the proximity of the ADA ramp. The west gable trim features diamond and octagonal shingles and has a simple one-over-one replacement window to match the original. The west elevation also had a porch that wrapped to the north. By the 1980s, the north porch had been replaced by a non-historic enclosure, which was demolished in 2017. The west portion of the porch was not rebuilt to provide access from the parking lot to the ADA ramp.

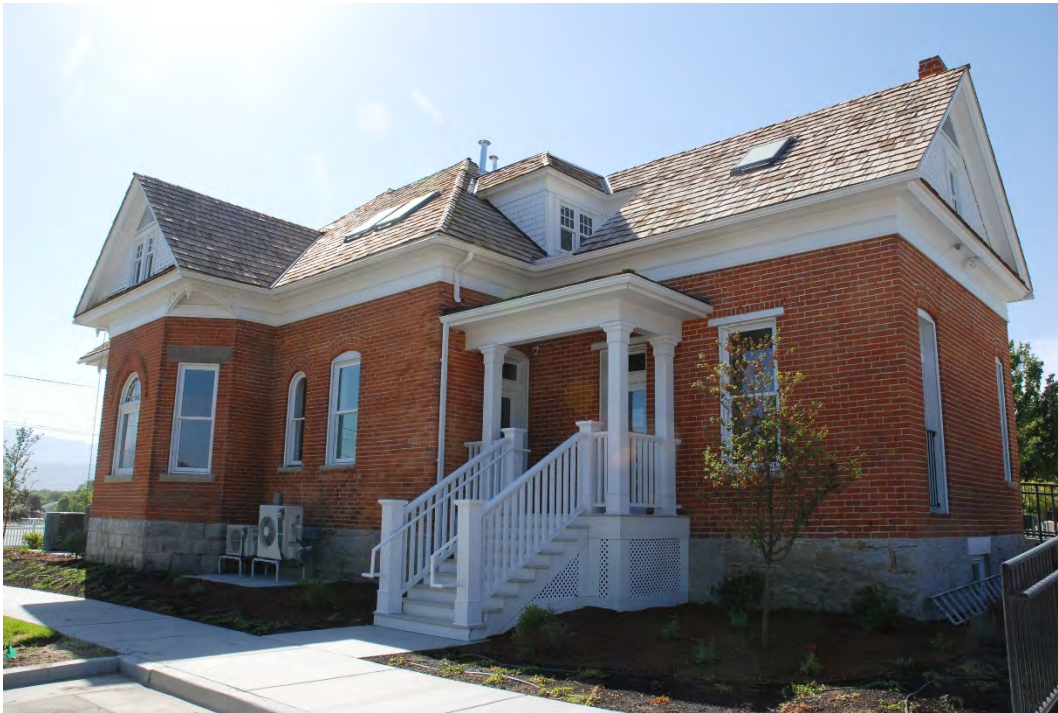
**Photograph 5**  
North elevation. Camera facing southeast.

The north elevation of the addition features two flat wood lintel openings, a window, and a door to the south [Photograph 5]. On the visible west-facing portion of the original house is a window opening on the main level and a hipped-roof dormer on the upper level. The south half of the original north elevation features a door opening with a segmental-arch hood. East of the door is a narrow roundhead one-over-one window with three courses of brick above. The round-head window was in good condition and was preserved, but the other windows and doors were damaged and replaced to match the originals. A small porch, similar to design to the new south porch was built to replace the non-historic porch. In order to facilitate egress from the porch, the west window was converted to a door and the south door was changed to a window. This modification has minimal impact on the overall character of the house.

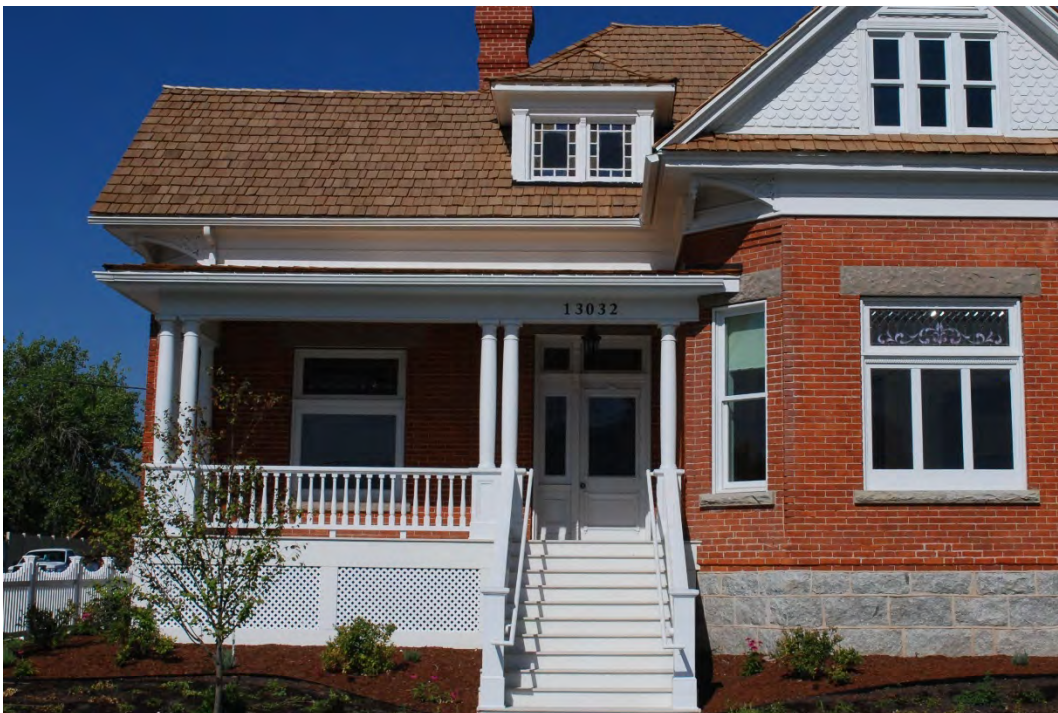
**Photograph 6**  
East elevation, façade details. Camera facing west.

The south half of the façade is a porch with paired Tuscan columns on classical plinths [Photograph 6]. The wood steps, rails and balustrade were removed in the 1990s when the porch was enclosed with aluminum siding. The lattice work under the deck was partially original, but damaged. The porch was restored to match a 1906 photograph of the house, revealing the original front window with geometric leaded-glass transom, and front door with sidelight and transom [Figure 1]. The exterior half-glass door is historic. Sheetrock from the enclosure was removed from the original beadboard soffits [Photograph 9]. Although the house is not a true Queen Anne because it lacks a turret, the design features some Queen Anne details. For example, the façade includes a small hipped belcast roof dormer with two small windows. The windows have a perimeter Queen Anne sash with colored glass. The windows are flanked and separated by engaged Tuscan-style flat columns

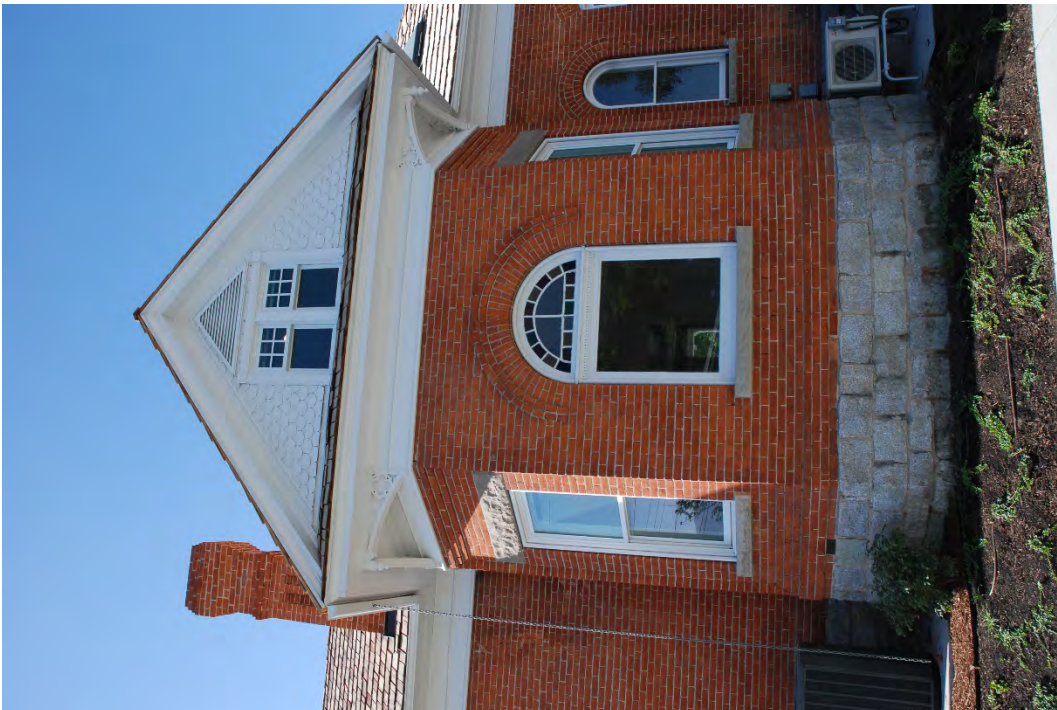
**Photograph 8**  
North elevation, bay details.  
Camera facing south.

The projecting north octagonal bay is unusually ornate for a secondary elevation [Photograph 10]. There is a central window featuring a full round-head arch with a corbelled brick molding. The Queen Anne-style arched window has colored lights around the perimeter [Photograph 8]. The transom bar features a stylized egg & dart above the fixed frame window. These elements were retained and repaired. The flanking double-hung replacement windows have flat sandstone lintels. The bay features wood brackets and pendants similar to the façade. The gable trim and Queen Anne windows are similar to the south elevation. There are no openings on the wall east of the bay, but the rare intact corbelled chimney stack is distinctive [Photograph 10].

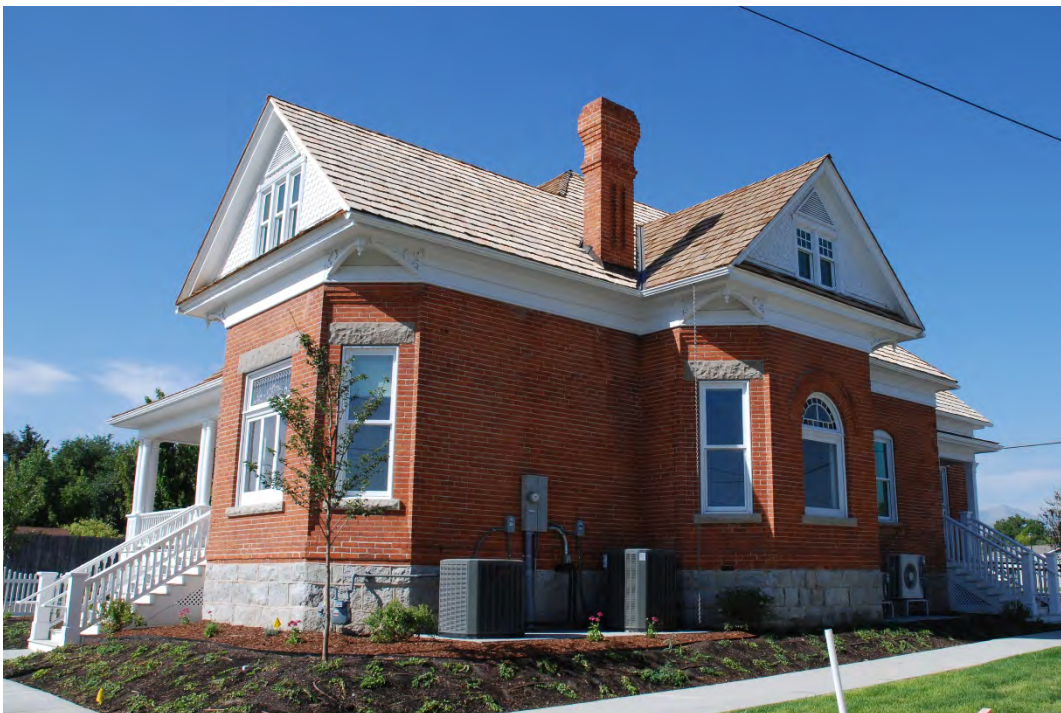
**Photograph 10**  
East and north elevations. Camera facing southwest.

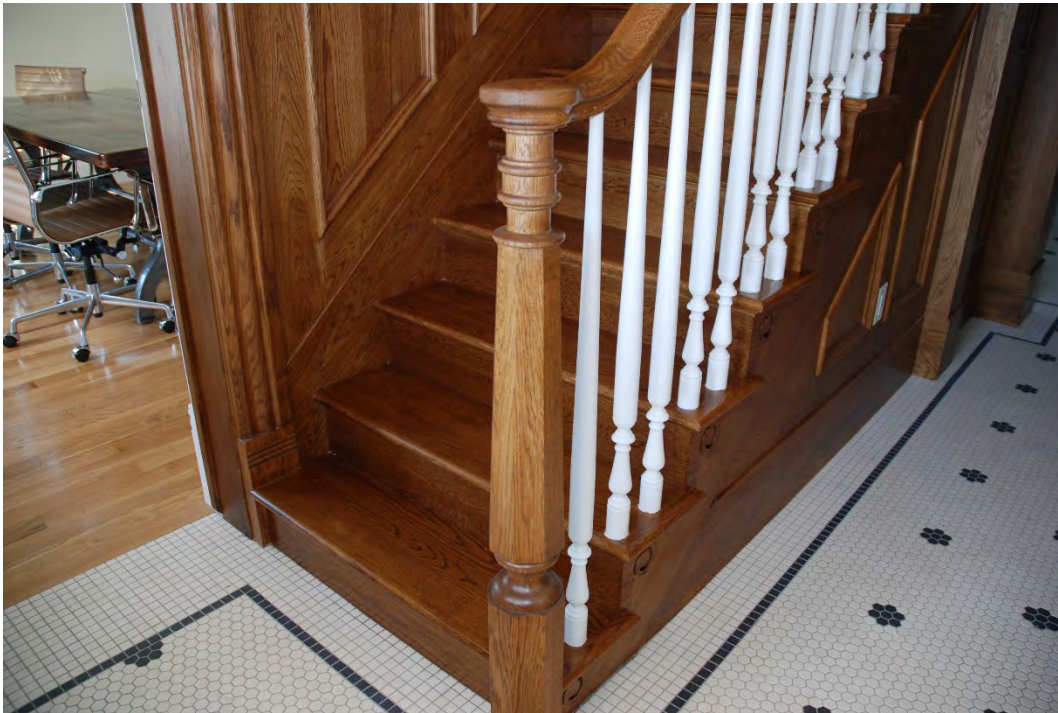
**Photograph 17**

During the 2019-2020 rehabilitation, the wood book shelves and the non-historic kitchen area were removed. All the ceilings were raised to the original heights and water damage was repaired. The front staircase was rebuilt with a Victorian Eclectic-style newel post, balustrade, and rail [Photograph 17]. The floors in the foyer, hall to the south room, and bathroom were tiled with the initials "GFB" laid in the foyer, a nod to the associated barn (demolished in 1968) [Figure 3]. The south room now serves as a lobby. Wood wainscoting was added to this room where the adobe-lined walls had been extensively water damaged [Photograph 14]. The bathroom was rehabilitated as an ADA-accessible restroom. New historically compatible quarter-sawn oak floors were installed throughout the remaining rooms, which will be used as conference rooms and office space [Photographs 11-13, 15-16, 22]. Existing woodwork was repaired and missing pieces replaced as needed. Canned lighting was installed to augment the new period appropriate light fixtures. The parlor fireplace was replaced with a historic oak mantel and new mirror [Photograph 11]. The fireplace inset was tiled with a metal firebox. The wall between the parlor and dining room was rebuilt and new half-glass pocket doors installed. In the library closet (under the stairs) a sample of the historic wallpaper was preserved.

Interior, main floor, stairs and newel post details. Camera facing northwest.

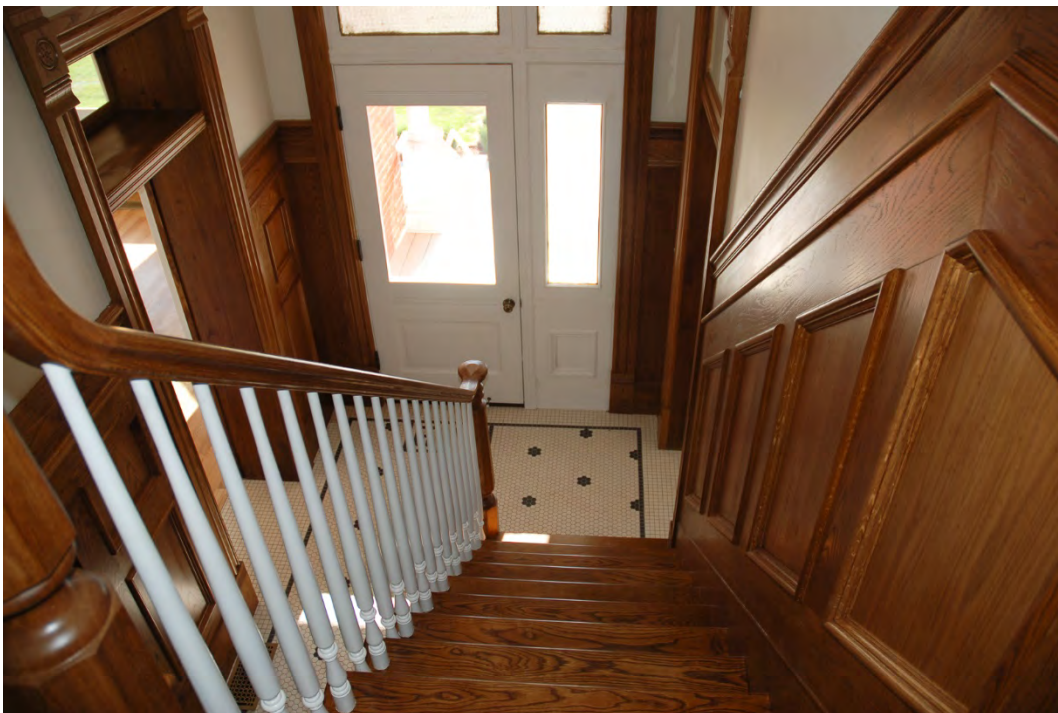
**Photograph 18**

Interior, second floor, stairs (view to entry foyer). Camera facing east.

The front staircase access the east two-thirds for the upper floor [Photograph 18]. The upper floor landing remains open with access to the former east, north and south bedrooms, as well as the front dormer niche. All of the former bedrooms have been transformed into office space with the attic ceiling shape preserved [Photographs 19-20]. The center bedroom and hall have been converted to a studio apartment [Photograph 21]. The studio apartment includes a kitchenette and a three-quarter bathroom. The hall is now a storage area. In the back (west) room the secondary stairs to the upper floor were retained and repaired with a new wood rail installed [Photograph 22]. This staircase leads to office space in the former west bedroom and a restroom (in the upper floor of the 1900 addition) [Photograph 23]. This area is not accessible from the front staircase. The basement stairs were rebuilt for safety reasons. The large basement room at the rear of the house has new carpet, but the stone and concrete walls have been left unfinished [Photograph 24]. A short hall leads to the mechanical room in the center of the basement. There is a small finished storage room that has not been altered. The portion under the original house is not excavated.

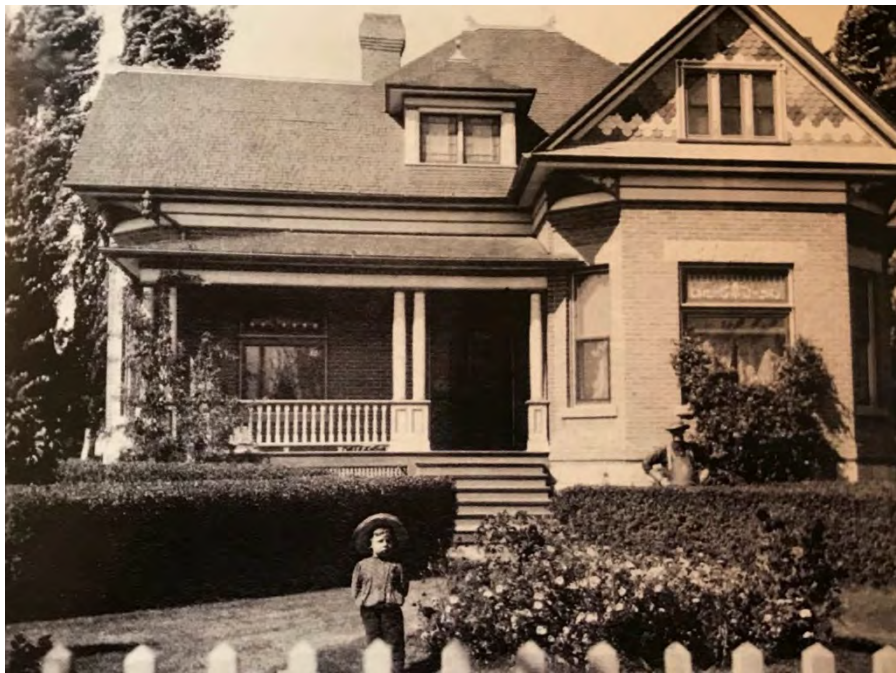
**Beckstead-Butterfield House, circa 1906**  
East elevation. Camera facing west.  
*Photograph courtesy Barbara Catron.*

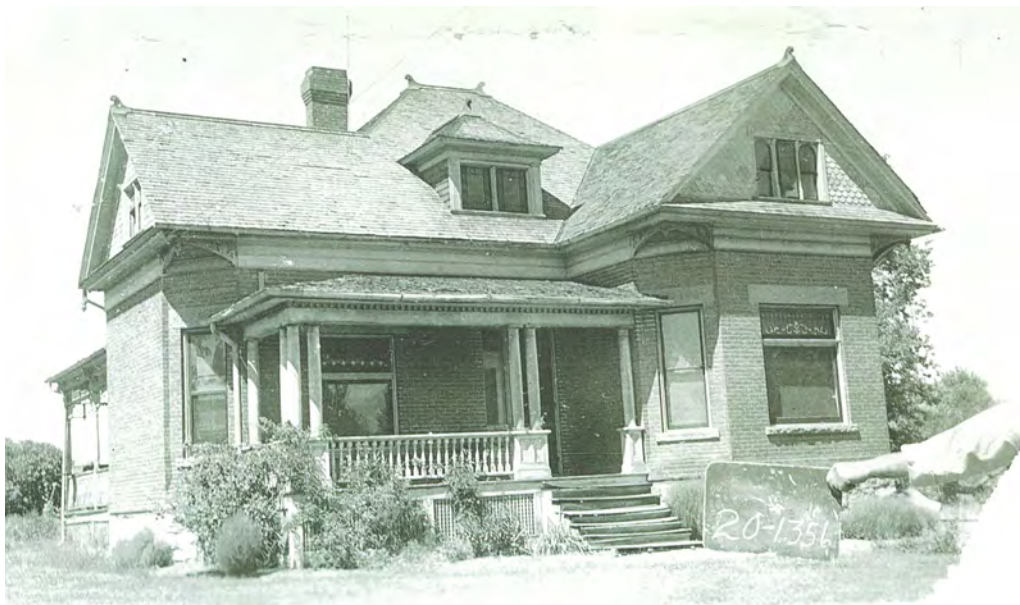
**Beckstead-Butterfield House, circa 1938**  
East elevation. Camera facing west.  
*Salt Lake County Tax Assessor's Office photograph, courtesy Salt Lake County Archives.*

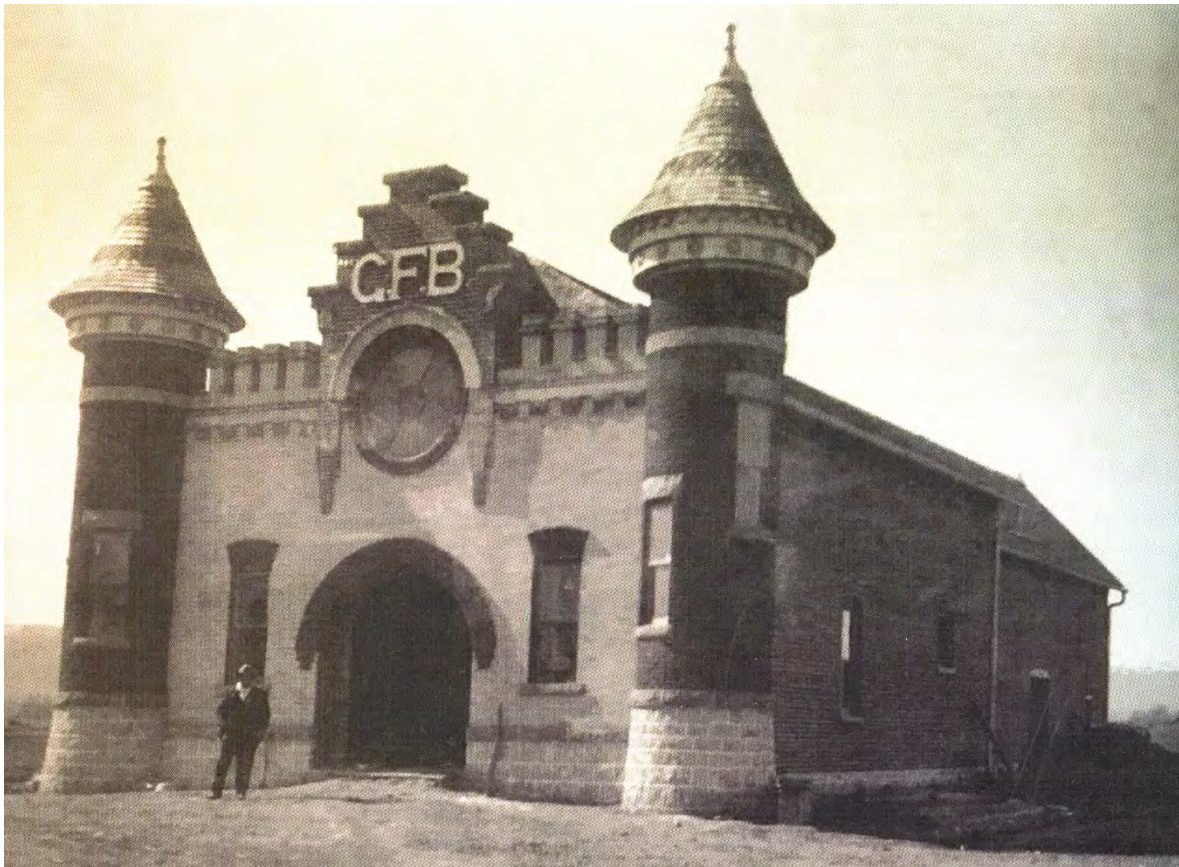
**Beckstead-Butterfield barn, circa 1910**  
**(formerly located just south and west of the house, demolished in 1968)**  
East and north elevations. Camera facing southwest.  
*Photograph courtesy Barbara Catron.*

Within the community of Riverton, the Beckstead house is more often associated with its second owners, George F. and Charlotte Beckstead. This is due to the fact that George F. Beckstead had a large brick barn built on the property soon after they acquired the house in 1900. The two-story barn sat slightly south and west of the house. It was built of brick with an ashlar granite foundation. The elaborate architecture of the barn included round towers at the front corners, a wide arched entrance, a stained-glass rose window, castellated parapet, and hard wood floors. The initials "G.F.B." were installed above the entrance [Figure 3]. The castle-like, brick barn was a landmark in the community until its demolition in 1968. The George F. Beckstead barn was built by Carl Madsen, the most prolific Riverton builder of the period. Madsen is also believed to be the builder of the Beckstead house a few years earlier, and probably built the 1900 addition to the house for George and Charlotte.
