National Register of Historic Places Registration Form

Historic name: Palace Apartments

Street & number: 145 S. 300 East

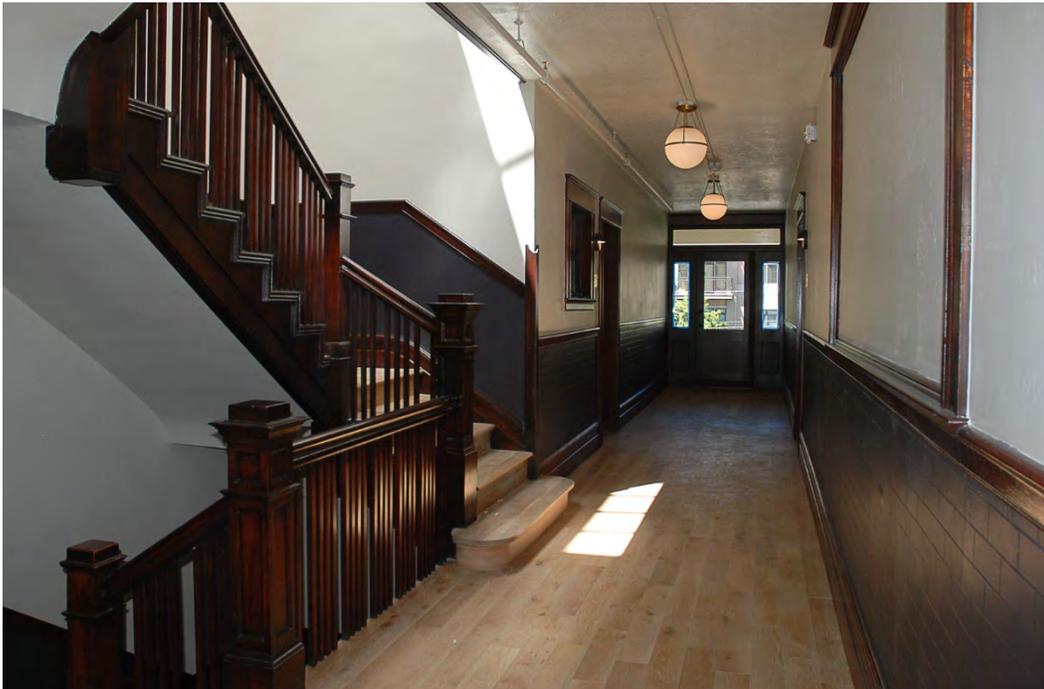
Photograph 19

Interior, second floor, stair and corridor. Camera facing west.

On the interior, the building has 5,194 square feet of space on each floor. The building originally had 28 units. The units are arranged along a double-loaded corridor with an interior staircase on the south side of the main hall and the rear exterior stairs between the porches. The main entry has a tiled foyer and the original brass mailbox cubbies on the north wall [Photographs 15 & 16]. The original wood stairs had opening in the risers. This detail was replicated with the glass block when the stairs were rebuilt in wood [Photographs 16 & 20]. The corridors have original woodwork including baseboards, wainscoting rails, and door casings [Photograph 17]. One unique feature is a number of interior windows that originally brought light into the units from the corridors. These window elements in the units had been removed during the 2015 remodel, but the frames have been retained with frosted glass in the corridors [Photographs 19 & 20].

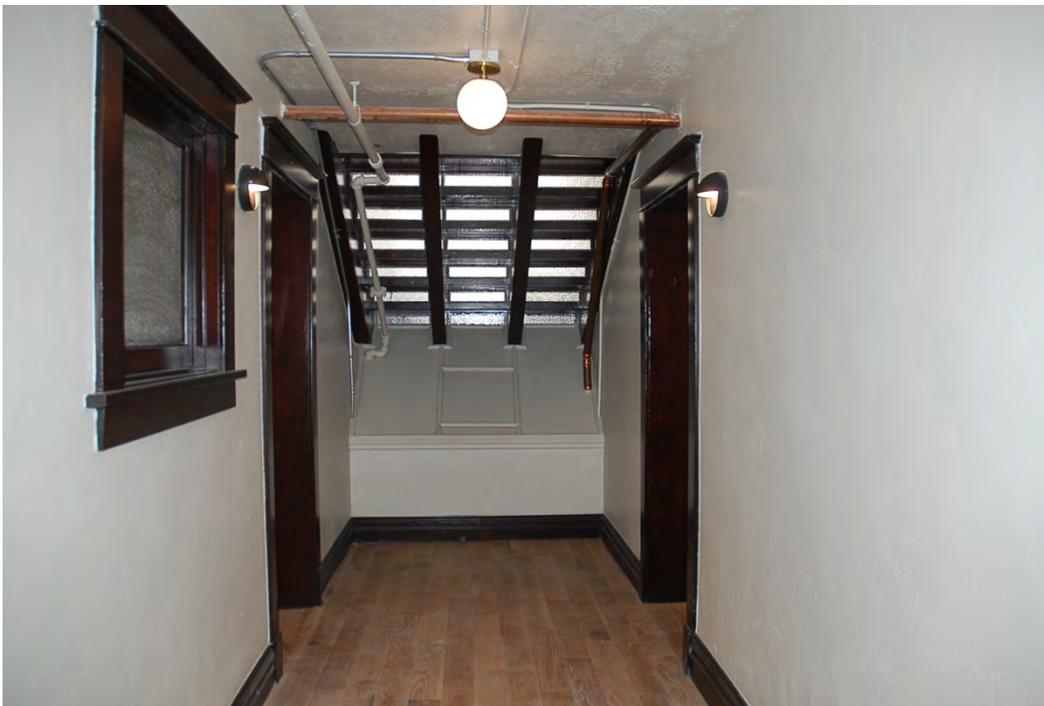
Photograph 20

Interior, basement, under stairs at west end. Camera facing west.

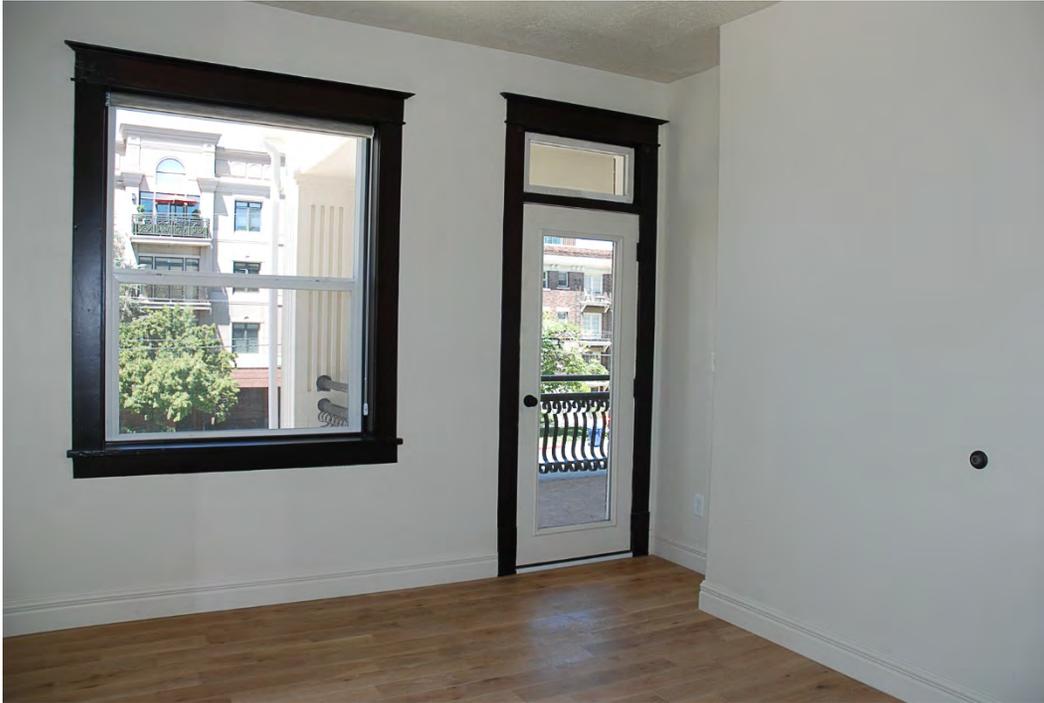
Photograph 21

Interior, second floor apartment, bedroom, Unit #302. Camera facing northwest.

During the recent rehabilitation, the unit layouts were modified slightly to provide for a more open kitchen and a closet for individual water heaters and a new stackable washer-dryer. The extant woodwork, such as casings and baseboards, were retained [Photograph 21]. The rehabilitated units were updated with new paint, finishes, doors, and light fixtures throughout. The living room and bedrooms have new hardwood floors, with a parquet design in the living room [Photographs 22, 23 & 24]. The kitchen was updated with tile, new cabinetry, and stainless-steel appliances [Photographs 24 & 25]. The bathroom were also remodeled with new fixtures, tiled showers or bathtubs, and hexagonal floor tile. A few boxed and finished ducts were needed for the new HVAC systems. Two additional studio apartments were added in the basement level where a laundry and storage room was originally located. The southeast corner of the basement was converted to a gym for tenants [Photograph 26]. The original mechanical room is below grade and located just east of the gym space.

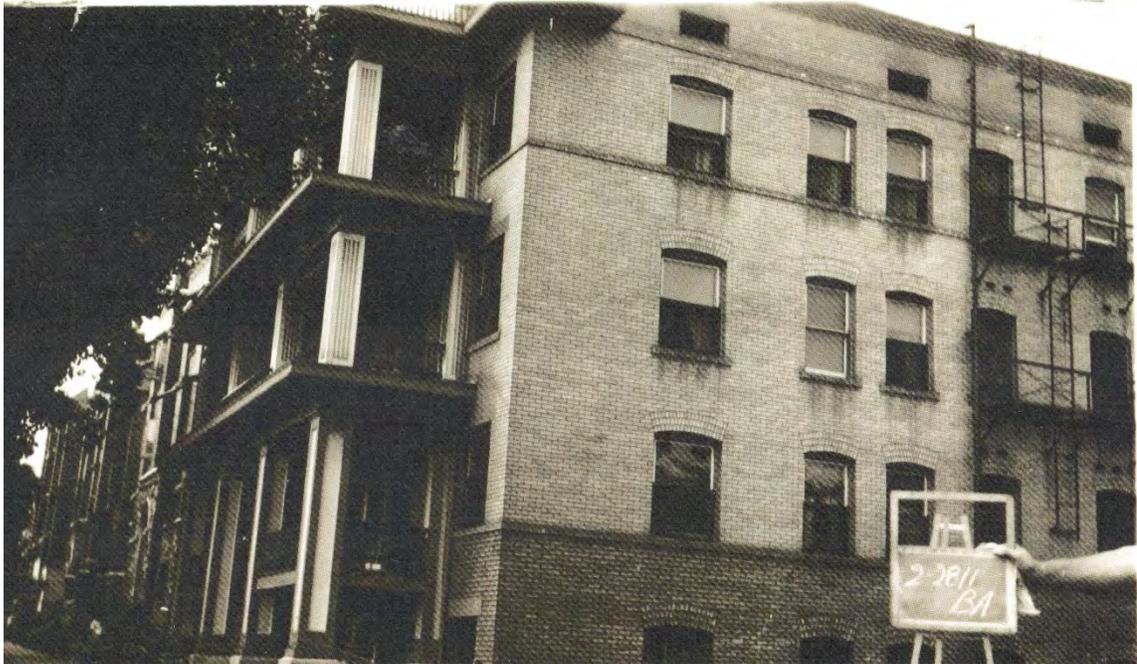
FIGURE 1

Palace Apartments, circa 1936

West and south elevations. Camera facing northeast.
