# National Register of Historic Places Registration Form

historic name Borden Company Plant

other name/site number Cache Valley Condensed Milk Company; Borden Western Milk Condensory

street & town 290 South 400 West ☐ not for publication

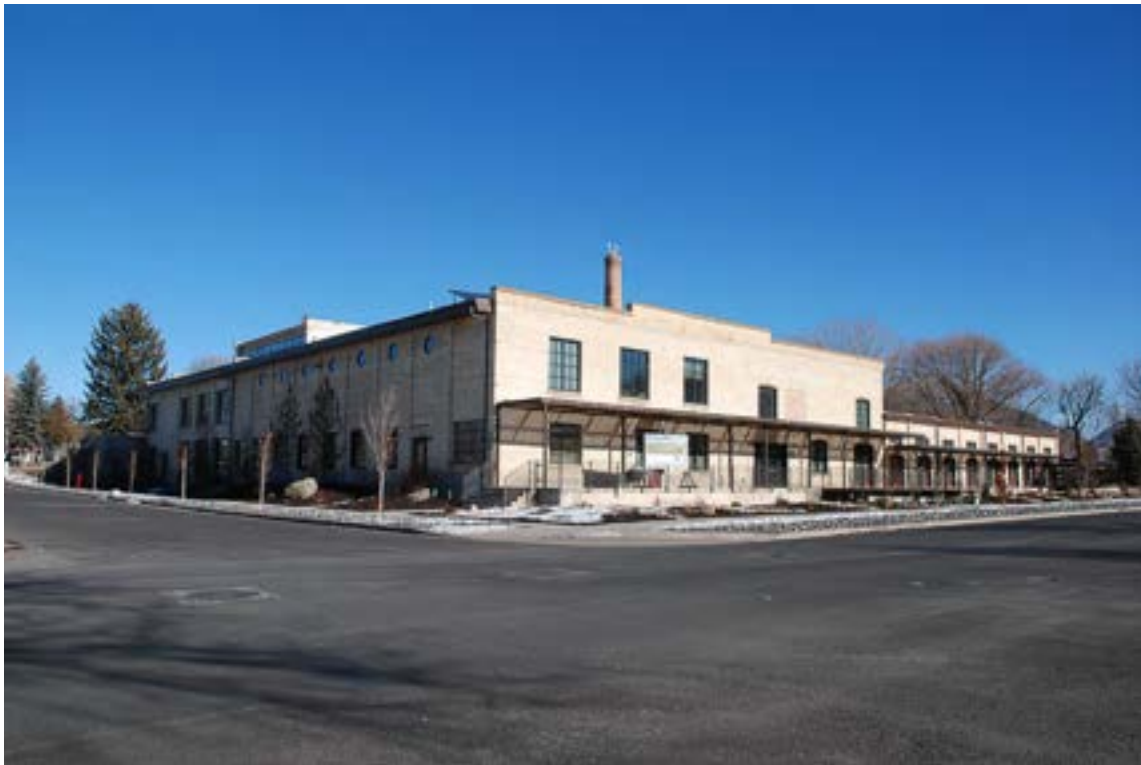
**Photograph 1**

Borden Company Plant, west and south elevations. Camera facing northeast.

A second addition was built around 1922 at the southeast corner, perpendicular to the main building façade. The addition is a tall one-story wing separated into eight bays by colossal piers on the long elevations. Each bay originally featured a five-light horizontal metal-sash window with concrete sills. On the east elevation of the addition are four bays with large loading doors in the middle two bays and horizontal windows in the flanking bays. The north elevation of the addition is similar to the south with horizontal windows and one metal door at the main level. During the recent rehabilitation, unit entries were added to each of the bays on the south and north elevations [Photograph 3 & 10]. This was the only major exterior modification to the building. On the east elevation, the former loading doors were filled with multi-light windows. All of the horizontal windows were retained and reglazed. As part of the rehabilitation, the former concrete loading dock across the entire south elevation was repaired and resurfaced with concrete. The dock is slightly curved at the east end to accommodate the rail spur that ran in front of the building. A section of the rail spur has been partially restored. The brise-soleil-style canopy was installed along the full width of the dock to shelter the main and unit entrances [Photograph 1].

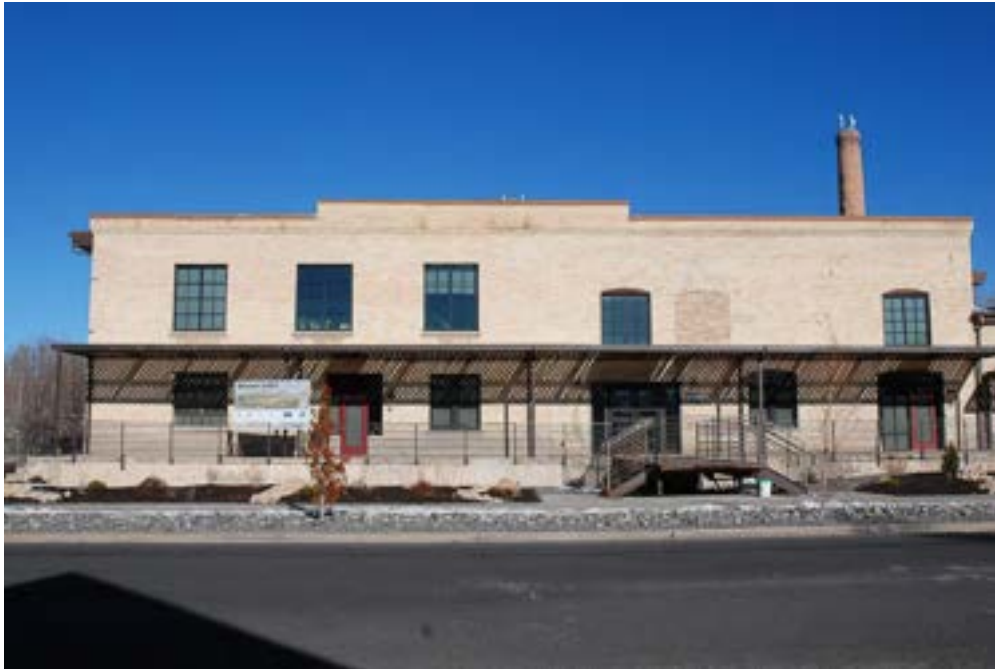
**Photograph 2**

Borden Company Plant, south elevation, west half. Camera facing north.

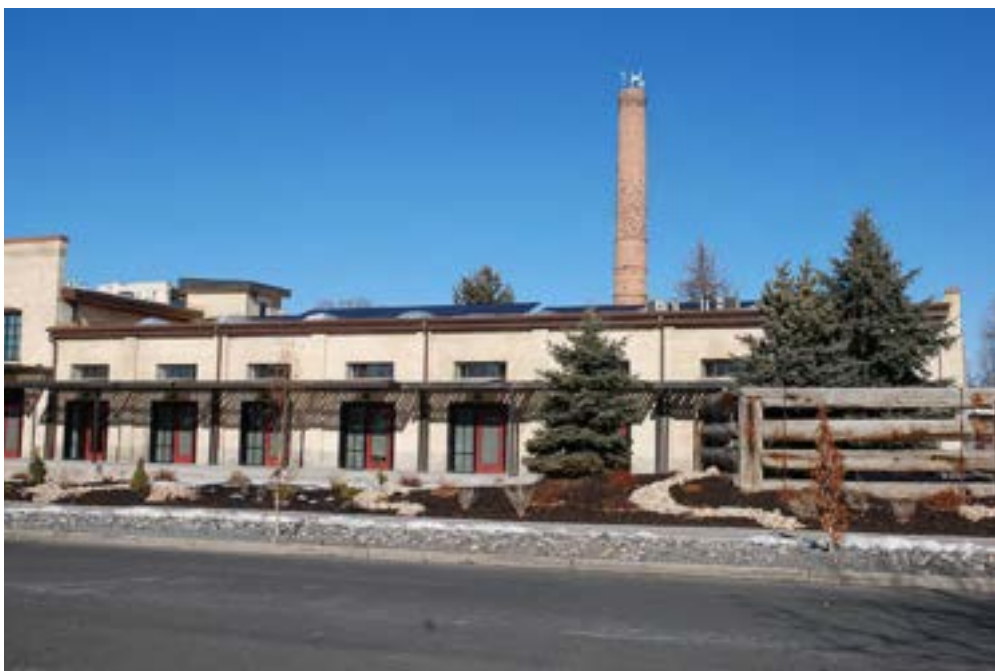
**Photograph 3**

Borden Company Plant, south elevation, east half. Camera facing north.

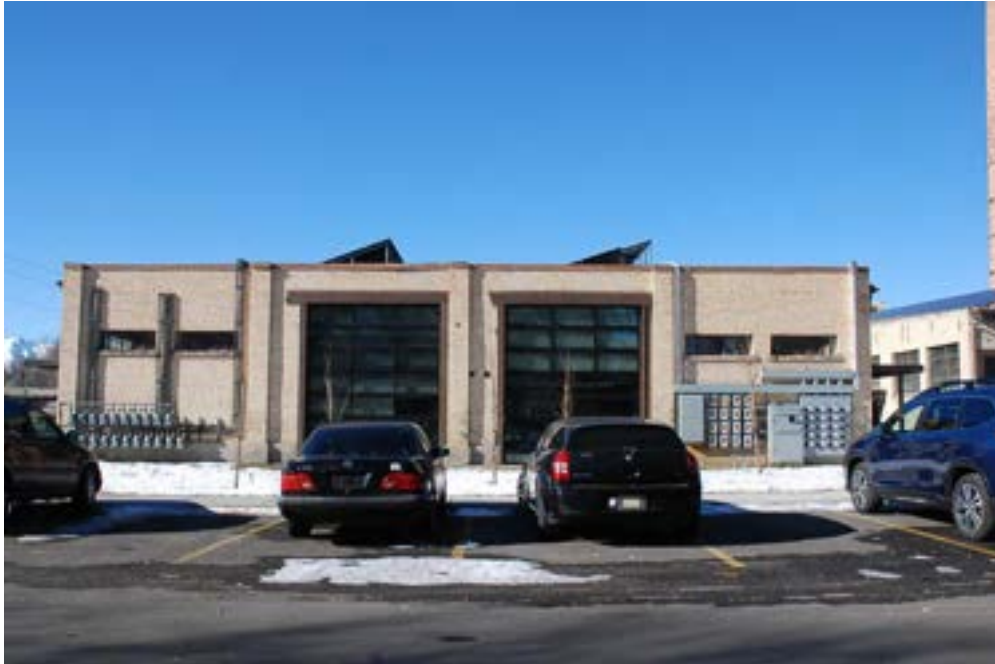
**Photograph 4**

Borden Company Plant, east elevation of southeast wing. Camera facing west.

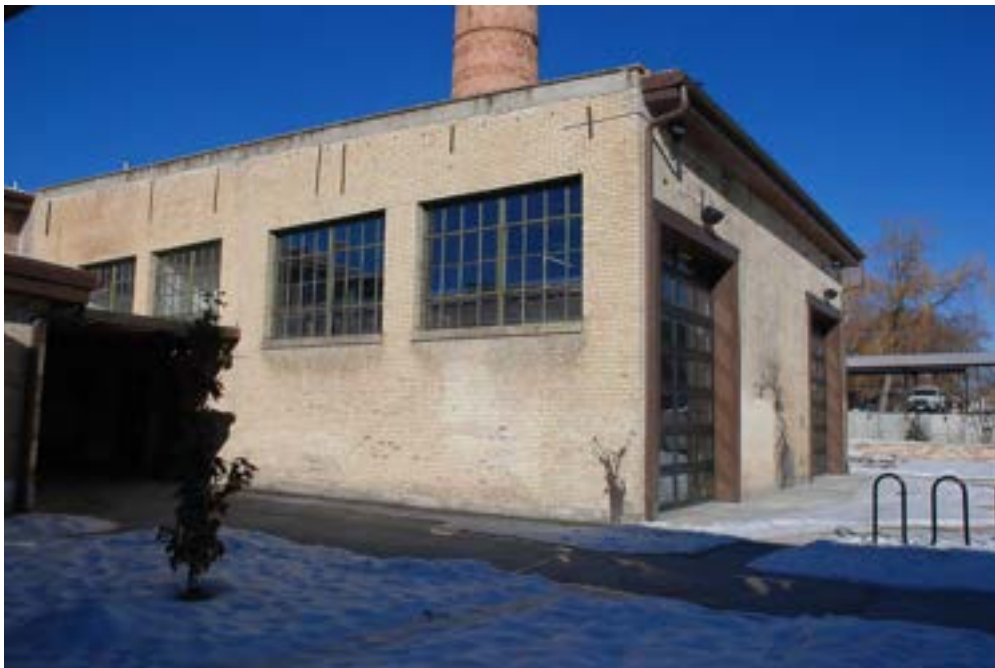
**Photograph 5**

Borden Company Plant, east and north elevations of stack wing. Camera facing northwest.

Sometime between 1925 and 1929, several smaller additions were made to the projecting northeast corner. These included a one-story brick washroom, the expansion of the coal/boiler rooms, and the construction of the smokestack. These brick additions also features daylight-factory windows. As noted above the north elevation appears as one-story due to the slope at the northwest corner of the property. The recent rehabilitation included the removal of the paint shed, the rehabilitation of all extant metal windows, and the filling of the east-facing loading doors with multi-light rolling overhead doors [Photographs 5 & 6]. The small courtyard and between the washroom to the south and the stack room to the north was modified as a public entrance for the east elevation [Photograph 11]. The washroom was adapted for use as a communal laundry, pet washing station, and bike storage. The stack room was rehabilitated as a clubhouse with public restrooms on two levels. The round red brick smokestack is located in the center of the clubhouse room. The stack rises approximately 82 feet with the word BORDENS facing west outlined in black brick [Photograph 25]. The smokestack is a landmark feature of the complex. It was retained, cleaned and seismically retrofitted.

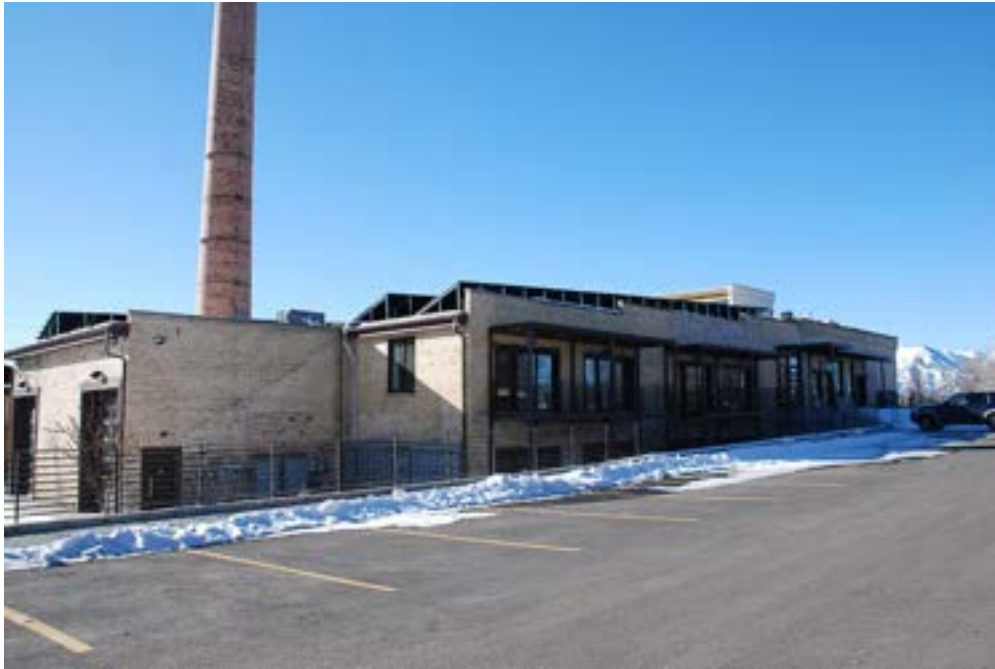
**Photograph 6**

Borden Company Plant, east and north elevations. Camera facing southwest.

Due to the slope of the site, the north elevation appears to be one story high; however, the 1904 center and 1916 west sections have two full stories. Prior to the recent rehabilitation most of the lower section was not visible due to a build-up of soil to accommodate the loading dock. In the 1980s, a corrugated metal painting shed was attached to the north elevation next to the rear dock. For the adaptive reuse, dirt was excavated next to the center section to provide outside access to the main level units. A balcony was created to access the second level units. New doors and windows were created for these units. The former loading dock doors were modified as a north entrance foyer with access to the parking lot. The large hole left by the removal of the paint shed was partially filled with brick around one unit's entry door [Photograph 6].

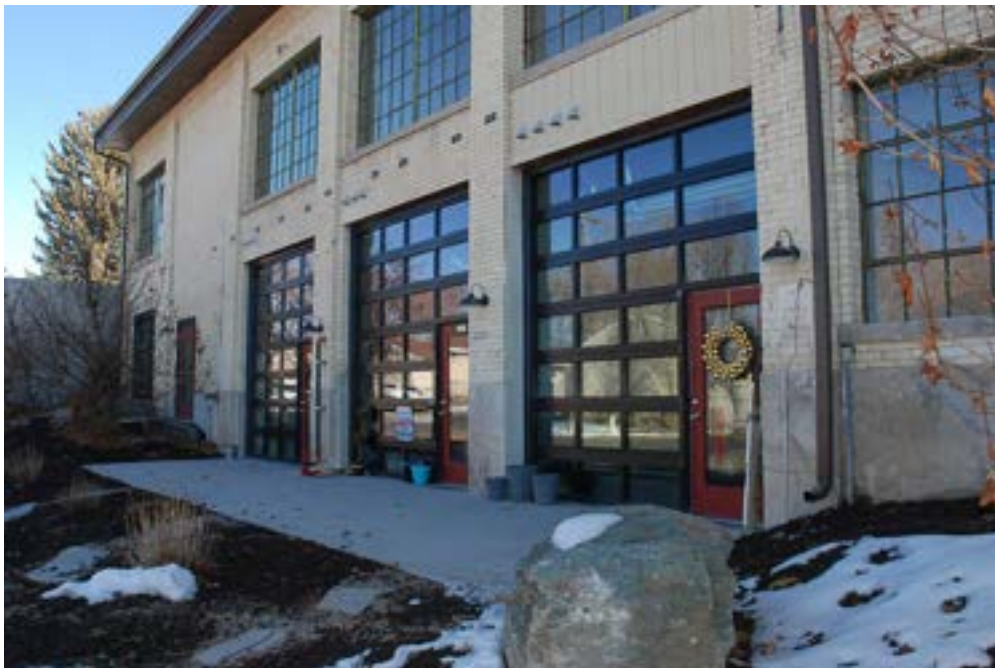
**Photograph 7**

Borden Company Plant, north half of west elevation. Camera facing northeast.

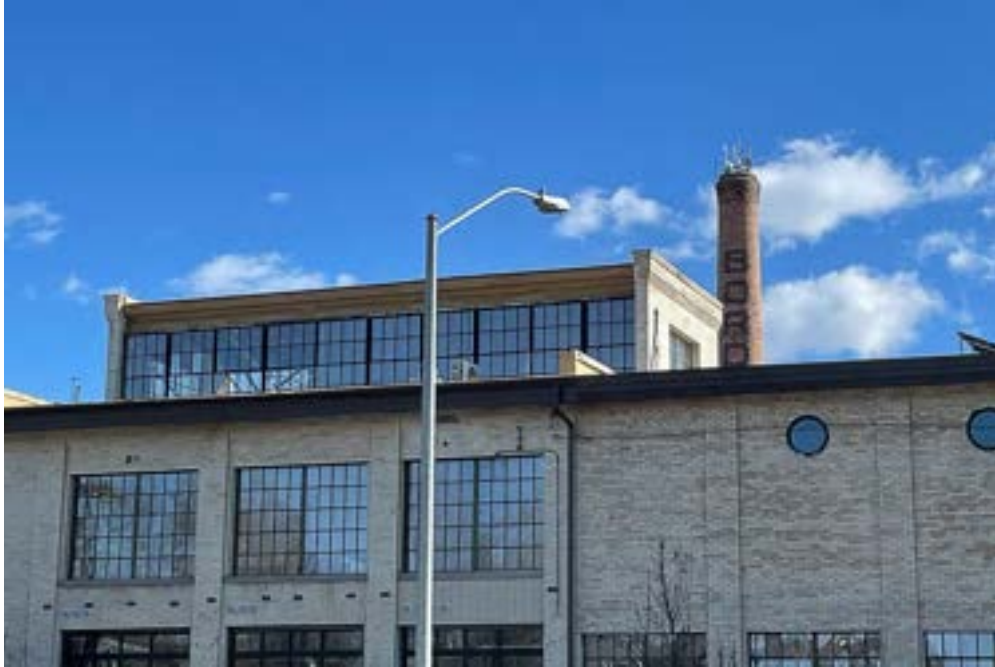
**Photograph 8**

Borden Company Plant, west elevation, upper levels of north half. Camera facing east.

During the recent rehabilitation, the windows on the main level were rehabilitated and the door opening was reglazed as a unit entry. The upper-level window façade openings were filled with daylight-factory-style windows similar to the extant windows on the west elevation. All of the historic metal-sash windows were retained. Additional windows were added to four main level blank bays with replacement windows to match the historic windows [Photograph 9]. The three loading doors were removed and the openings replaced with unit entries surrounded by multi-light windows [Photograph 7]. The round openings on the upper level were unblocked and reglazed [Photographs 8 & 9]. The monitor was rehabilitated with no major modifications [Photograph 8].

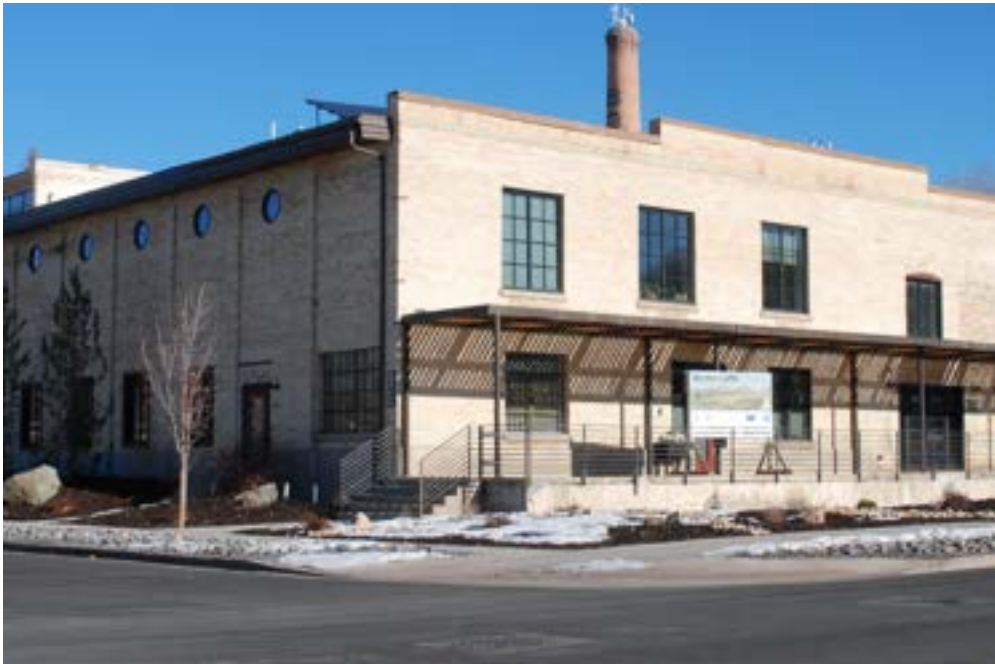
**Photograph 9**

Borden Company Plant, southwest corner. Camera facing northeast.

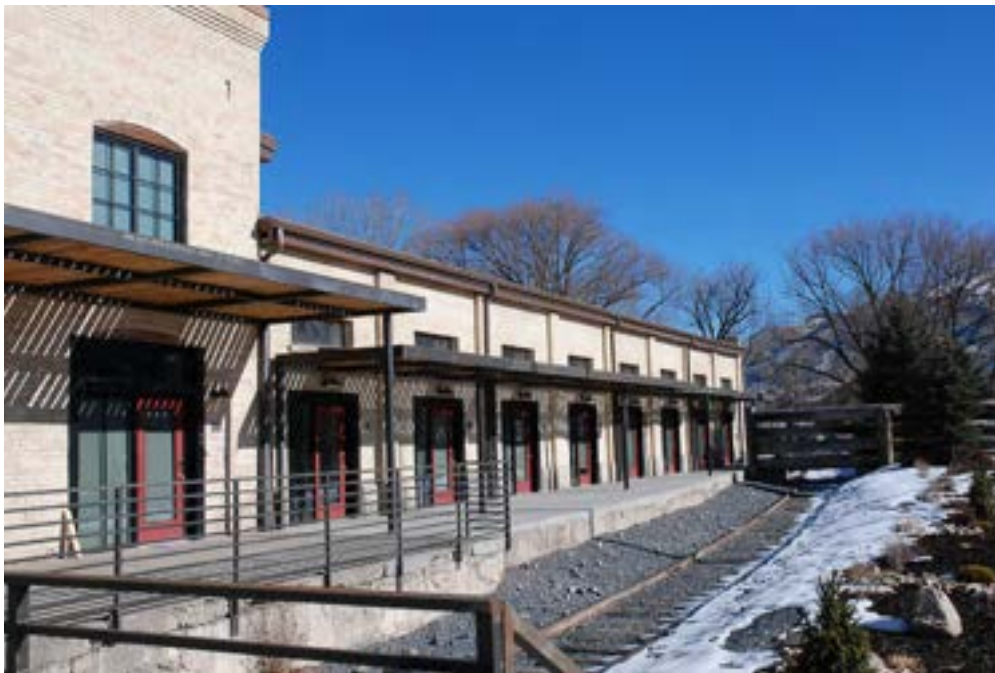
**Photograph 10**

Borden Company Plant, south elevation with view of rail siding. Camera facing east.

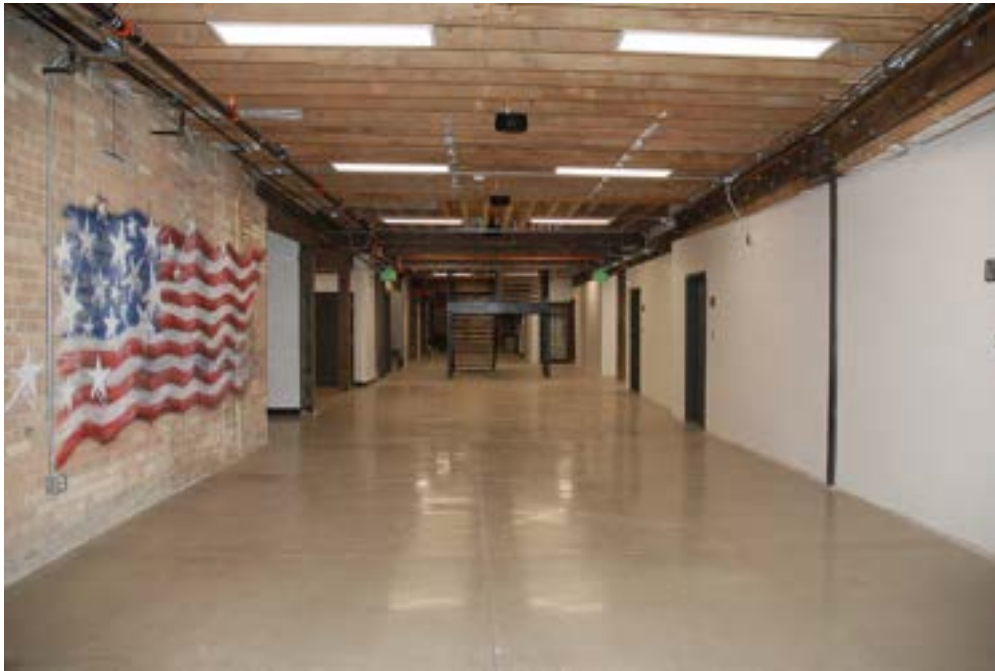
**Photograph 12**

Interior, main level, corridor. Camera facing north.

Two intersecting corridors were created in the north half. One wider corridor to access the east entrance foyer and a narrower corridor on both floors to access the new clubhouse space in the stack room. Prior to the rehabilitation, the building only had two narrow staircases. A closed wood staircase in the 1904 section and a metal open staircase in the 1916 section. Neither of these staircases met current code and were removed. Two new wide and open metal stairs were installed in the north and south halves of the main north-south corridor providing access to both of the two-story sections of the building [Photograph 13]. The corridors are decorated with graffiti art in a nod to the building's period of vacancy [Photographs 12 & 20].

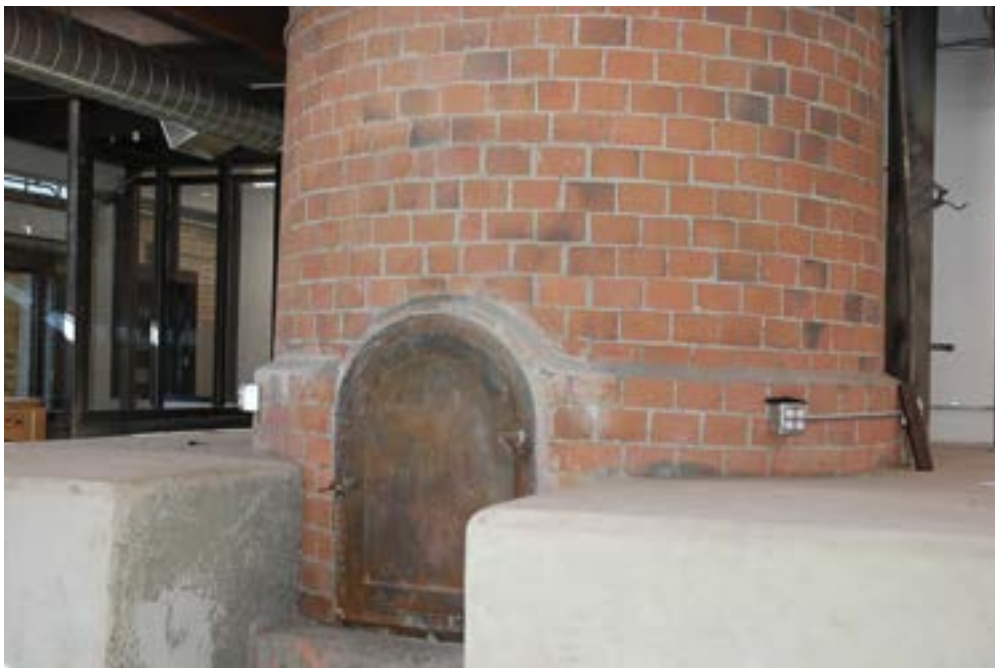
**Photograph 19**

Interior, main level, clubhouse, stack detail. Camera facing west.

The final building phase included the expansion of the boiler room and the construction of the smokestack on the interior of the building circa 1925. The 82-foot stack replaced a shorter stack. The washroom addition and the north shop were built around the same time. During the recent rehabilitation, four additional units were created in the northwest quadrant of these auxiliary spaces, two on the main level and two on the upper level. The four units have exterior access to the north, but no loft space. The stack room was divided into two levels with a metal staircase, making three staircases in the building. The stack is visible on both levels [Photographs 18 & 19]. The edges of the new second-level deck are independent from the original walls, so that the new full-glass height rolling garage doors can be opened and the original windows are visible [Photograph 5]. There are public restrooms (both levels), roof access, a custodial closet, and the leasing office next to the clubhouse (stack room). The washroom addition is divided into a communal laundry, dog-washing station, and bike storage.

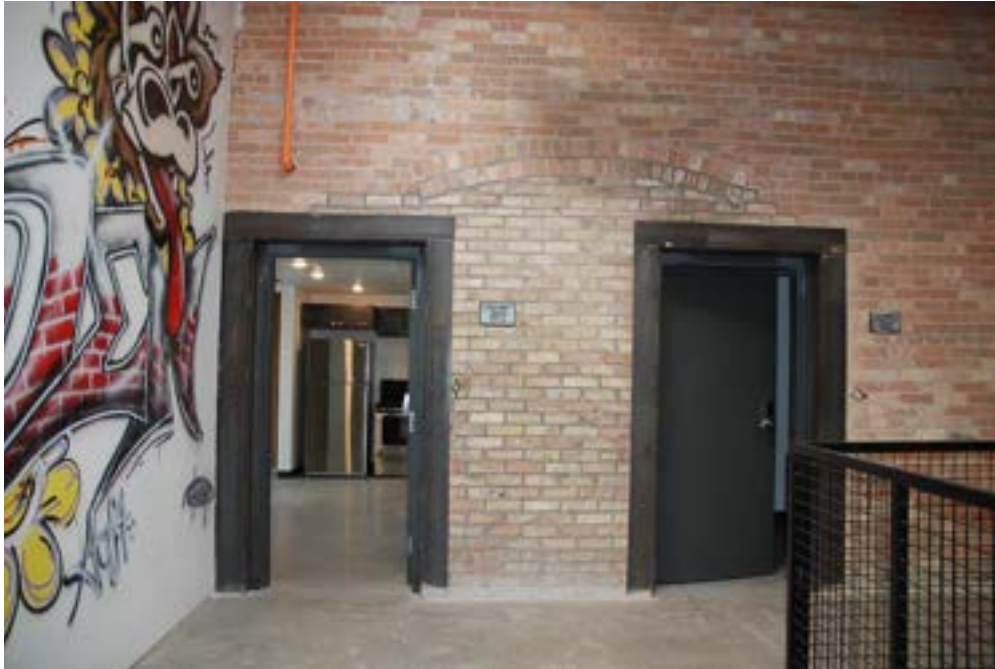
**Photograph 20**

Interior, second level, entrance to Unit 201 and Unit 202. Camera facing west.

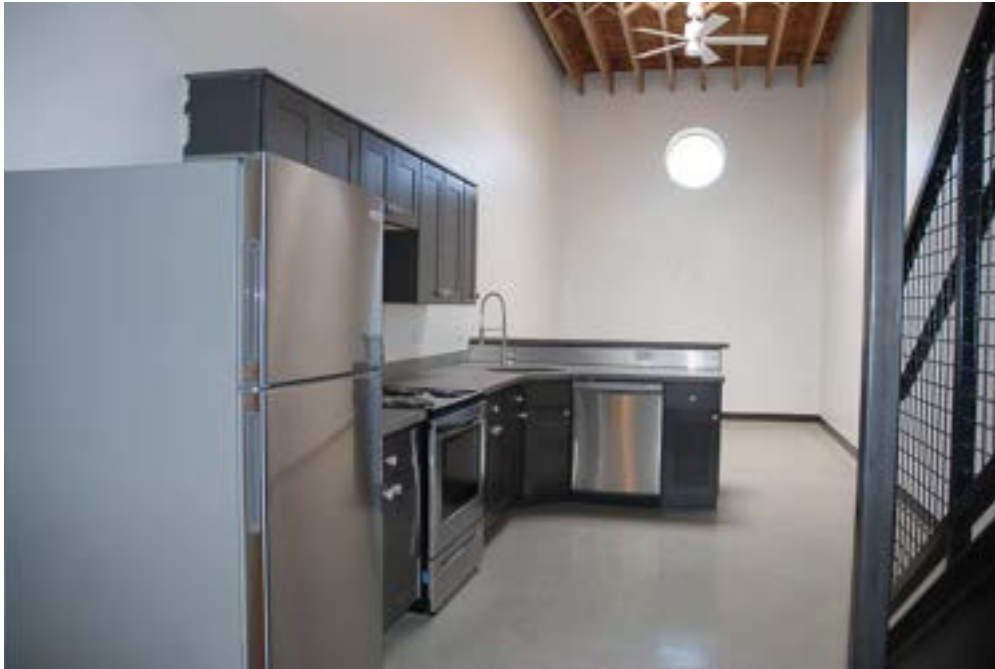
**Photograph 22**

Interior, second level, Unit 204. Camera facing west.

When the west section was built in 1916, the plant's square footage and capacity nearly doubled. The north end became the new receiving room. Just to the south, the large space with monitor lighting became the pan room. The south two-thirds of the addition was the sealing room and can storage. The milk plant office was moved to the southwest corner of the main floor [Figure 4]. The interior support system included a combination of steel posts and wood timbers, with a few structural I-beams added later. During the recent rehabilitation, the main floor of the west section was divided into ten units, two with lofts [Photographs 14 & 23]. The units at the northwest and southwest corners have exterior access. Because the second level has a higher ceiling, twelve of the thirteen units have a second-story loft that is half the size of the unit. Three units near the north end have a third-story room in the roof monitor space [Photograph 24]. Seven of the units feature the round fan openings, now glazed [Photograph 22].

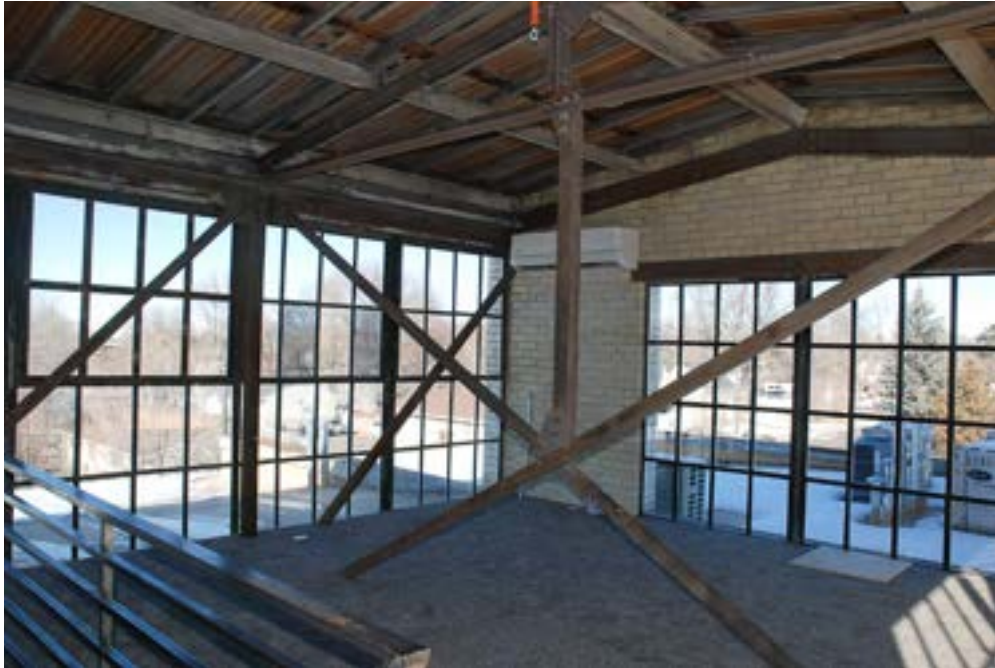
**Photograph 24**

Interior, third level, Unit 211, monitor room. Camera facing northwest.

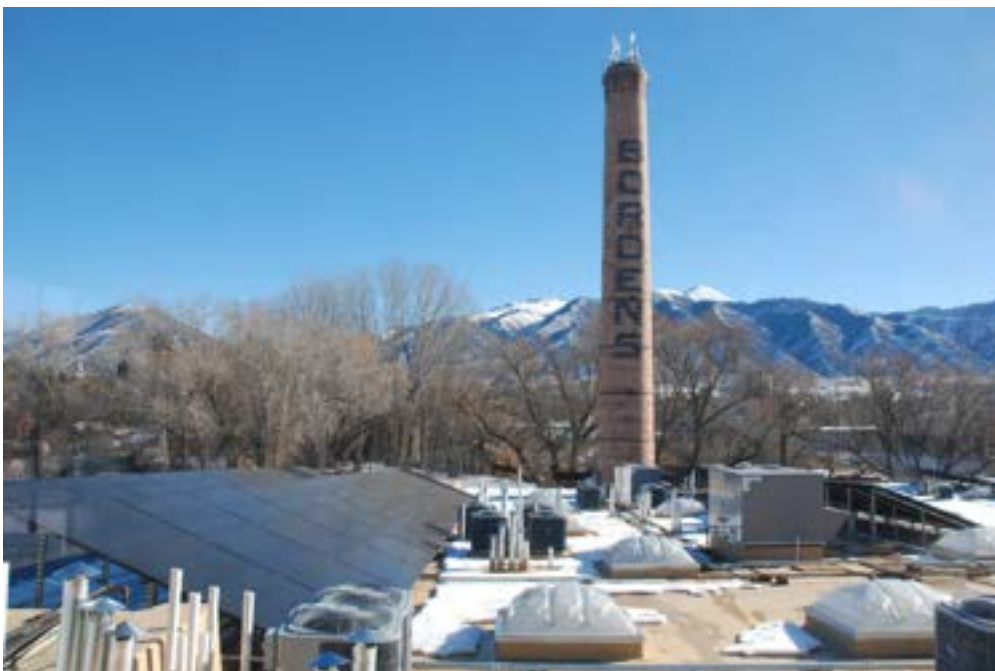
**Photograph 25**

Borden Company Plant, view of stack and roof.

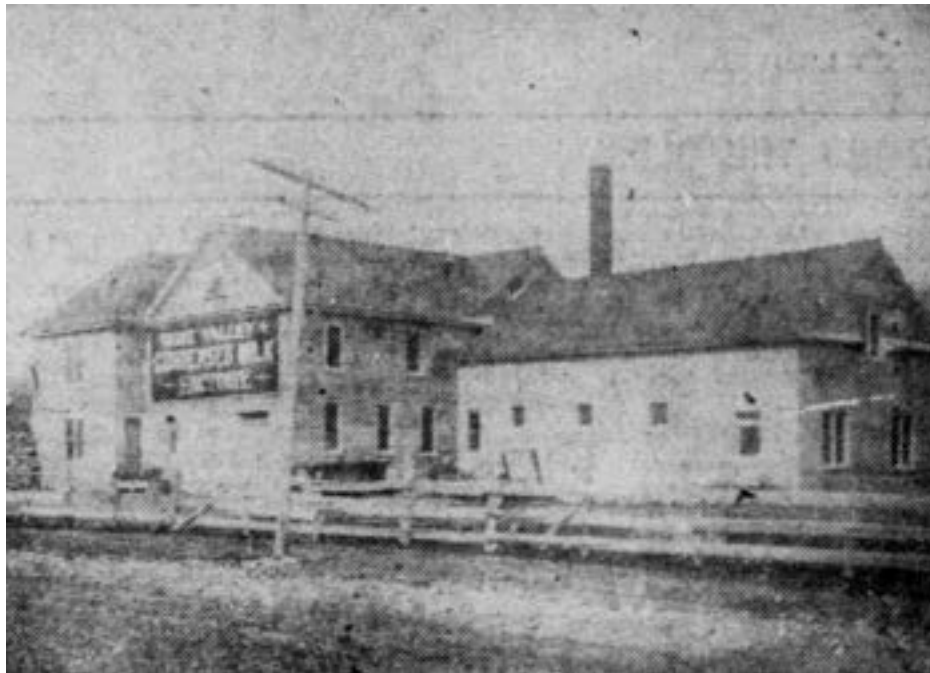
**Figure 1**

Cache Valley Condensed Milk Factory, south and west elevations. Camera facing northeast. Photographed for an article in the *Salt Lake Herald Republican* in 1906 (best available copy).

The first milk factory constructed at the site was built in 1904. It was a 1½ to 2-story brick building with a stone foundation and intersecting gable roofs [Figure 1]. Around 1907, the original building was partially encased with extensions of the south and west elevations. On a 1911 Sanborn Fire Insurance Map, the 1904 footprint can be seen as the northeast section with the circa 1907 extension to the west and south [Figure 2]. The extension is currently visible as center section of the south elevation (façade). The modest Victorian features of the building are best viewed on the façade, which has segmental-arched rowlock brick window hood moldings, at both the main and upper levels. There are three courses of corbelled brick just below the parapet. The corbelled parapet originally wrapped around the building but has been obscured by later additions [Photograph 1]. The center roof slopes slightly to the east behind the parapet. Prior to the recent rehabilitation most of the window and door openings on the south elevation were replaced with aluminum and later blocked with plywood [Figures 7 & 8]. One of the upper window openings has been blocked with brick since the 1970s.

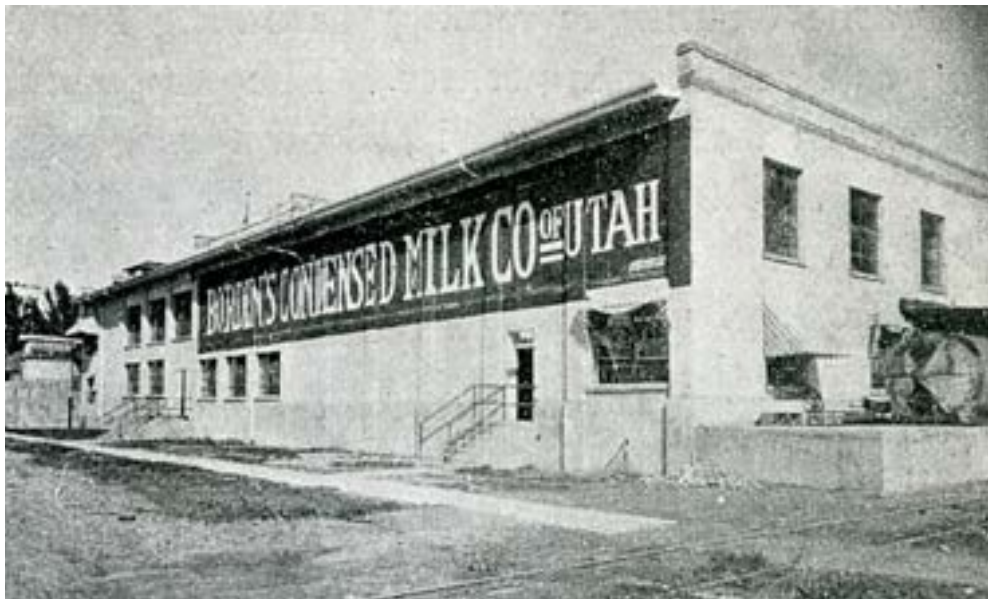
**Figure 3**

Borden Condensed Milk Company, south and west elevations. Camera facing northeast.  
Courtesy Tony Johnson photograph collection, circa 1917.

The west half of the building is a two-story section added in 1916 [Figure 3]. This north-south block addition doubled the original two-story space, lengthened the façade by fifty feet, and squared the northwest corner as seen on a 1930 Sanborn map [Figures 4 & 5]. The brickwork is identical with a seam where the two sections meet [Photographs 1, 2 & 9]. The original parapet was raised to provide a stepped parapet and a continuation of the corbelling visually unifying the parts. The addition originally had a built-up roof. The fenestration of the west addition features flat window lintels. The main and upper levels of the façade addition originally had daylight factory windows with metal sashes [Figure 4]. By the time of the recent rehabilitation, only one original façade window was extant, although damaged. One main level window was converted to a door (circa 1960s). The west elevation is primarily the 1916 two-story addition, which was built at the point where the topography slopes downward from north to south, and east to west. The concrete foundation appears raised along the west elevation. The elevation is divided into fourteen bays divided by colossal brick piers. The five north bays are slightly wider than the bays to the south. At the north end of the building, a monitor of daylight factory metal-sash windows is visible on the roof. The monitor has daylight factory windows on all four sides with brick corners. There are large daylight factory style windows in four of the five larger bays on the second level of the south elevation. The main level has similar windows in four of the narrower bays. The three large loading doors in the central bays were originally windows that were enlarged (circa 1960s). Seven of the narrower bays feature a round opening just under the cornice line, which appear to have held fans for ventilation.

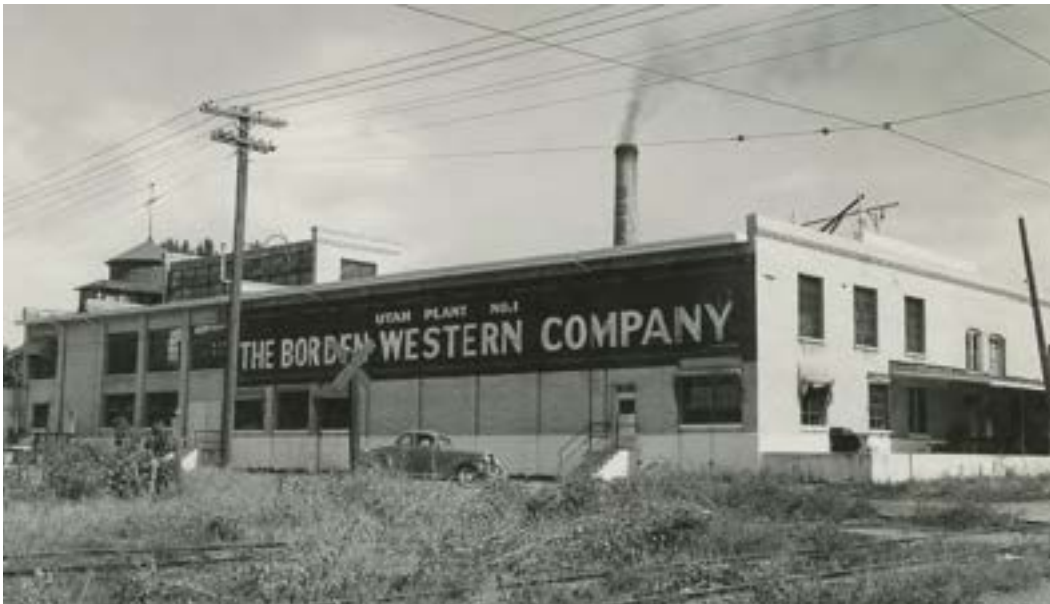
**Figure 5**

Borden Western Company Milk Condensery, Utah Plant #1, south and west elevations. Camera facing northeast. Courtesy Tony Johnson photograph collection, circa 1937.

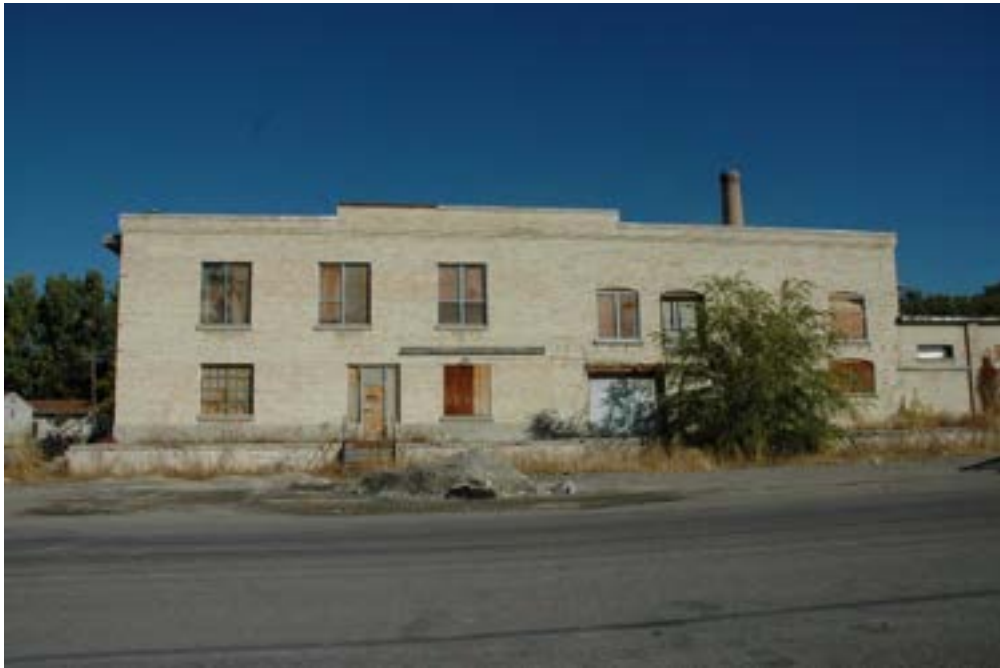
**Figure 7**

Borden Company Plant, south elevation. Camera facing north.  
Photographed in 2005 by author, pre-habilitation.

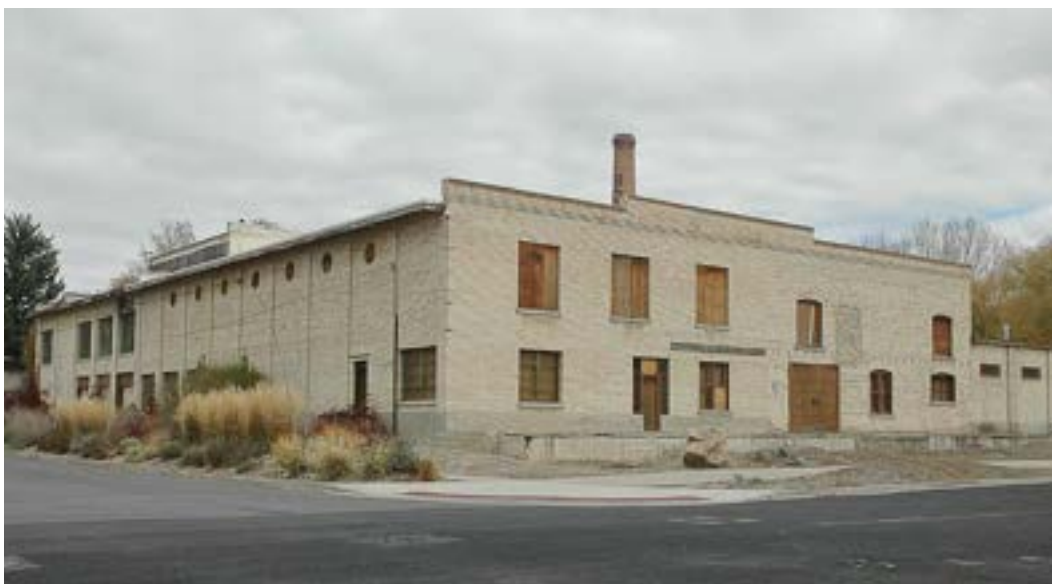
**Figure 8**

Borden Company Plant, south and west elevations. Camera facing northeast.  
Photographed in 2014 by author, pre-habilitation.
