NATIONAL REGISTER OF HISTORIC PLACES REGISTRATION FORM

Historic name: Rushmer Building

Name of related multiple property listing: Commercial and Industrial Properties of Ogden, Utah, 1845-1975

Street & number: 2434-2436 Washington Boulevard

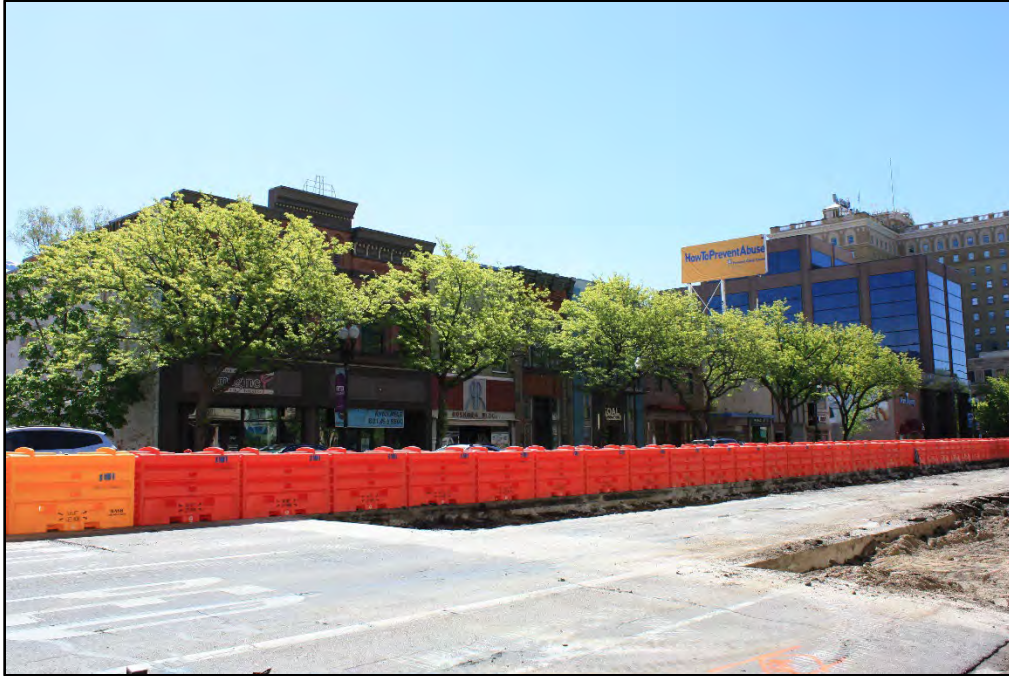
Photo 1 of 24. Overview of the east side of the 2400 Block of Washington Boulevard, facing southeast. The Rushmer Building is second from the left.

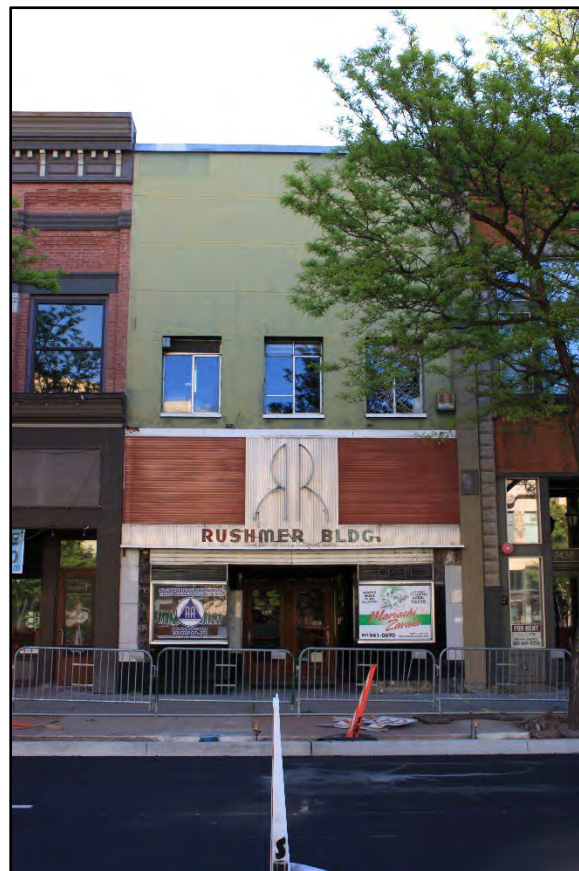
Photo 2 of 24. West (primary) elevation of the Rushmer Building, facing east.

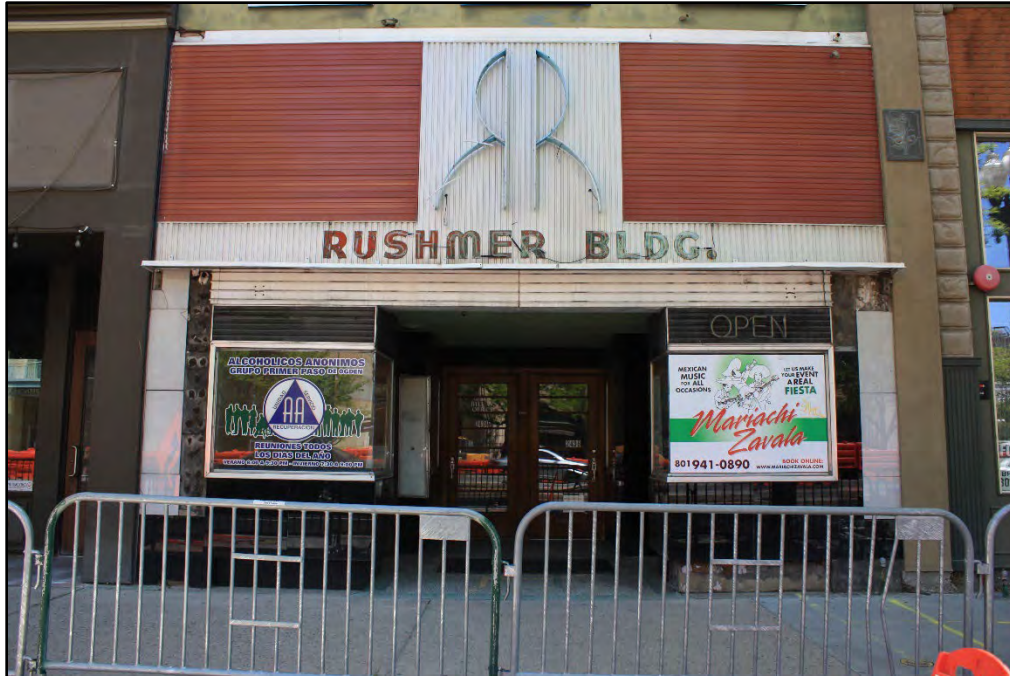
Photo 3 of 24. Overview of the first-story storefront, facing east.

In 1939, the storefront was reconfigured, and the exterior of the first story was clad in Vitrolite glass, characteristic of Art Deco and Moderne storefronts of the 1930s and 1940s (see Figure 2 and Figure 3). Opposing aluminum sash display cases were constructed at the sidewalk on either side of the central entrance to capture the attention of pedestrian consumers in the commercial district. The terrazzo floor was designed to draw consumers into the entrance toward the flanking wood stile and rail doors featuring seven horizontal lites, which lead to two commercial spaces on the first floor. Opposing display cases are adjacent to either entry.

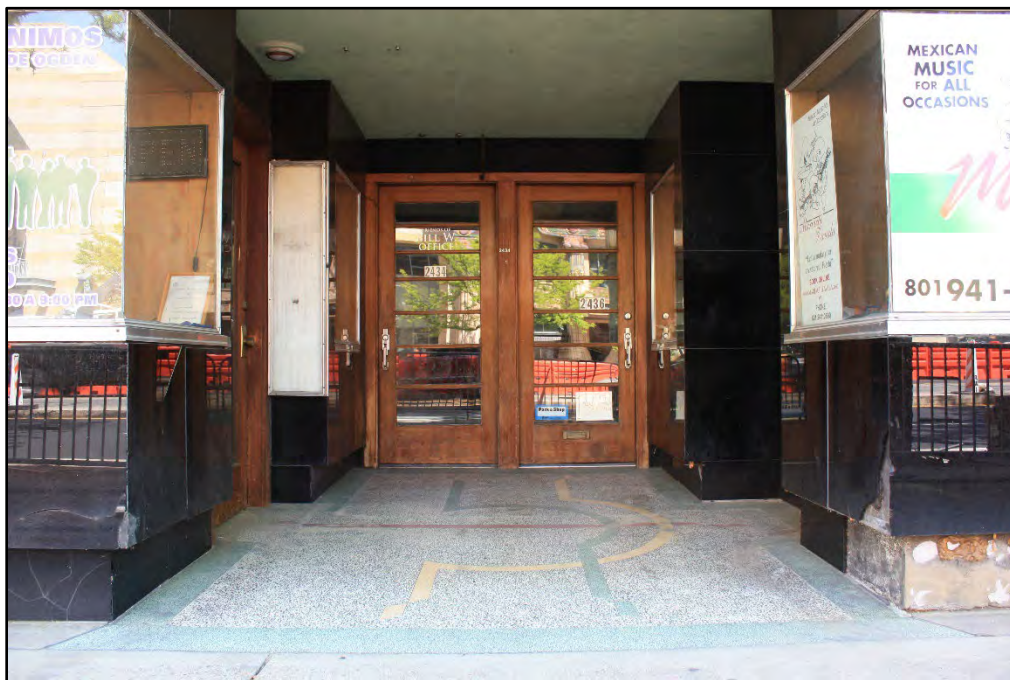
Photo 4 of 24. Centered entry to the flanking first-story commercial spaces with a side entry (left) to the second story commercial space.

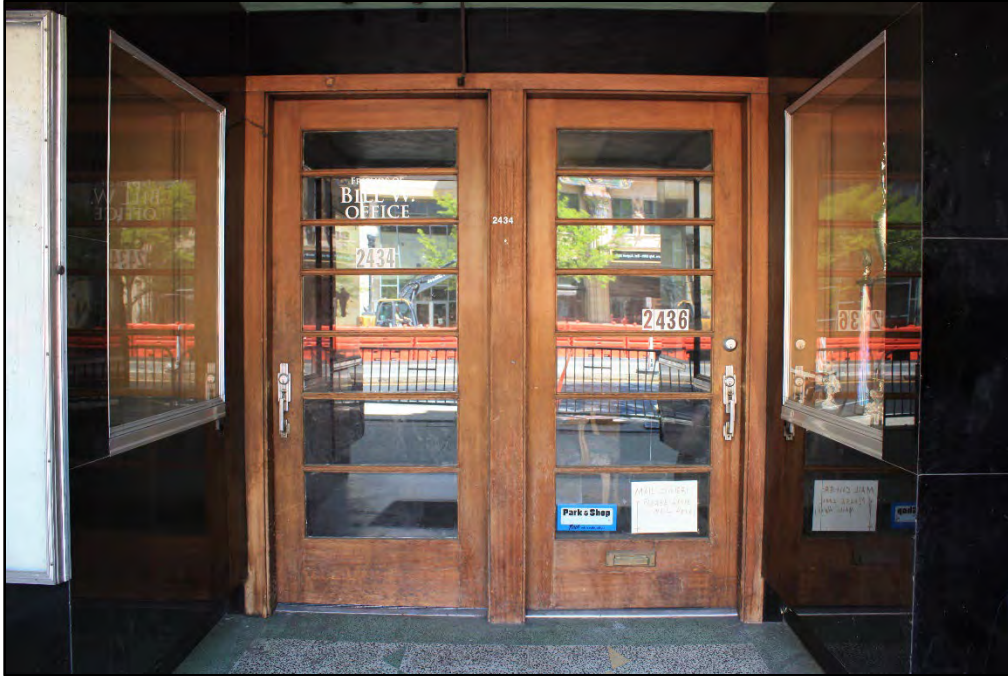
Photo 5 of 24. Detail of the flanking entry doors.

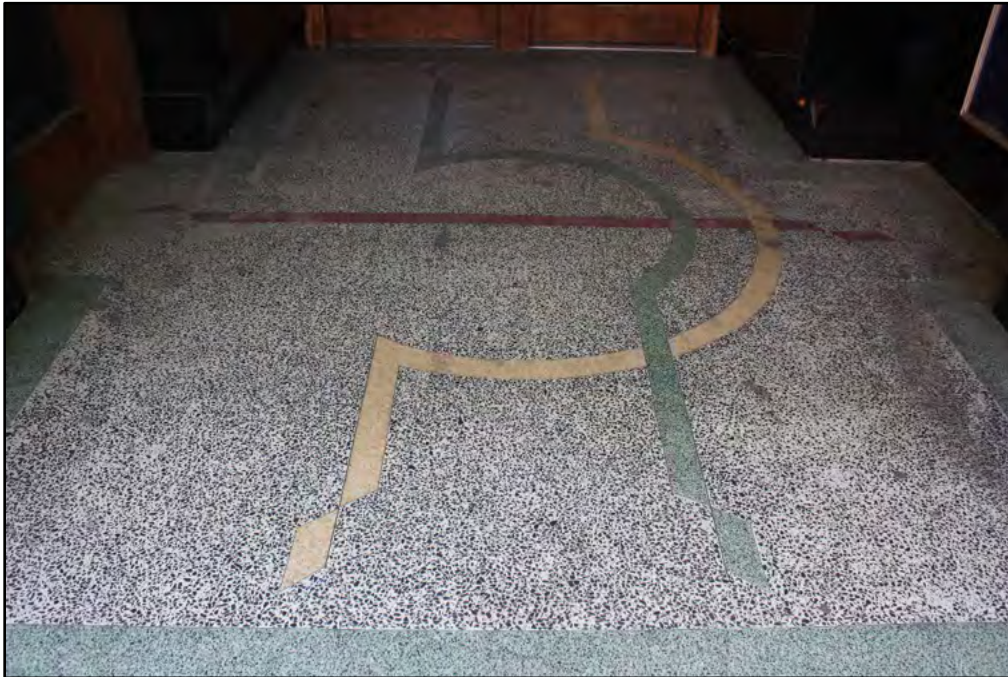
Photo 6 of 24. Detail of the patterned terrazzo floor

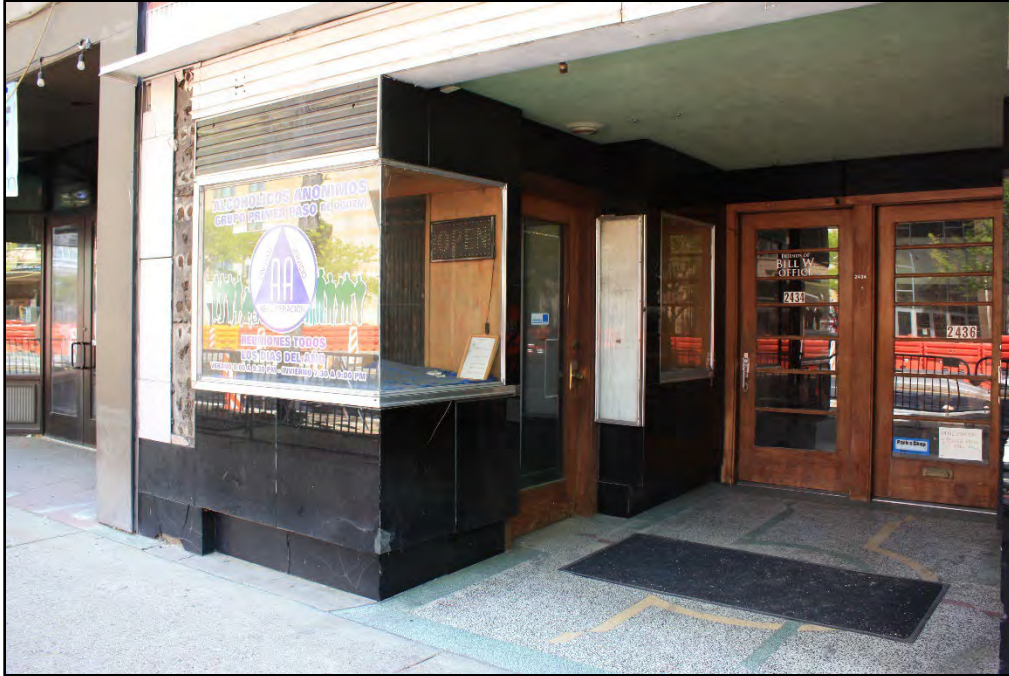
Photo 7 of 24. Overview of the north display cases and the side entry to the second-story commercial space, facing northeast.

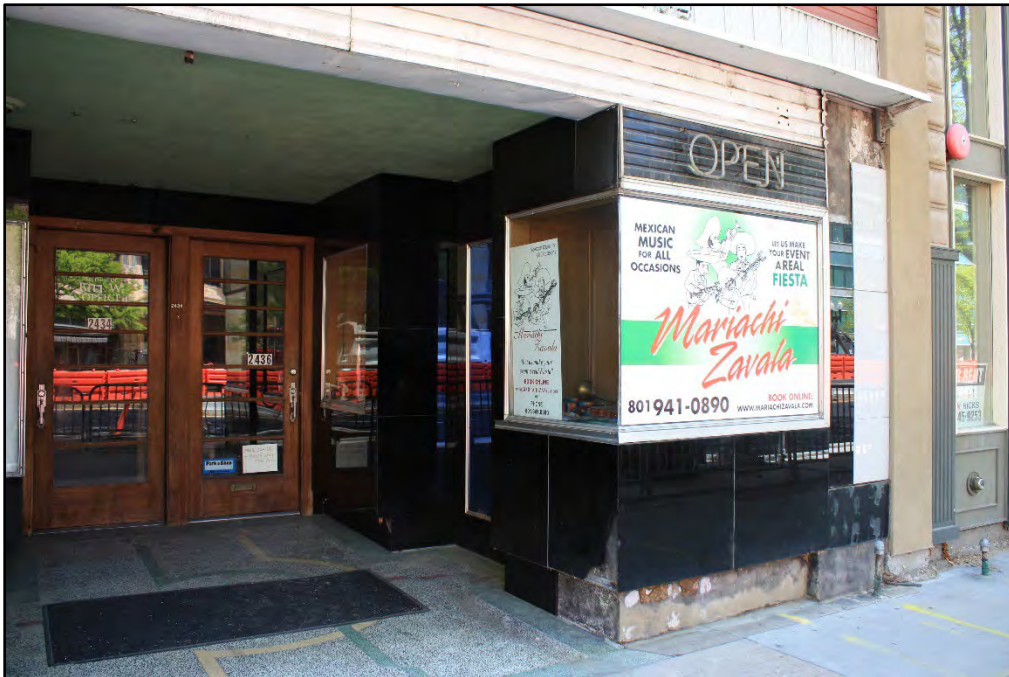
Photo 8 of 24. Overview of the south entrance display cases, facing southeast.

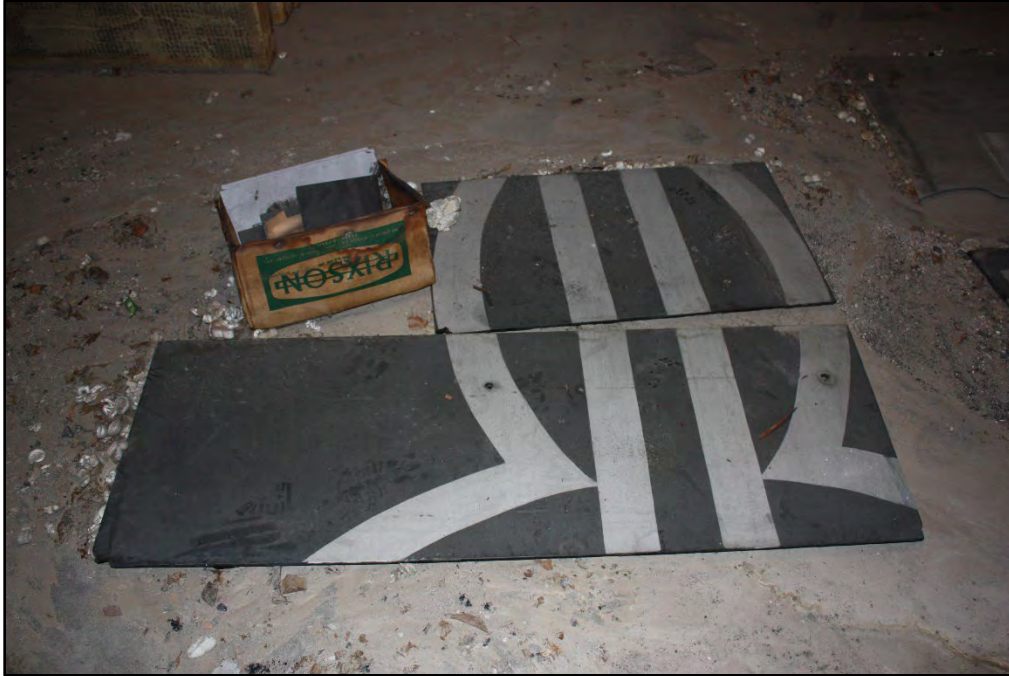
Photo 9 of 24. Pieces of the Vitrolite sign that is being stored on-site at the Rushmer Building.

The Vitrolite glass initially extended above the storefront emblazoned with the name and symbol of the Rushmer Building. In 1955, a fire occurred and the Vitrolite sign was replaced with the extant two-tone ribbed metal.

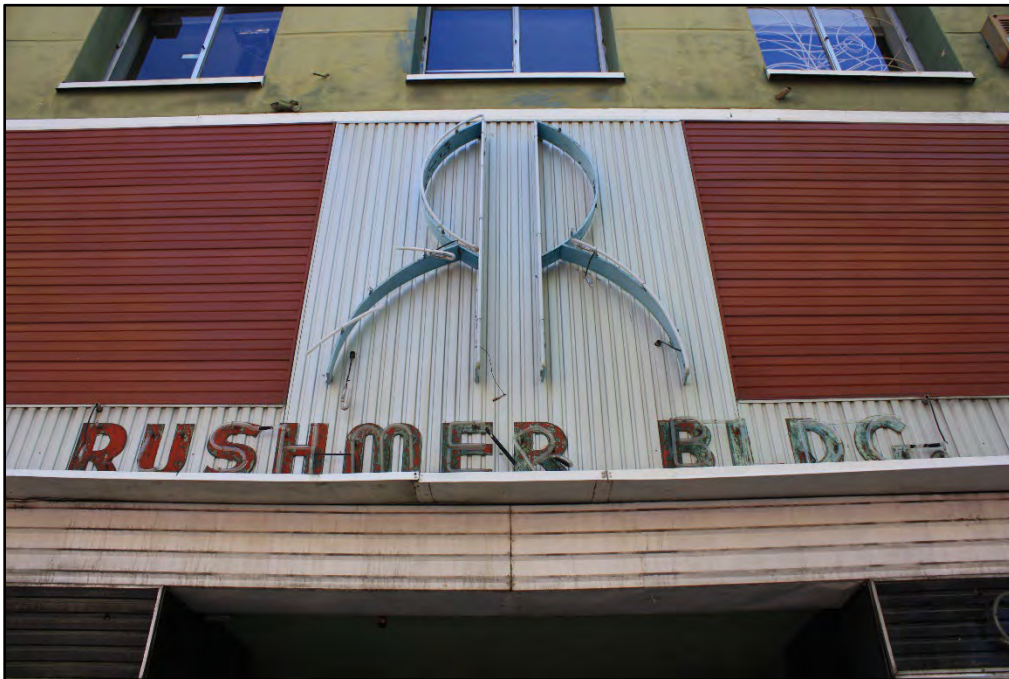
Photo 10 of 24. Ribbed metal signage replaced the Vitrolite signage in 1956, facing east.

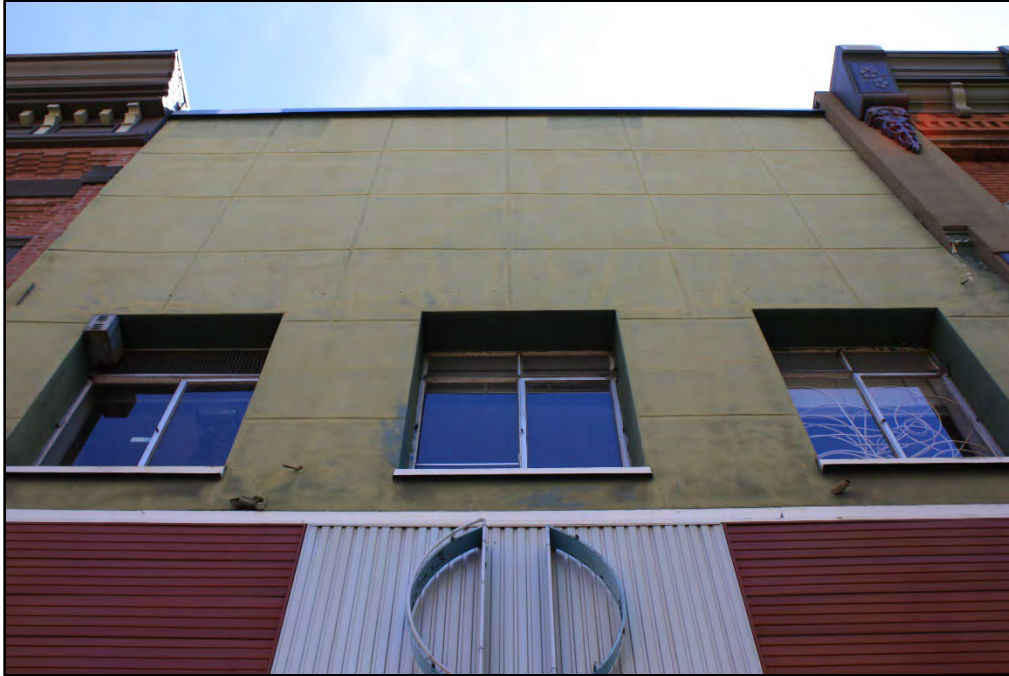
Photo 11 of 24. Exterior stucco cladding and sliding aluminum sash windows in the second story, facing east.

In 1956, the exterior of the second story was covered with concrete stucco that is incised to simulate rectangular panels. Concurrently, the original window openings were reduced in size, and the original glazing was replaced with the extant sliding aluminum sash windows. The smaller windows provided greater surface area for applied signage at the second story, characteristic of 1950s and 1960s storefronts. When this modification was made, Farr Jewelers occupied the second-story commercial space, and a large “Farr & Co.” sign was affixed to the exterior of the second story (see Figure 4).

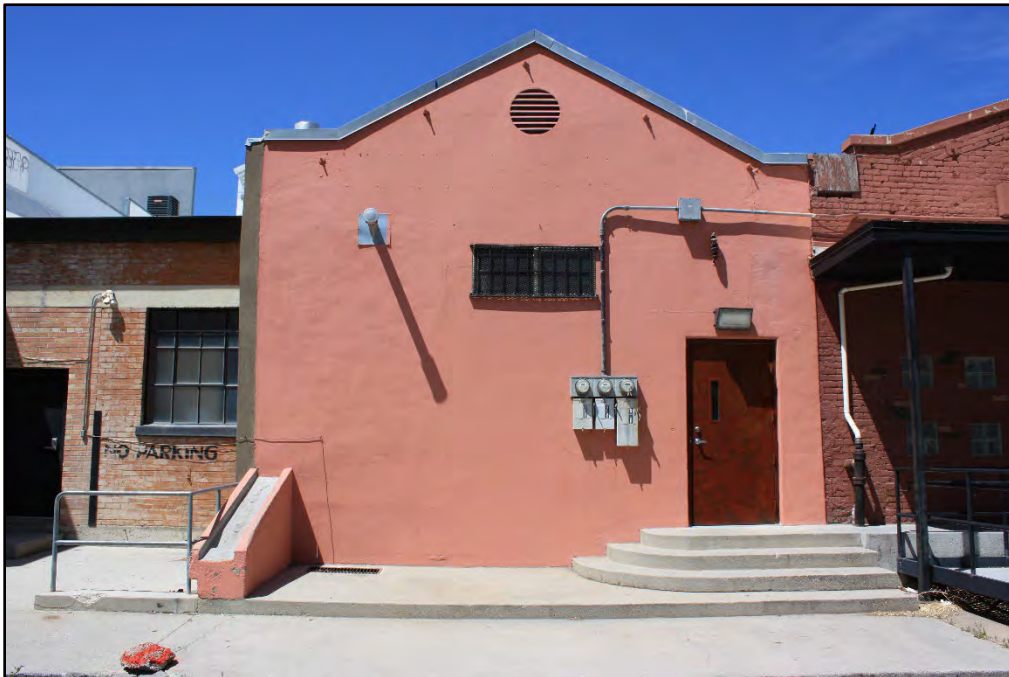
Photo 12 of 24. East (rear) elevation with the entry stairs and entrance to the second story at grade, facing west.

The east (rear) elevation faces Canal Alley—historically, the location of an irrigation canal—and a parking lot and contains a rear entrance into the second-story store at grade. Historically, the east elevation stood two stories tall above grade. A well adjacent to the first story was created by the fill for the existing road and covered with the existing concrete entry stairs. The exterior of the first story remains extant underground and retains the historic or original freight entry door and two original windows. The freight door consists of two outer hinged wood doors with a two-lite transom in a segmental arch door surround. The door is offset to the north end of the west elevation. The windows are fixed three-over-three lite wood sash windows with two-lite transoms set in segmental arched openings and supported on sandstone.

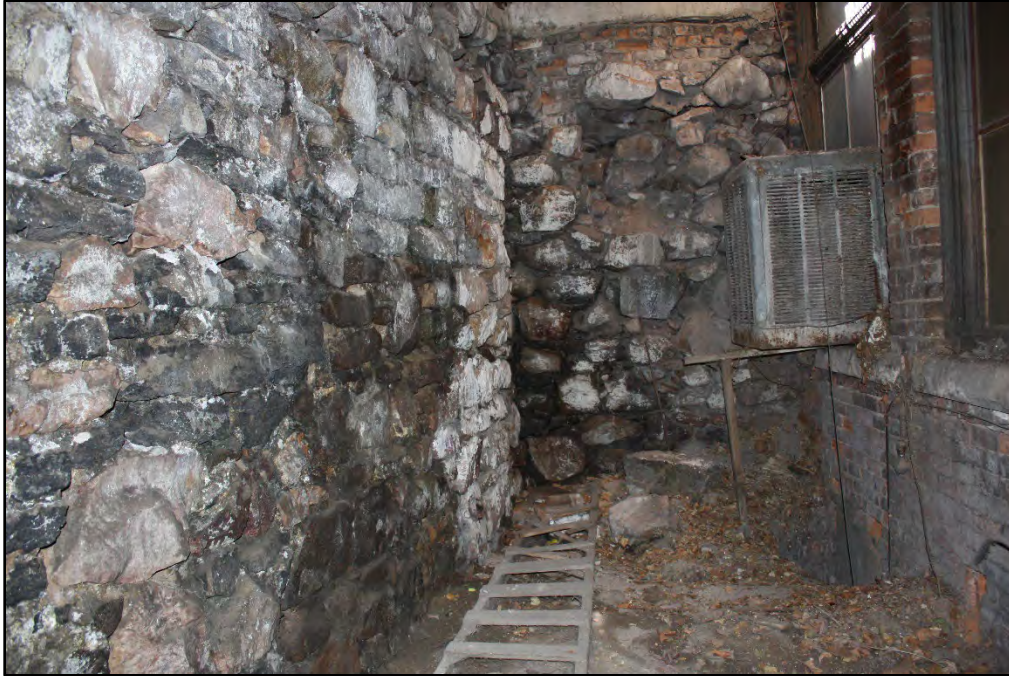
Photo 13 of 24. Road fill enclosing the east (rear) elevation at the first story, facing south.

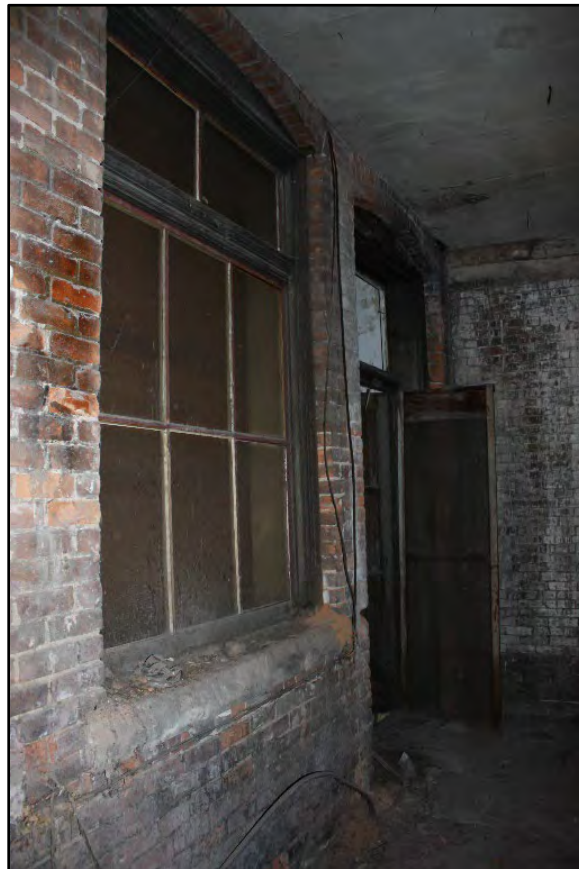
Photo 14 of 24. Freight door (right) and original window (left) in the first story of the east elevation, facing northwest.

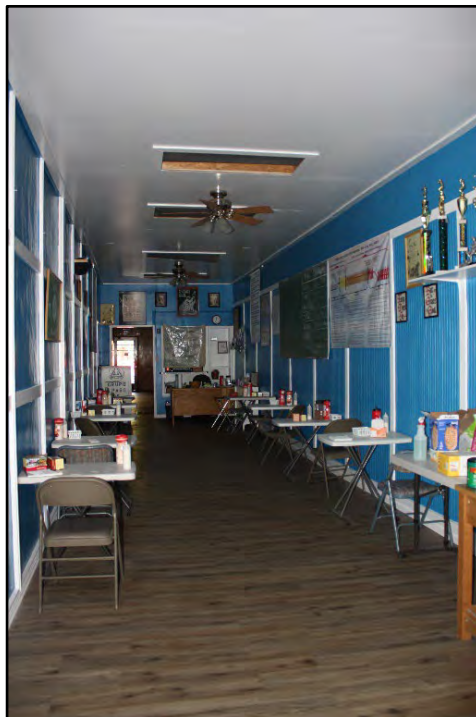
Photo 16 of 24. Interior of the rear north commercial space with beadboard wall cladding, facing west.

rear space is open, with vinyl flooring, beadboard wainscoting, and a false ceiling. A modern bathroom is between the rear north commercial space and the freight area at the rear of the building.

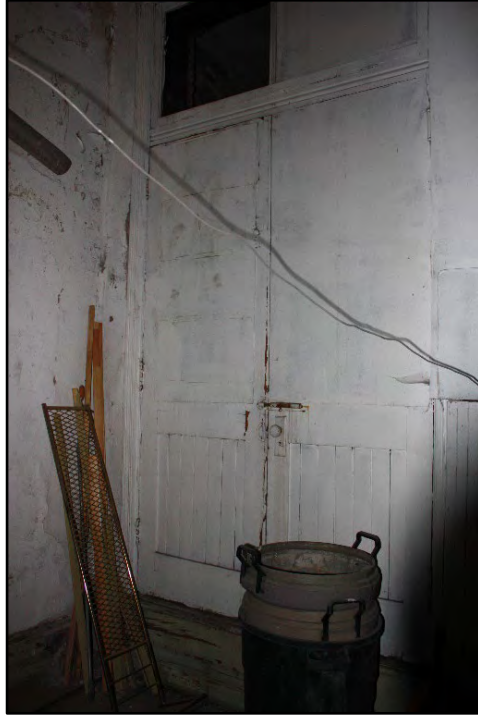
Photo 21 of 24. Interior view of the hinged freight doors, facing east.

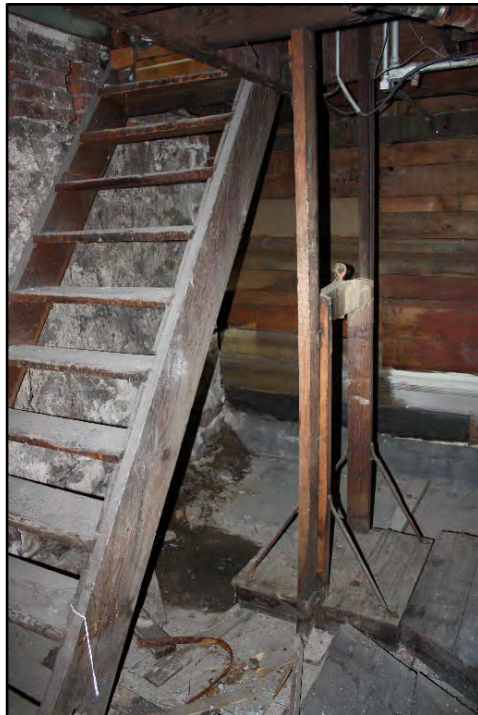
Photo 22 of 24. The pulley-operated elevator in the basement, facing northeast.

The south commercial space on the first story dates primarily from the late 1960s and 1970s and consists of a showroom, small front room, corridor, office, lavatory, and freight area. The showroom is finished with vinyl tile flooring, wood paneling covering the walls, and a drop ceiling that has reduced the full height of the ceiling. A small room adjacent to the storefront entrance retains the access window for the south storefront display. Beyond the showroom, a narrow corridor leads to a small room, which may have served as an optometrist's office, and the rear freight space. The basement is accessed from the rear freight area. The pulley-operated elevator and shaft remain intact in the first floor and basement.

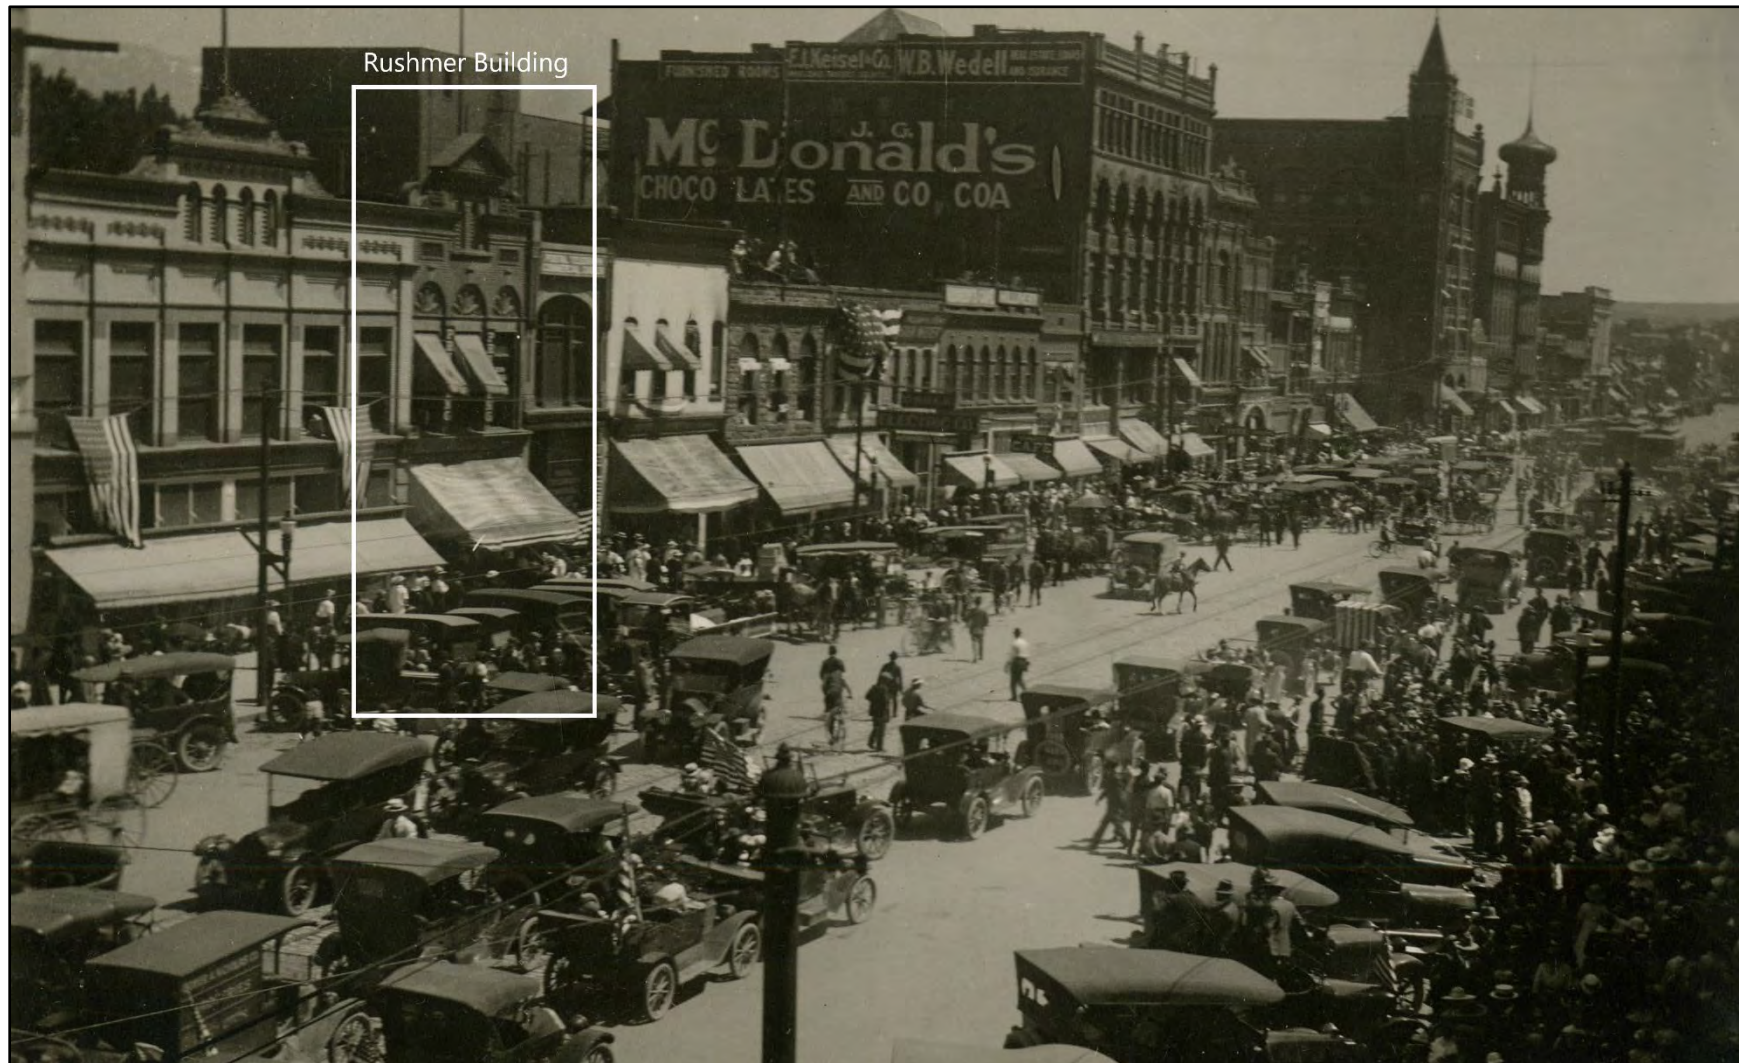
Figure 1. Image of the Rushmer Building ca. 1920 with the intact Victorian Eclectic exterior. Courtesy of James Jacobs.

The building is a two-part commercial block-type building in a row of abutting commercial buildings (see Figure 1). The building has a narrow street frontage that is 22 feet wide and a long interior that is 119 feet deep. The north and south side walls adjoin the neighboring buildings while the west (primary) elevation faces Washington Boulevard, and the east (rear) elevation faces Canal Alley and a parking area in the middle of the block. The foundation is constructed of uncoursed stone ashlar below grade. The

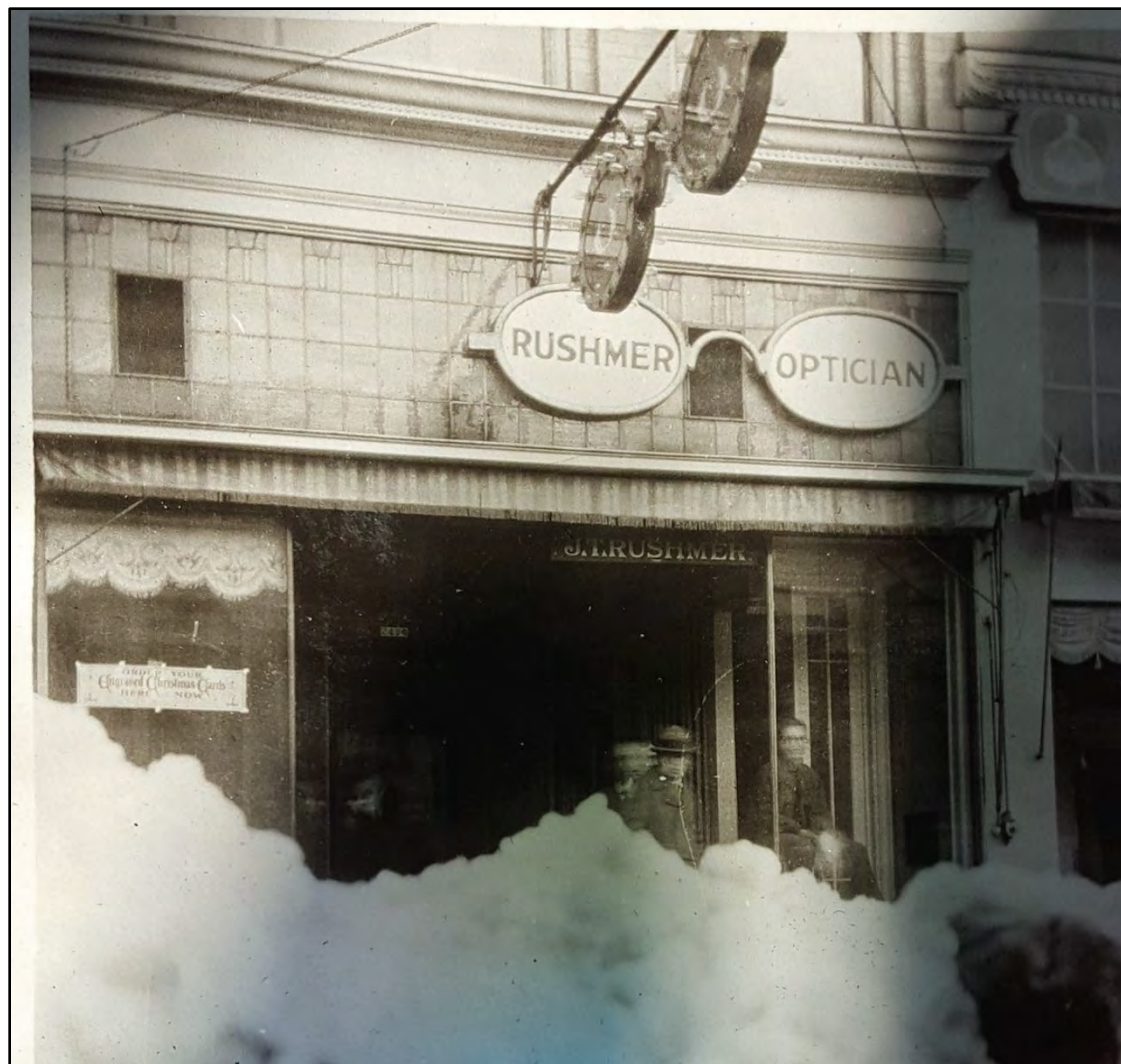
Figure 2. Image of the Rushmer Building ca. 1924 with a Victorian storefront. Courtesy of James Jacobs.

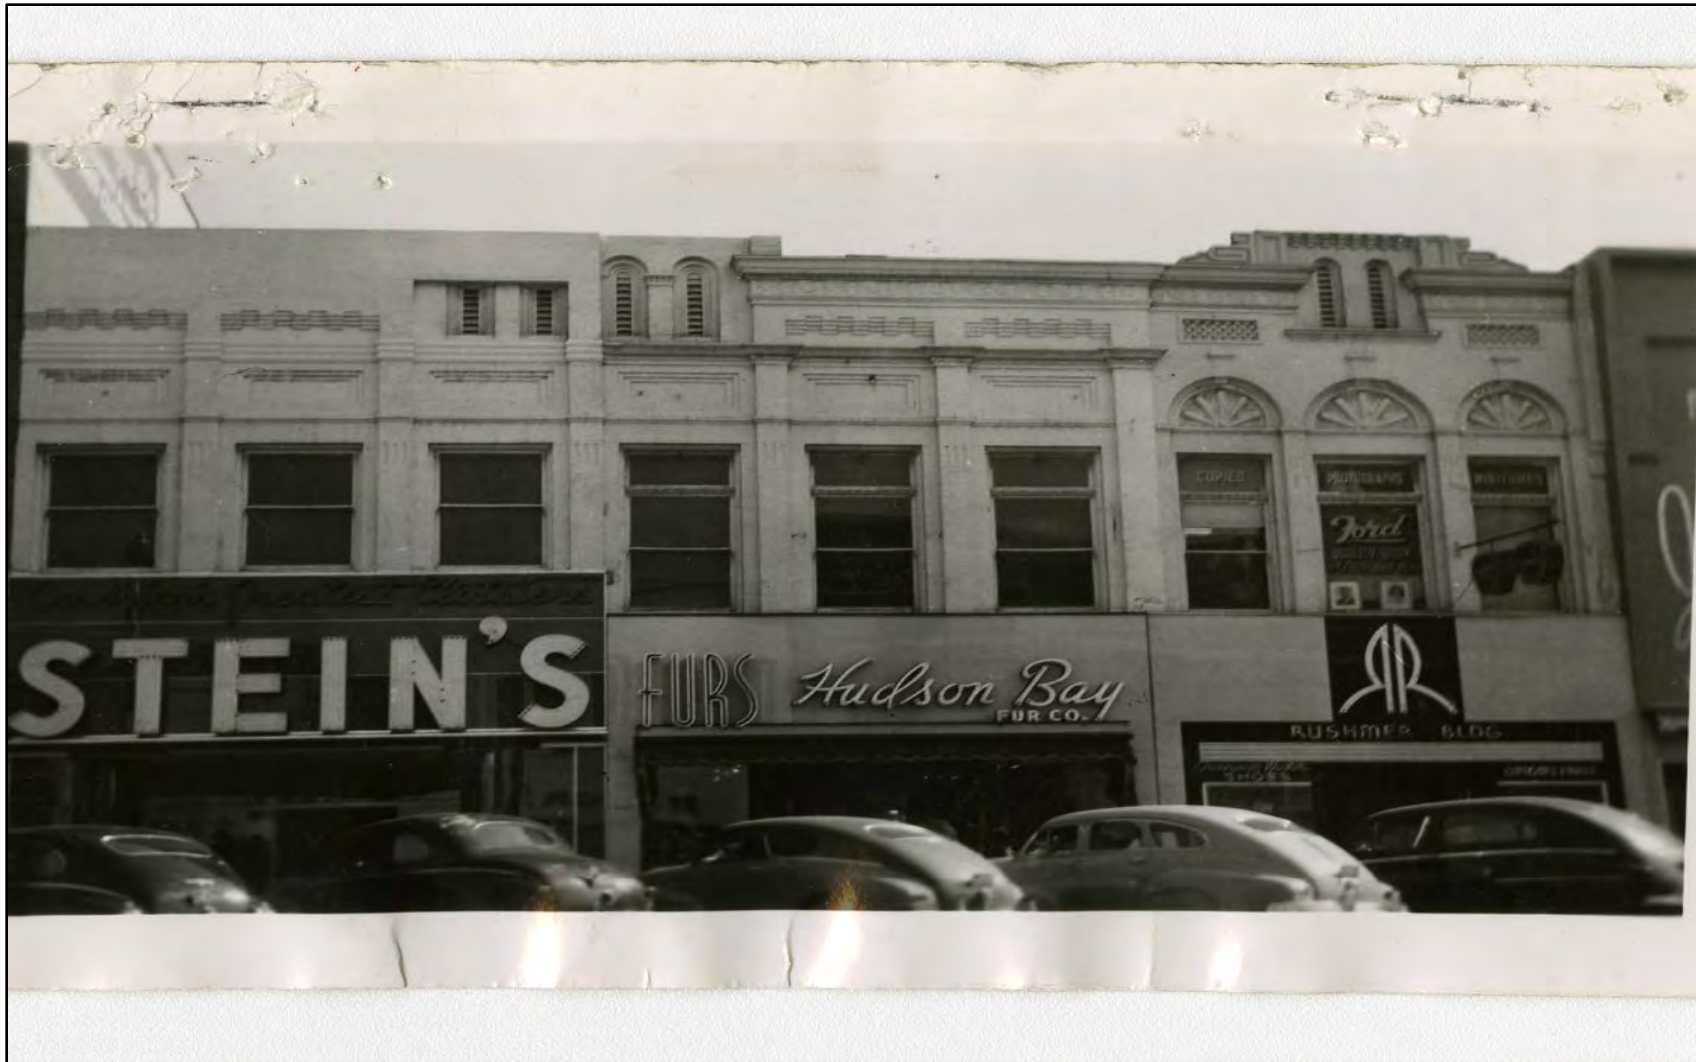
Figure 3. Image of the Rushmer Building ca. 1940 with the Art Deco storefront and most of the original second-story storefront. Courtesy of Special Collections Department, Stewart Library, Weber State University.

Rushmer modernized the storefront of his building in 1939 during the height of Vitrolite use in Ogden; the storefront was noted as "one of the most attractive in the city, being done in black and gray Carrara Glass, with colorful neon signs" (*Ogden Standard-Examiner* 1939). The Rushmer Building's Vitrolite storefront featured a streamlined black surface topped with the building's symbol and large neon eyeglasses (see Figure 3).

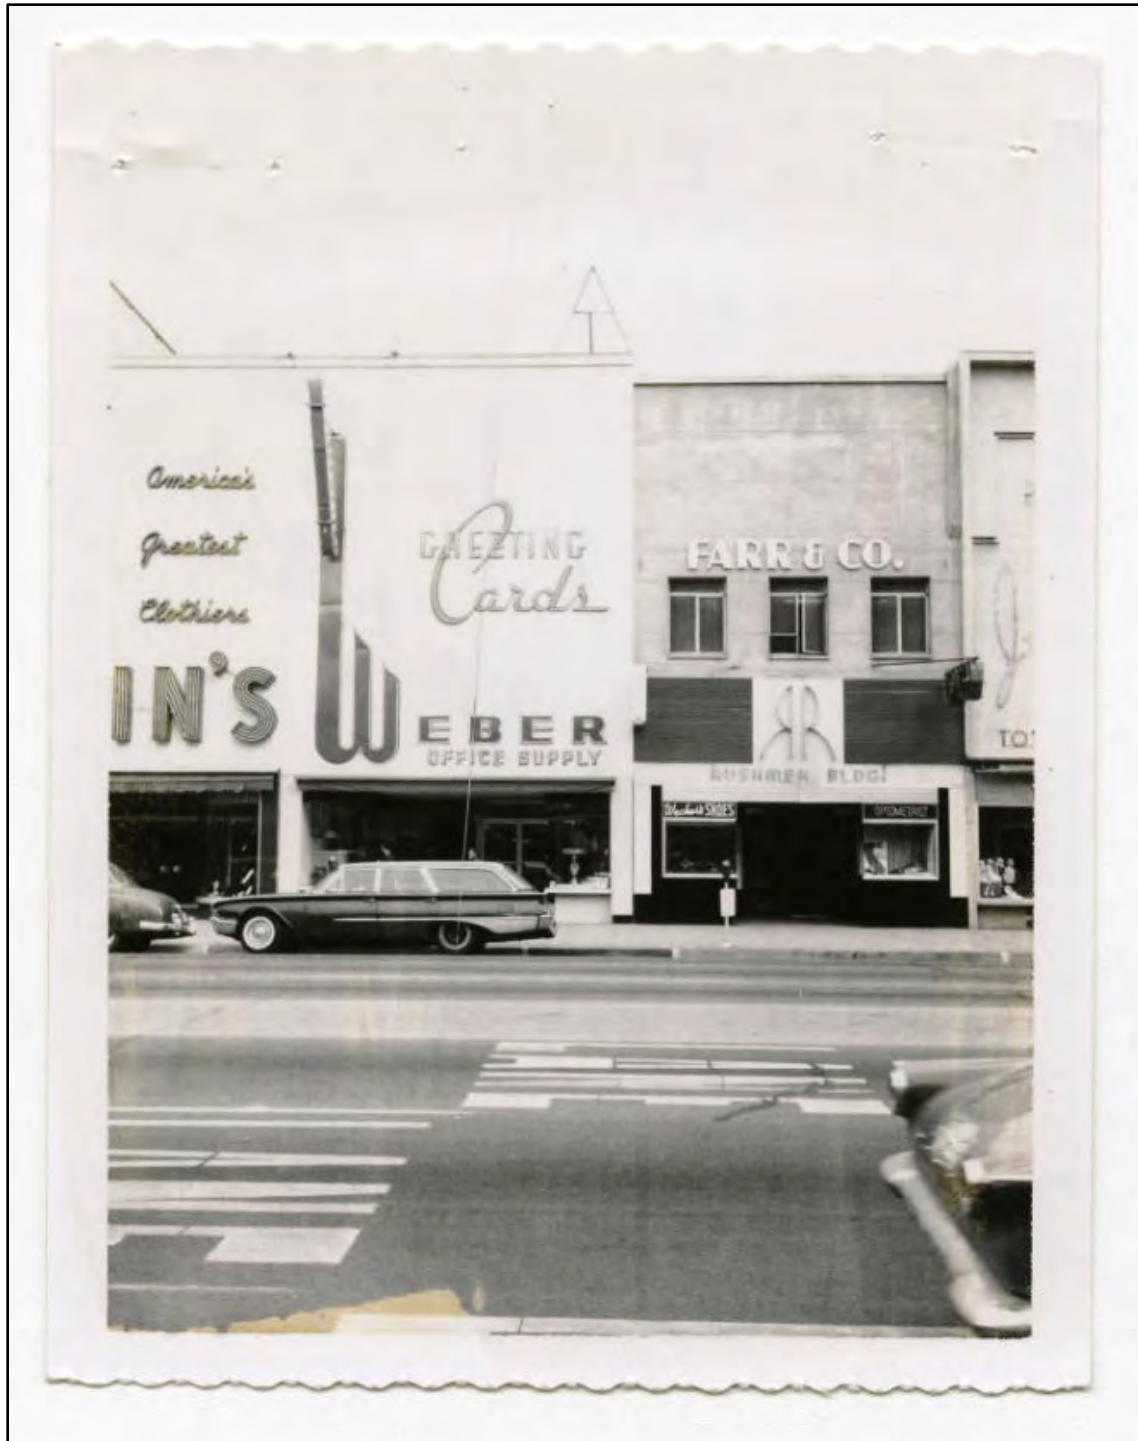
Figure 4. Image of the Rushmer Building ca. 1960 with the Art Deco storefront, ribbed metal signage and stucco on the second-story storefront. Courtesy of Special Collections Department, Stewart Library, Weber State University.

In 1955, a fire started at the Rushmer Building; it was caused by "defective wiring in the [Vitrolite] false front" and spread to the second story (*Ogden Standard-Examiner* 1955). The fire may have been sparked by the wiring for the large neon signs, which ran behind the Vitrolite glass. As a result of this fire, the Vitrolite Rushmer Building sign was presumably removed and replaced with the existing one of ribbed metal. The following year, in 1956, Rushmer applied, possibly by himself since the newspaper referred to him as "owner-builder," the existing stucco front on the second story (*Ogden Standard-Examiner* 1956). The second story subsequently displayed a large sign for "Farr & Co" characteristic of the period (see Figure 4).

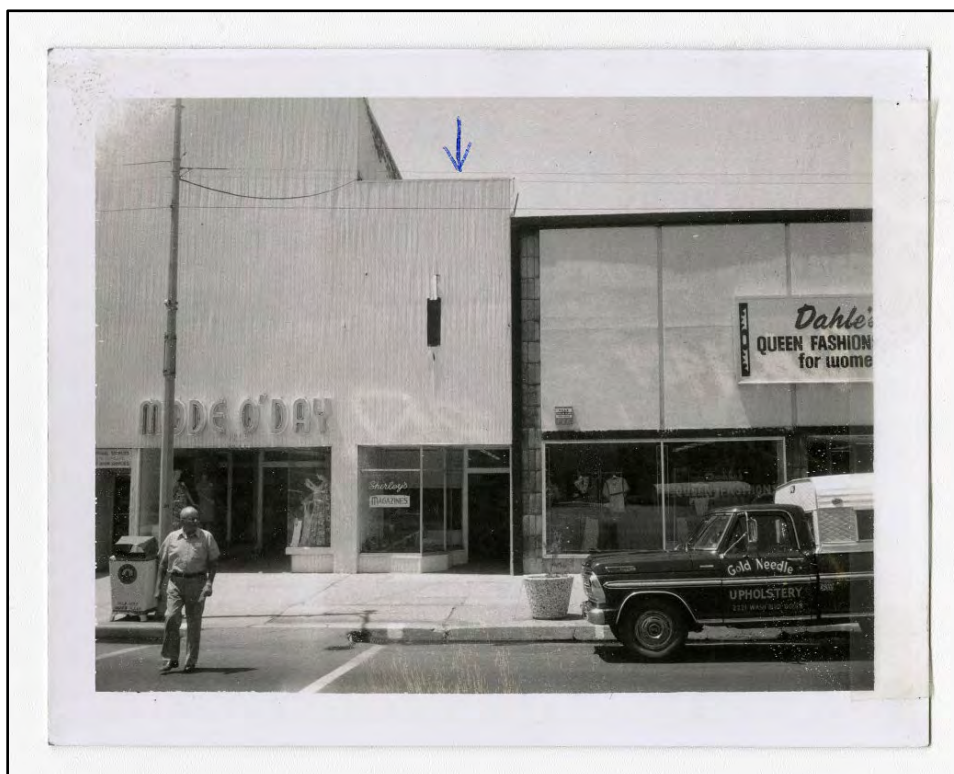
Figure 9. 2243 Washington Boulevard, ca. 1970, with architectural slipcover. Demolished ca. 1977. Courtesy of Special Collections Department, Stewart Library, Weber State University.

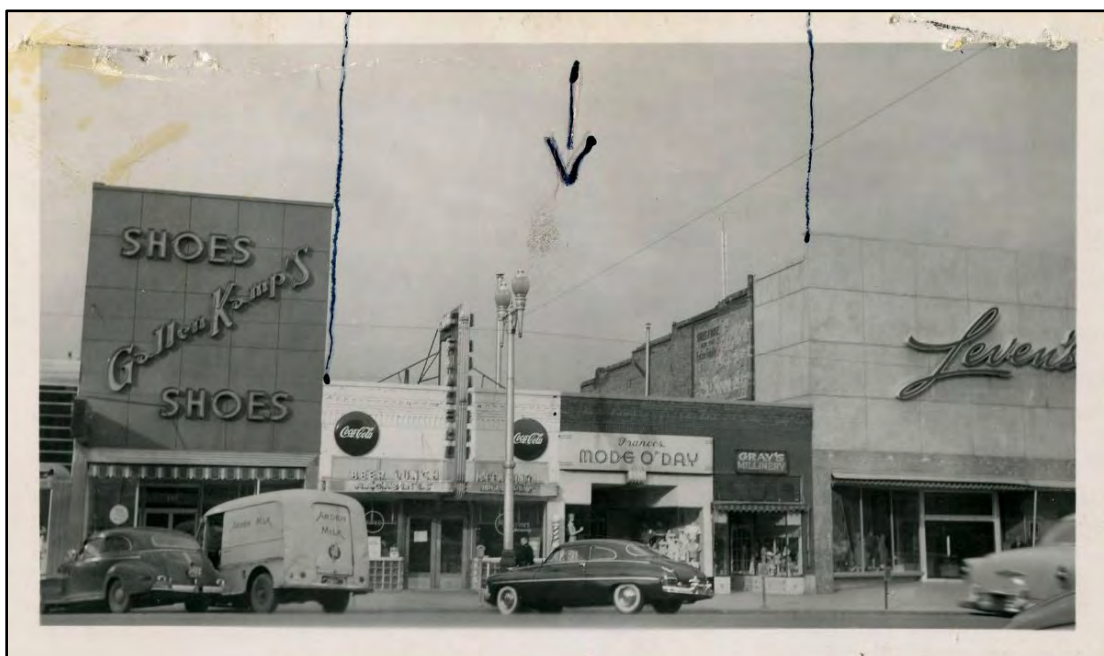
Figure 10. 2317 (far left) and 2305 (far right) Washington Boulevard, ca. 1950 with architectural slipcover. Demolished ca. 1977. Courtesy of Special Collections Department, Stewart Library, Weber State University.

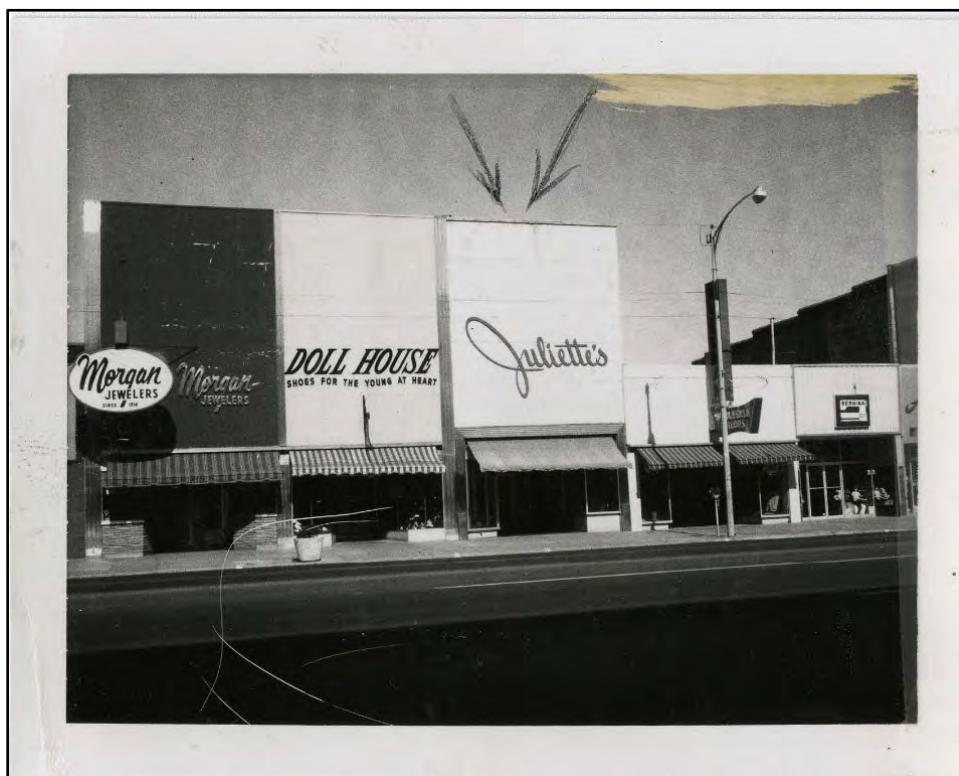
Figure 12. Morgan Jewelers at 2321 (far left), Doll House at 2319 (left center), and Juliette's at 2317 (center) Washington Boulevard, ca. 1970, (right) altered with architectural slipcovers. Demolished ca. 1977. Courtesy of Special Collections Department, Stewart Library, Weber State University.

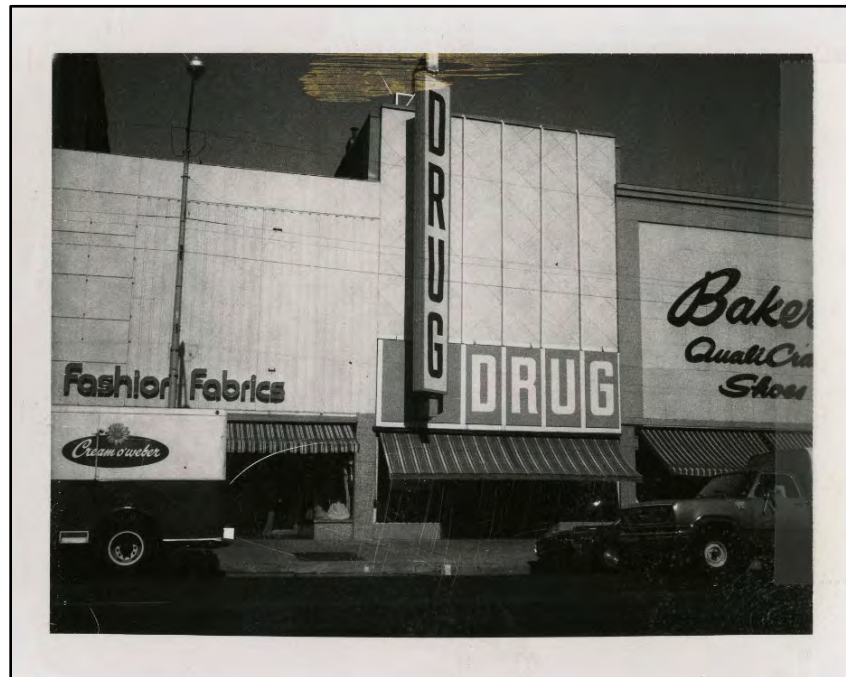
Figure 16. Top Drug at 2353 Washington Boulevard, ca. 1970, (right) modernized with architectural slipcover. Demolished ca. 1977. Courtesy of Special Collections Department, Stewart Library, Weber State University.

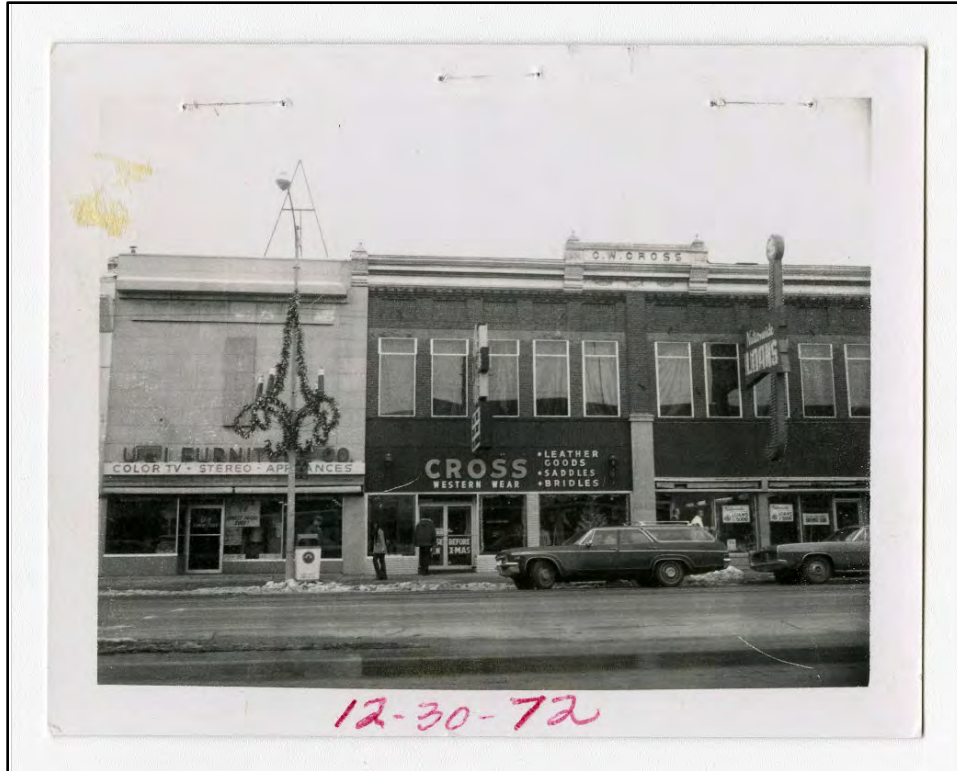
Figure 17. 2242 Washington Boulevard, ca. 1970, (left) with architectural slipcover. Courtesy of Special Collections Department, Stewart Library, Weber State University.
