NATIONAL REGISTER OF HISTORIC PLACES REGISTRATION FORM

Historic name: Rushmer Building

Name of related multiple property listing: Commercial and Industrial Properties of Ogden, Utah, 1845-1975

Street & number: 2434-2436 Washington Boulevard

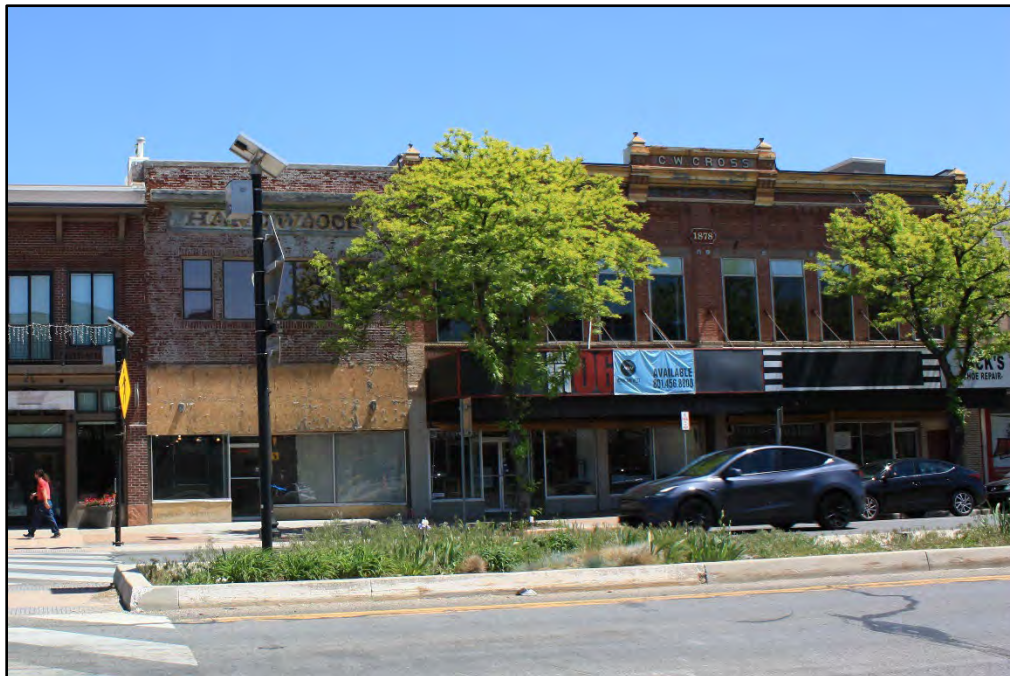
Figure 18. 2242 Washington Boulevard (left) with the architectural slipcover removed (2021).

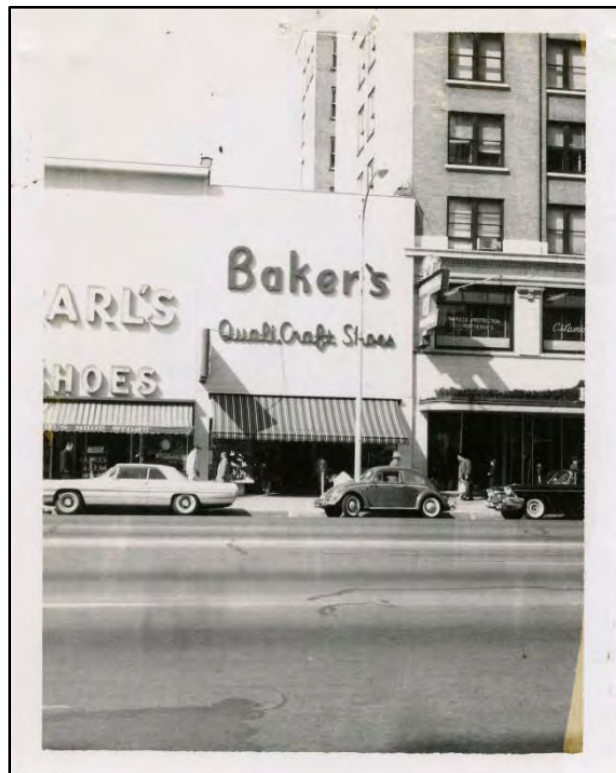
Figure 20. Earlier location of Baker's Quality Craft Shoes at 2415 Washington Boulevard, ca. 1960, (center) with architectural slipcover. Demolished. Courtesy of Special Collections Department, Stewart Library, Weber State University.

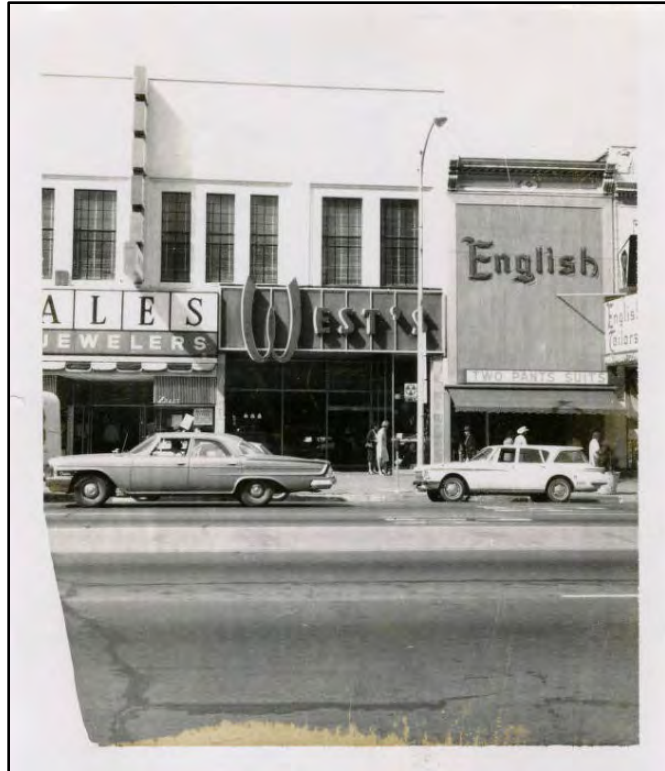
Figure 21. English Tailors (left) at 2427 and Zales Jewelers (right) at 2431 Washington Boulevard, ca. 1960. Both demolished. Courtesy of Special Collections Department, Stewart Library, Weber State University.

Most one- and two-part commercial blocks on Washington Boulevard between 22nd and 26th Streets were modernized with either or both a streamlined street-level store front an upper story stucco and an architectural slipcover and signage (Stewart Library 1920–1975). Since the late 1970s, many have been demolished, and many of the slipcovers have been removed or altered in later periods. Based on Weber County Tax Assessor photographs from the 1940s–1970s, the west side of the 2300 block was entirely modernized with new street-level storefronts and stucco or architectural slipcovers (Figure 9–Figure 17). These blocks, bounded by Washington Boulevard, 24th Street, and 22nd Street were demolished ca. 1977 in an early urban renewal project for the construction of the Ogden City Mall which was subsequently demolished between 2002–2004 for the extant The Junction mixed-use development. On the east side of the 2200 block several of the one-part commercial blocks retain architectural slipcovers; however, at least one slip cover has been removed at 2246 Washington Boulevard to reveal the early twentieth century façade, and one building at 2276 Washington Boulevard has been demolished (Figure 18–Figure 20). In the 2400 block of Washington Boulevard, either neighboring or across the street from the Rushmer Building, several buildings exhibiting modernized storefronts have also been demolished, one building was inaccurately restored (see Figure 4; Figure 21–Figure 23, and at least four buildings have been further altered.

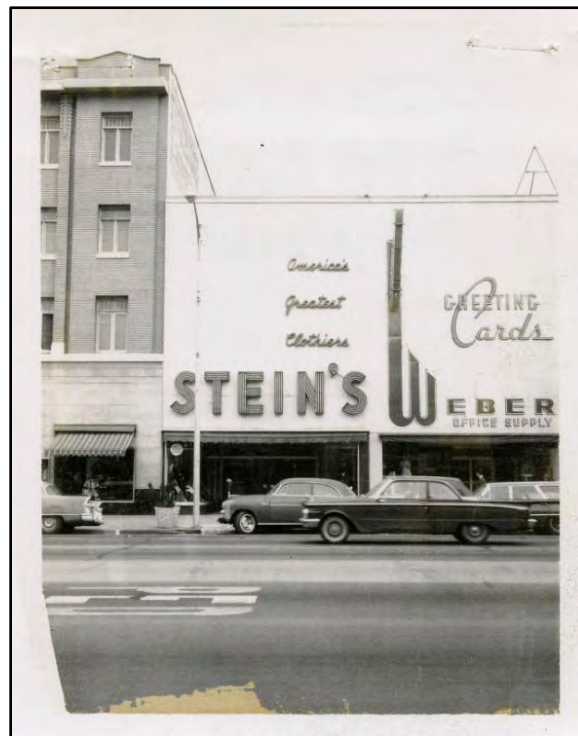
Figure 22. 2430 Washington Boulevard, ca. 1960. The architectural slipcovers have since been removed and the adjacent building at 3420 Washington Boulevard has been demolished. Courtesy of Special Collections Department, Stewart Library, Weber State University.
