Mexican Branch LDS Meetinghouse

NATIONAL REGISTER OF HISTORIC PLACES REGISTRATION FORM

United States Department of the Interior National Park Service / National Register of Historic Places Registration Form Mexican Branch LDS Meetinghouse

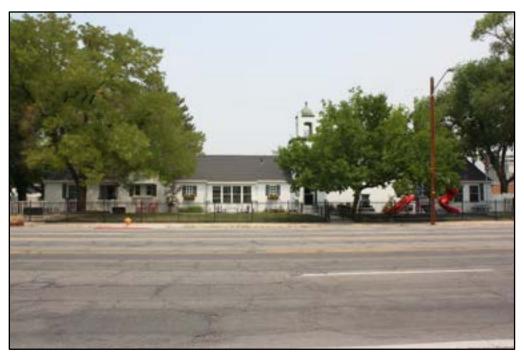
Photo 1 of 54. Overview of the Mexican Branch meetinghouse south (primary) elevation. Camera facing north.

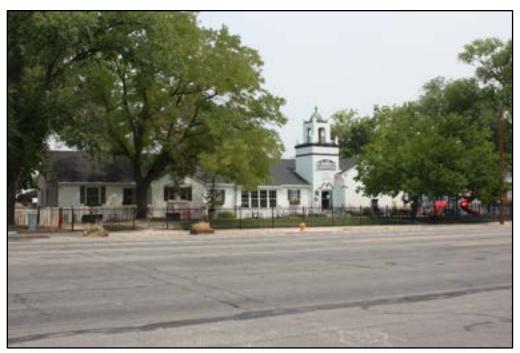
Photo 2 of 54. Overview of the Mexican Branch meetinghouse south (primary) elevation. Camera facing northeast.

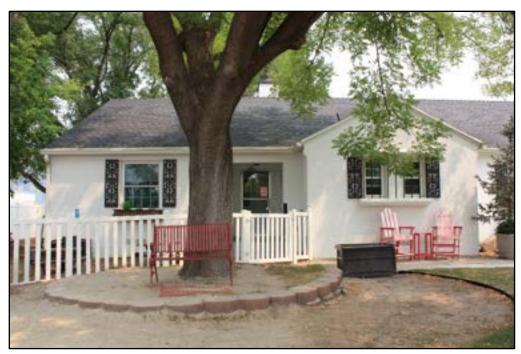
Photo 3 of 54. West addition (left) and the original Mexican Branch meetinghouse, Bays A, B, and C of the south elevation. Camera facing north.

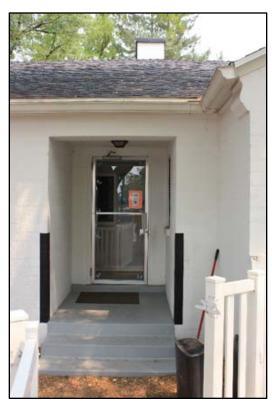
Photo 4 of 54. Entrance into the west addition with typical aluminum glazed door. Camera facing north.

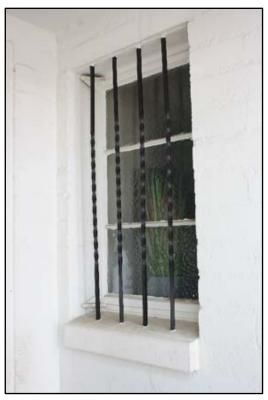
Photo 5. Detail of the original window in west elevation of branch president's office of the Mexican Branch meetinghouse. Camera facing north.

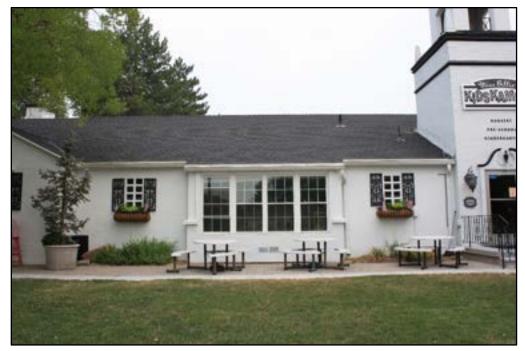
Photo 6 of 54. Original Mexican Branch meetinghouse, Bays D, E, and D of the south elevation. Camera facing north.

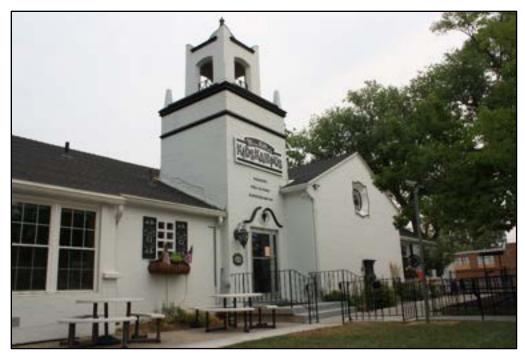
Photo 7 of 54. Original Mexican Branch meetinghouse entrance, Bays F and G of the south elevation. Camera facing northeast.

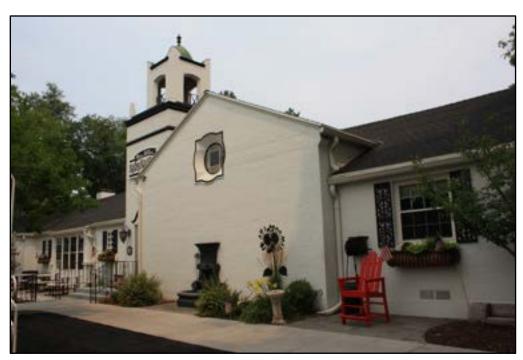
Photo 8 of 54. South end of the chapel in the original Mexican Branch meetinghouse, Bays F and G of the south elevation. Camera facing northwest.

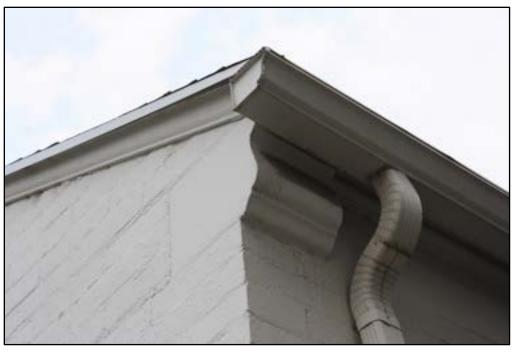
Photo 9 of 54. Detail of curvilinear quoin bracket at the southeast corner of the east wing. Camera facing northwest.

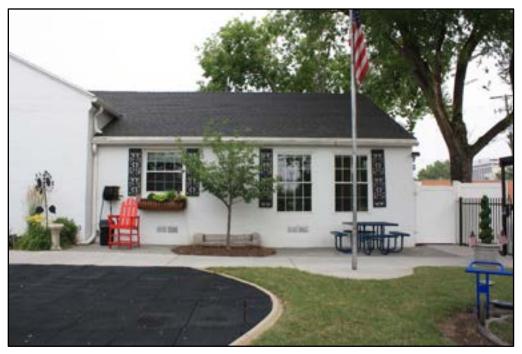
Photo 10 of 54. East addition to the Mexican Branch meetinghouse, Bays A and H of the south elevation. Camera facing north.

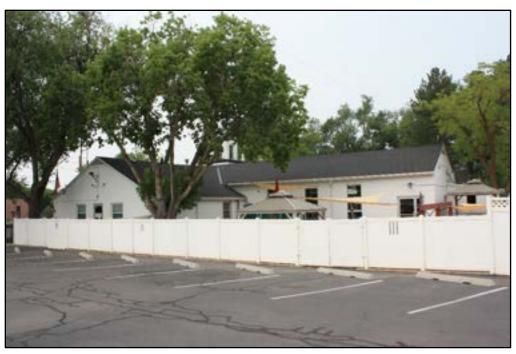
Photo 11 of 54. East and south elevations of the east addition (left) and the east elevation of the chapel of the original Mexican Branch meetinghouse. Camera facing southwest.

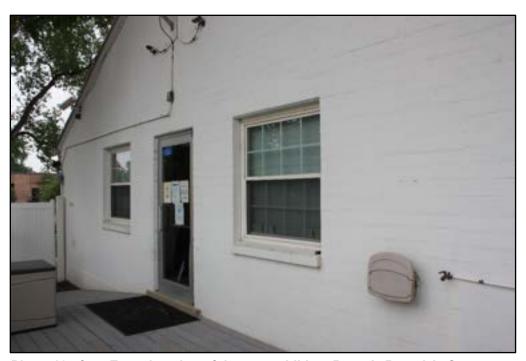
Photo 12 of 54. East elevation of the east addition, Bays A, B, and A. Camera facing southwest.

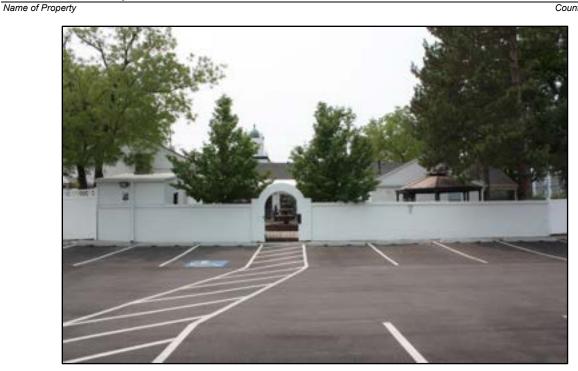
Photo 13 of 54. Overview of the Mexican Branch meetinghouse north elevation. Camera facing south.

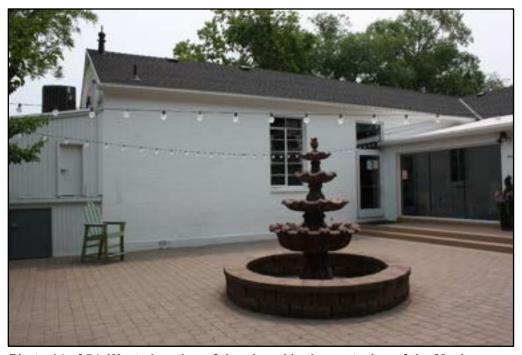
Photo 14 of 54. West elevation of the chapel in the east wing of the Mexican Branch meetinghouse (left) and the north elevation of the recreation/cultural hall (right). Camera facing east.

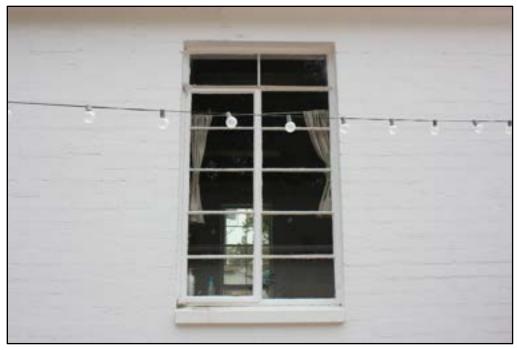
Photo 15 of 54. Detail of original two-by-four casement window with transom in the west elevation of the chapel in the east wing of the Mexican Branch meetinghouse. Camera facing east.

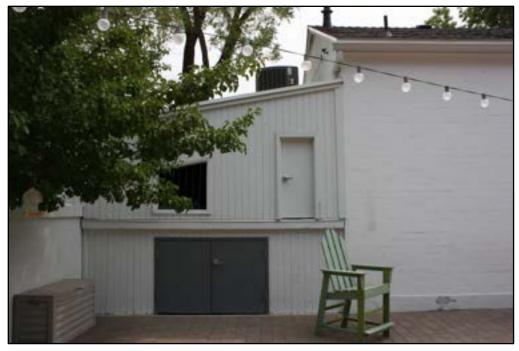
Photo 16 of 54. West elevation of the addition to the chapel. Camera facing east.

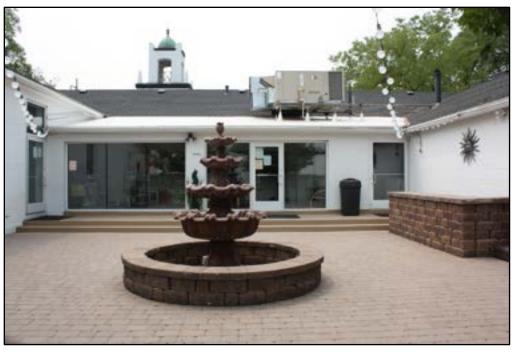
Photo 17 of 54. North elevation of the recreation/cultural hall of the Mexican Branch meetinghouse. Camera facing south.

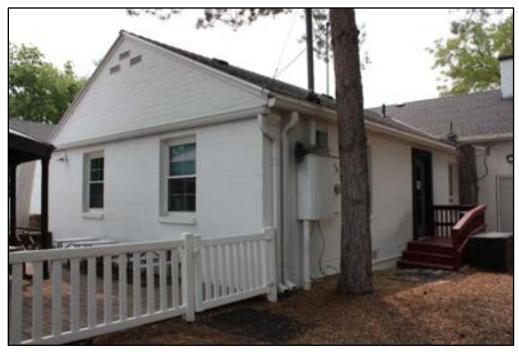
Photo 18 of 54. North and west elevations of the west wing of the Mexican Branch meetinghouse. Camera facing southeast.

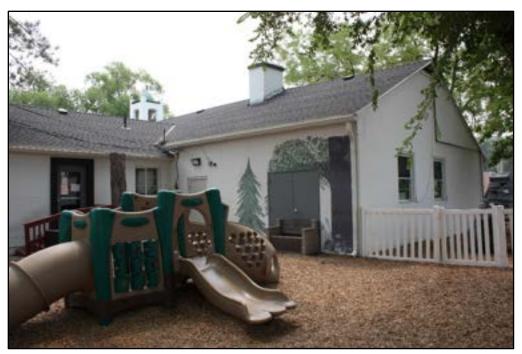
Photo 19 of 54. North and west elevations of the west addition to the Mexican Branch meetinghouse. Camera facing southeast.

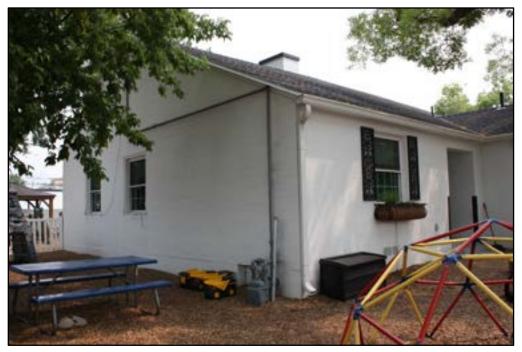
Photo 20 of 54. West and north elevations of the west addition to the Mexican Branch meetinghouse. Camera facing northeast.

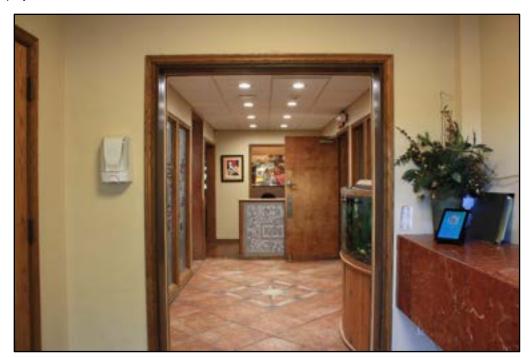
Photo 21 of 54. Main entrance in the Mexican Branch meetinghouse. Camera facing north.

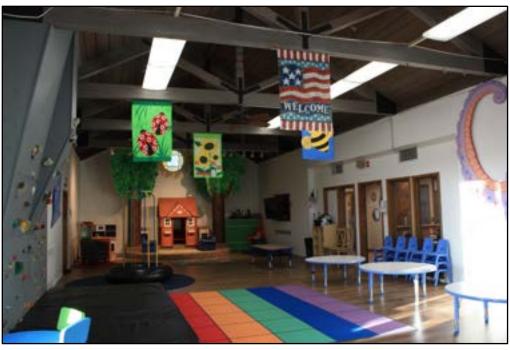
Photo 23 of 54. Interior of the chapel in the east wing of the Mexican Branch meetinghouse. Camera facing southwest toward the main entrance.

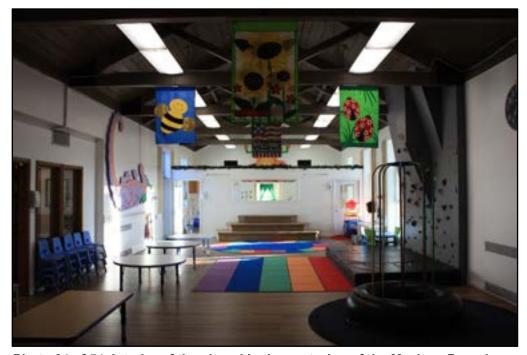
Photo 24 of 54. Interior of the chapel in the east wing of the Mexican Branch meetinghouse with a recent partition wall in the north end of the chapel. Camera facing north.

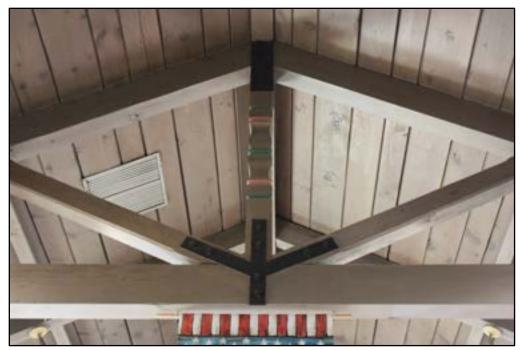
Photo 25 of 54. Detail of truss and wood ceiling in the chapel of the Mexican Branch meetinghouse.

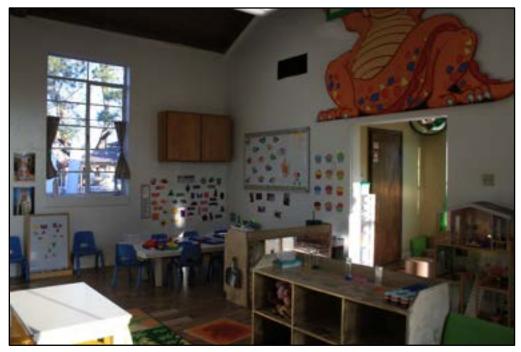
Photo 26 of 54. Space north of the partition wall in the chapel of the Mexican Branch meetinghouse. Camera facing northwest.

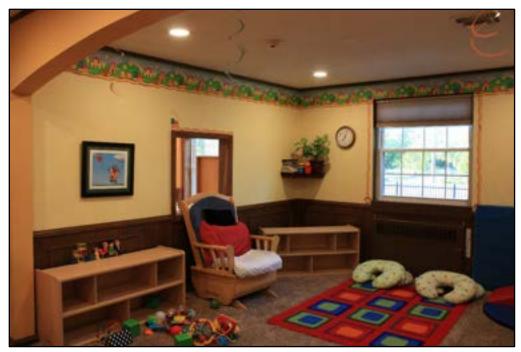
Photo 29 of 54. West half of the east addition adjacent to the chapel in the Mexican Branch meetinghouse. Camera facing southeast.

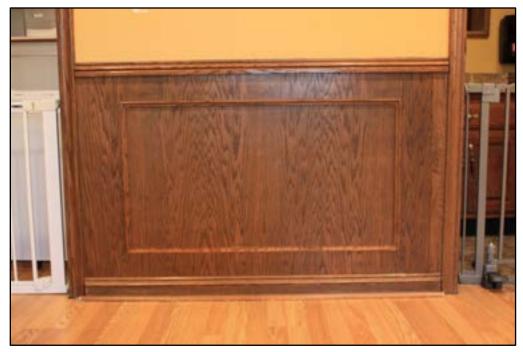
Photo 30 of 54. Detail of original wood wainscoting in the east addition of the Mexican Branch meetinghouse.

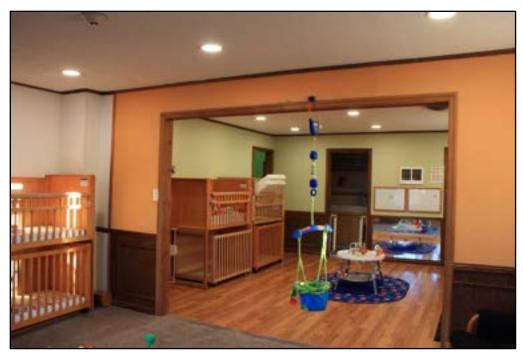
Photo 31 of 54. East half of the east addition of the Mexican Branch meetinghouse toward the entrance into the adjacent east addition rooms (farleft corner). Camera facing northwest.

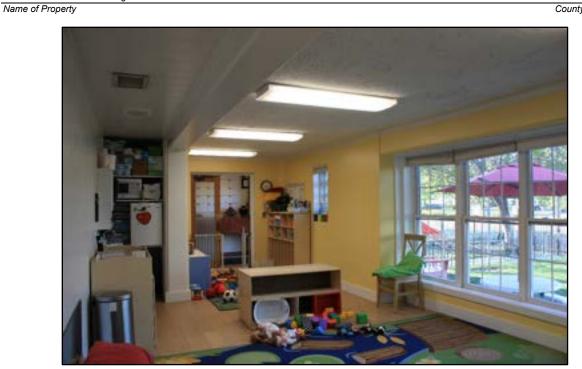
Photo 33 of 54. Primary room in the south half of the Mexican Branch meetinghouse with the doorway to the main entrance in the background. Camera facing southeast.

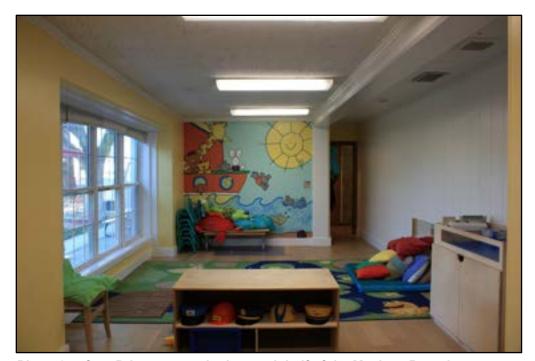
Photo 34 of 54. Primary room in the south half of the Mexican Branch meetinghouse with the entrance to the north-south corridor in the background. Camera facing west.

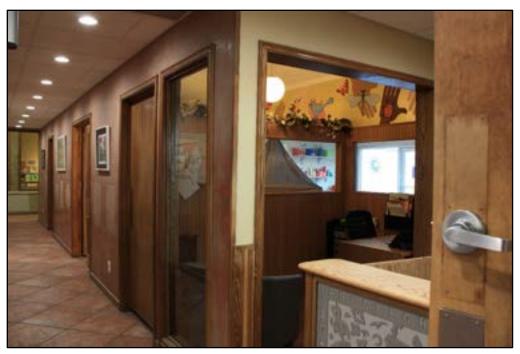
Photo 35 of 54. Recreation/cultural hall in the Mexican Branch meetinghouse from the main entrance with the east-west corridor (left). Camera facing northwest.

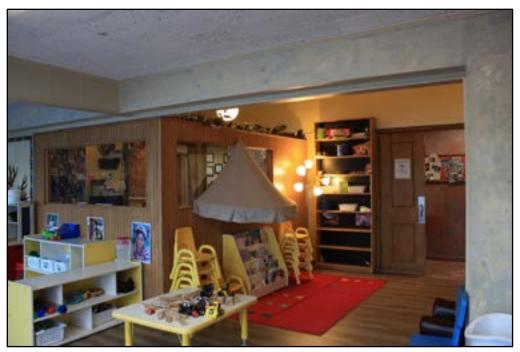
Photo 37 of 54. Recreation/cultural hall of the Mexican Branch meetinghouse with the office in the foreground (left) and the entrance the from east-west corridor in the background (right). Camera facing southeast.

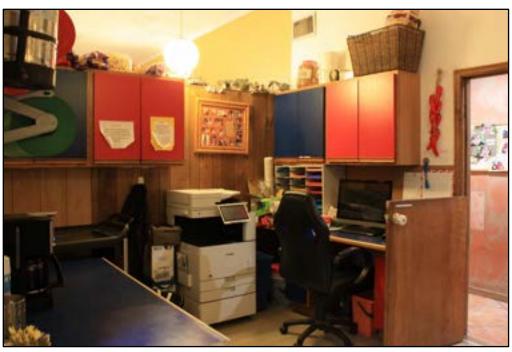
Photo 39 of 54. Office in the pantry of the Mexican Branch meetinghouse. Camera facing southeast.

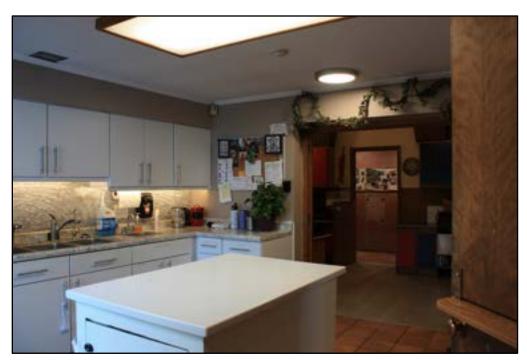
Photo 40 of 54. Kitchen of the Mexican Branch meetinghouse with the office/former pantry in the background. Camera facing southeast.

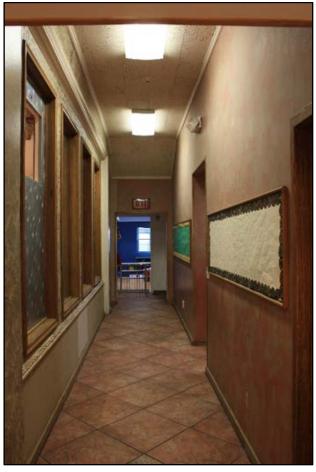
Photo 41 of 54. North-south corridor of the Mexican Branch meetinghouse with the juncture of the east-west corridor (right), Relief Society room (left), and north end of the west wing in the background. Camera facing north.

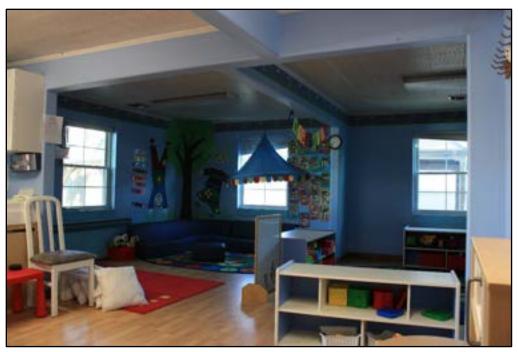
Photo 42 of 54. Classrooms in the north end of the west wing of the Mexican Branch meetinghouse. Camera facing north.

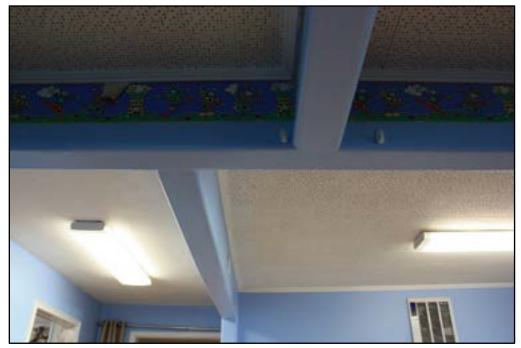
Photo 43 of 54. Detail of the ceiling where walls have been removed to create an open plan space in the Mexican Branch meetinghouse. Camera facing south.

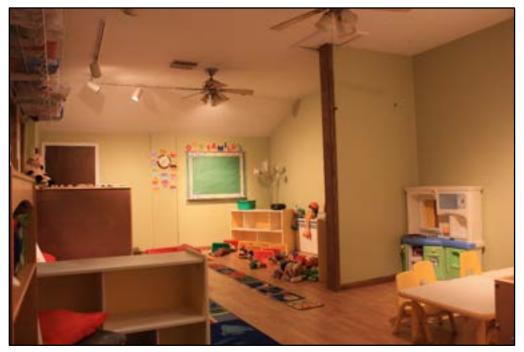
Photo 45 of 54. Relief Society room in the Mexican Branch meetinghouse. Camera facing southwest.

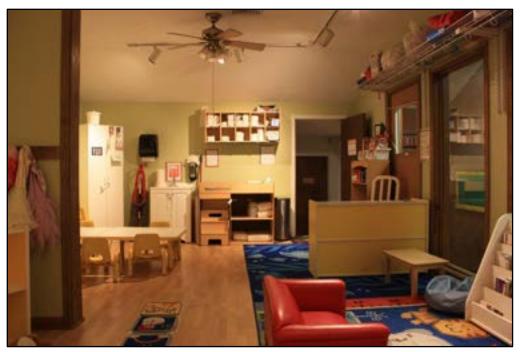
Photo 46 of 54. Relief Society room in the Mexican Branch meetinghouse. Camera facing north.

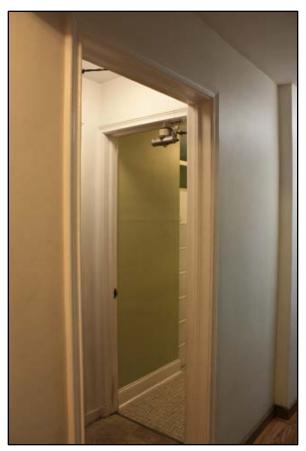
Photo 47 of 54. Entrance to the former branch president's office at the south end of the north-south corridor and junction with the secondary entrance in the west addition of the Mexican Branch meetinghouse. Camera facing southwest.

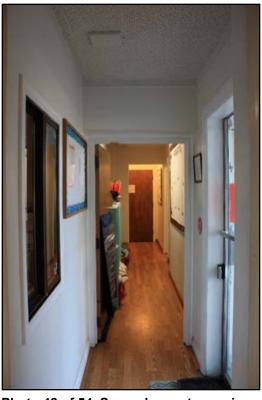
Photo 48 of 54. Secondary entrance in the west addition of the Mexican Branch meetinghouse. Camera facing east.

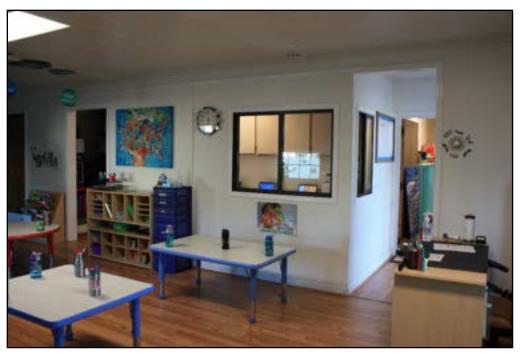
Photo 49 of 54. Computer lab constructed in west addition to the Mexican Branch meetinghouse with the secondary entrance corridor in the background (right). Camera facing northeast.

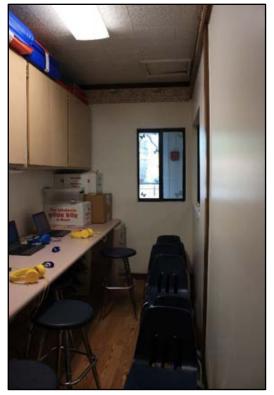
Photo 50 of 54. Computer lab in the west addition of the Mexican Branch meetinghouse. Camera facing south.

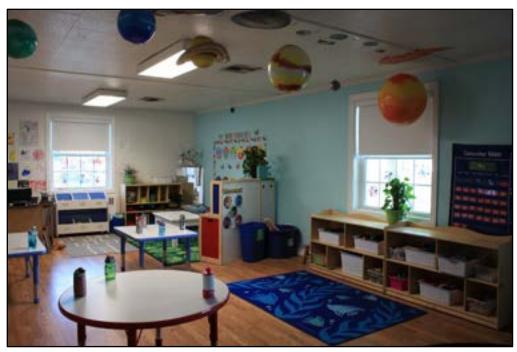
Photo 52 of 54. West addition to the Mexican Branch meetinghouse. Camera facing southwest.

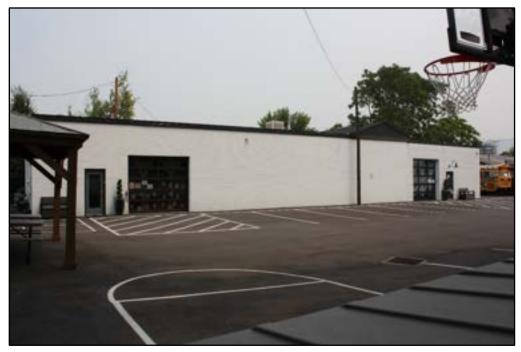
Photo 53 of 54. South elevation of the non-contributing building behind (north of) the Mexican Branch meetinghouse. Camera facing northeast.

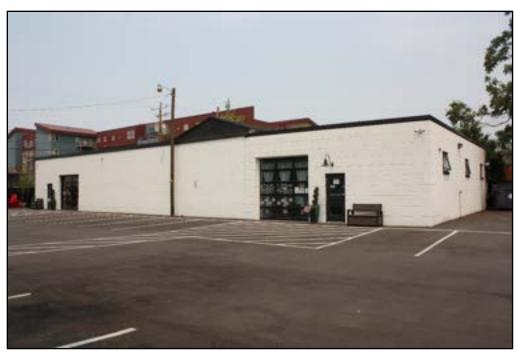
Photo 54 of 54. South and east elevations of the non-contributing building behind (north of) the Mexican Branch meetinghouse. Camera facing northwest.

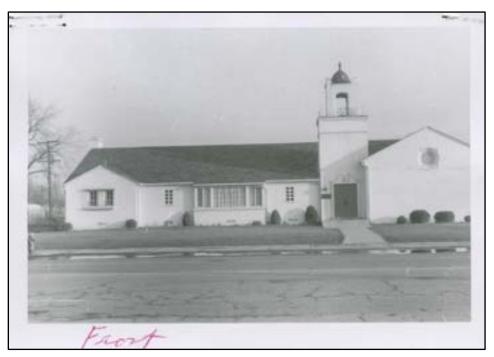
Figure 1. South elevation of the Mexican Branch meetinghouse, 1958 (courtesy of the Church History Department, Church of Jesus Christ of Latter-day Saints).

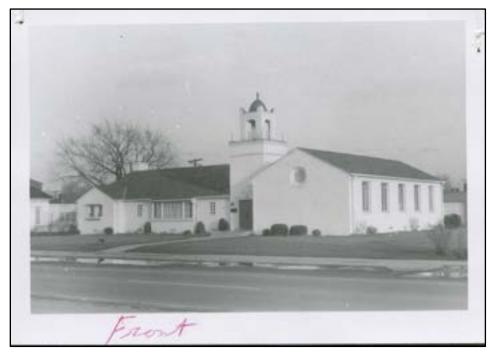
Figure 2. South and east elevations of the Mexican Branch meetinghouse, 1958 (courtesy of the Church History Department, Church of Jesus Christ of Latter-day Saints).

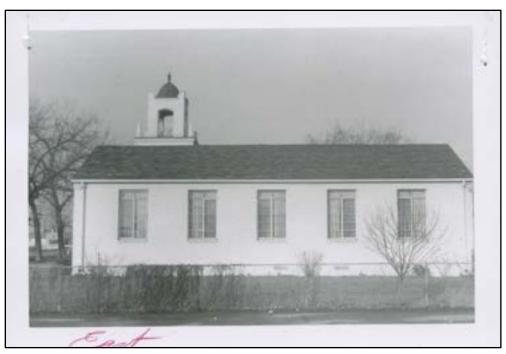
Figure 3. East elevation of the Mexican Branch meetinghouse, 1958 (courtesy of the Church History Department, Church of Jesus Christ of Latter-day Saints).

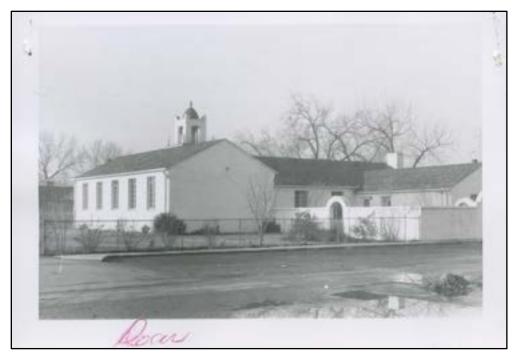
Figure 4. East and north elevations of the Mexican Branch meetinghouse, 1958 (courtesy of the Church History Department, Church of Jesus Christ of Latter-day Saints).

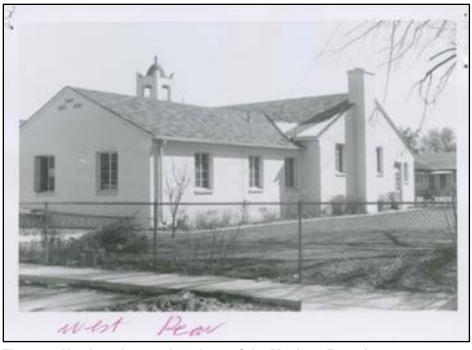
Figure 5. North and west elevations of the Mexican Branch meetinghouse, 1958 (courtesy of the Church History Department, Church of Jesus Christ of Latter-day Saints).

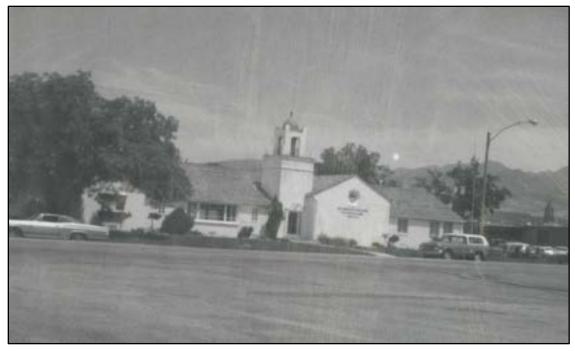
Figure 6. South elevation of the Mexican Branch meetinghouse, ca. 1970 (courtesy of the Church History Department, Church of Jesus Christ of Latter-day Saints).

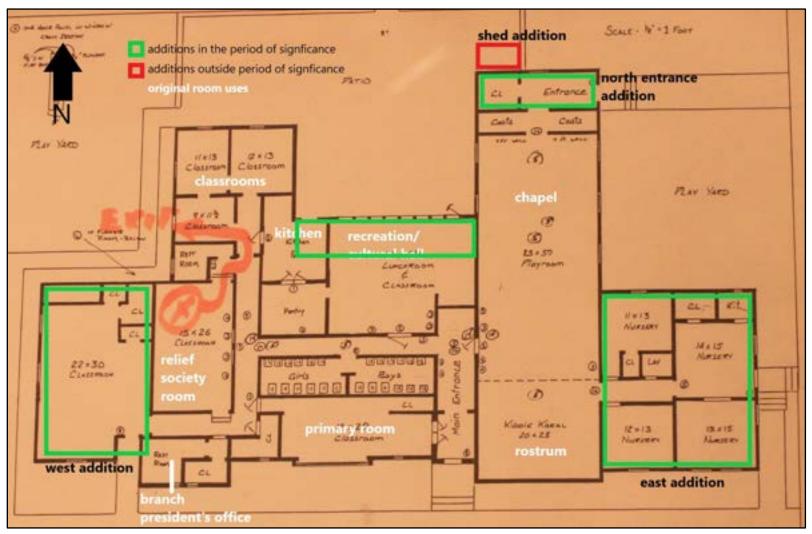
Figure 7. Floor plan of the existing daycare and early education facility with additions and original room uses of the Mexican Branch/Lucero Ward (personal communication, Samuel Palfreyman, Historic Sites Curator, Church History Department, to Anne Oliver, SWCA Environmental Consultants, 2021).

The original U-shaped plan consisted of the typical room uses and configuration used by the Church of Jesus Christ in the first half of the twentieth century, including the chapel and recreation/cultural hall close together and an adjoining kitchen and classrooms (Starrs 2009). Despite the additions, the original plan is still present. On the interior, the building retains the original chapel with the exposed rafter ceiling with decorative king posts in the king trusses. The original portion of the meetinghouse retains multiuse rooms centered around an interior corridor. Floor finishes are a mix of wood flooring and carpeting. Original paneled wood wainscots are also present in some multiuse rooms of the east addition. The chapel and the recreation/cultural hall have been partitioned into smaller multiuse spaces. New interior partition walls do not extend the full height to the ceiling and maintain the original span of a room.

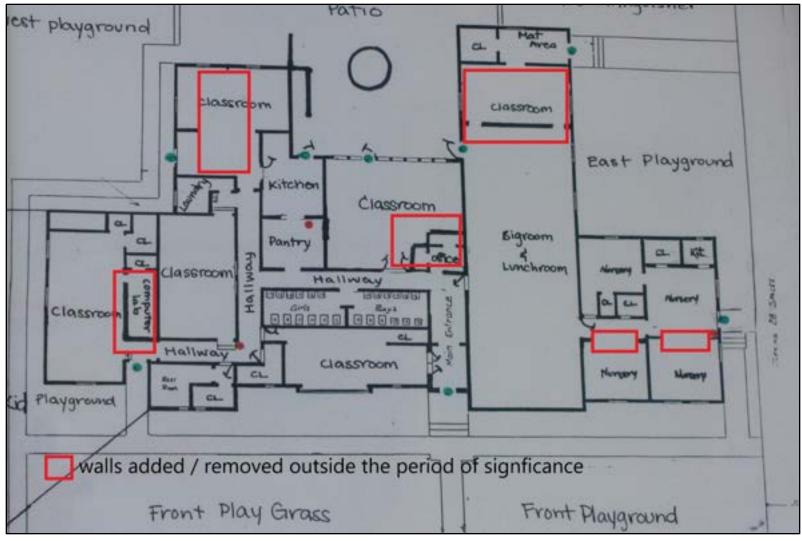
Figure 8. Recent floor plan of the existing daycare and early education facility with added or removed walls marked in red.

The interior has been adapted for use as a daycare and early education facility. Overall, the original plan of the building and its additions are discernable. However, the east addition and north extension walls have been removed or reduced to create large open spaces; the chapel and recreation/cultural hall have been divided with partial-height walls; a computer lab has been constructed in the west addition; and the office for the branch president has been converted into a lavatory (building plans reviewed by Samuel Palfreyman, Church History Department 2021). The original 1948–1950 plan consisted of the main entrance, which led to the chapel and rostrum in the east wing and a primary room directly to the west in the south half of the main volume. A central east-west-oriented corridor in the main volume provided access to the recreation/cultural hall in the north half of the main volume, lavatories in the south half of the main volume, and a north-south-oriented corridor in the west wing. This corridor provided access to the Relief Society room, the branch president's office, the kitchen and pantry, and classrooms at the north end of the west wing. Additions were constructed ca. 1962 at the east and west ends of the building parallel the primary façade and extend the building's length parallel to the street. An entrance into the north end of the chapel was also constructed at this time (Netronline 2021).
