**National Register of Historic Places
Registration Form**

historic name Poulsen-Hall House

street & town 90 S. 100 East not for publication

Poulsen-Hall House, Manti, Sanpete County, UT

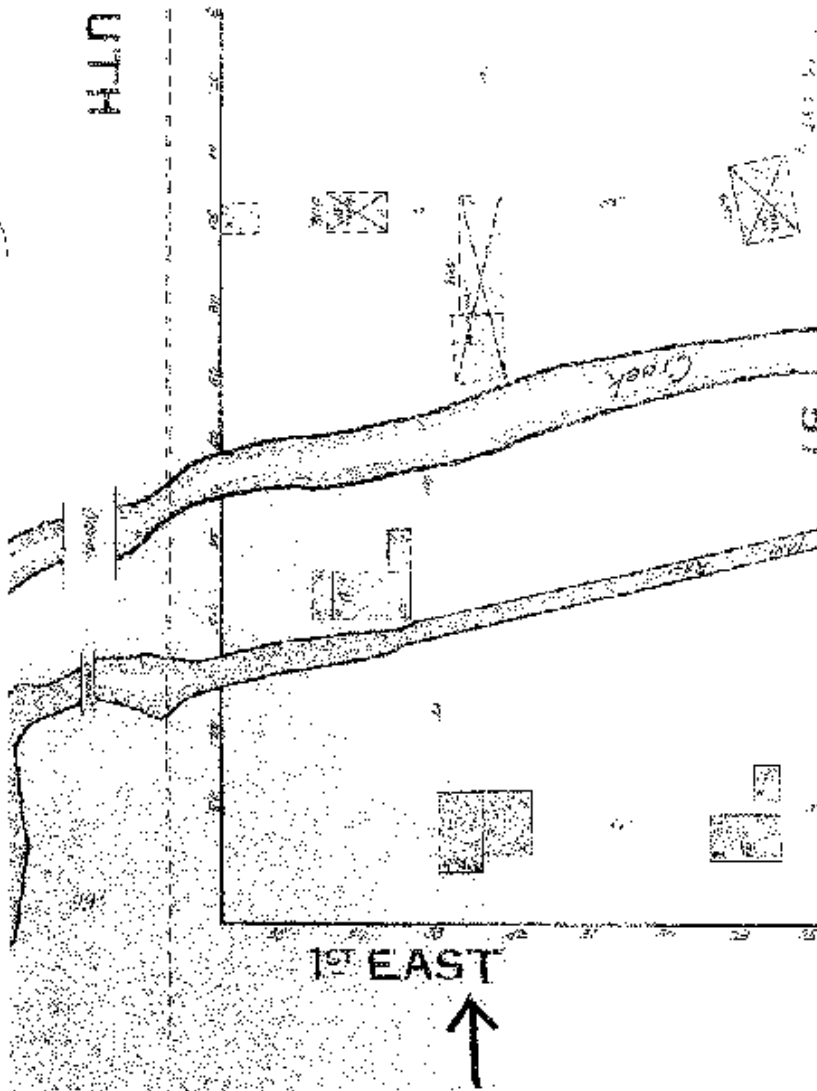
Manti, Utah
1892
Sheet 03

According to the Sanborn maps of Manti, the northwest lean-to addition was added between 1892 and 1908. It is a brick addition built on a rubble foundation. The soft pink brick was covered in stucco sometime in the mid-twentieth century. The stucco has been removed on the upper portion of the north elevation. The current roof was installed in the late 1990s and consists of small, dark blue, asphalt shingles. The ridgeline of the south wing features metal flashing and two finial knobs.³ The gable ends have narrow raking cornices of wood. A small low-pitch gable-roof dormer window was added to the rear of the north wing in the 1990s. The dormer is sheathed in vertical plank siding. The house originally had two corbelled brick chimneys. The south wing chimney is extant, but has been shortened. The north wing chimney was removed in the 1990s. There is a

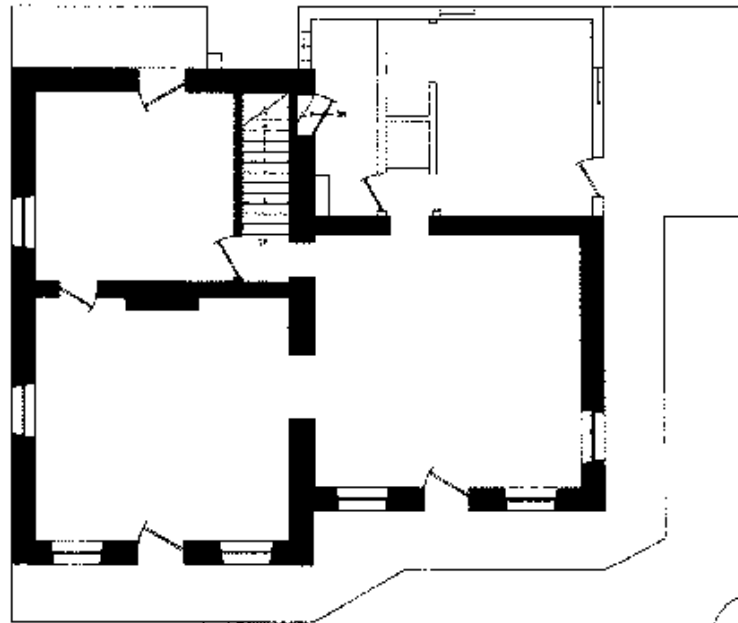
Main Floor Plan

MAIN FLOOR PLAN
SCALE APPROXIMATE

On the interior, the house has approximately 1,020 square feet of space on the main floor, 650 square feet on the upper floor, and a small root cellar at the southwest corner of the house. The living room (the original parlor) is located in the front two-thirds of the south wing. The interior, including the hand-grained faux oak finish, was restored in the 1990s.⁵ The room was repainted in 2004. The fireplace features the original wood mantel. The stone tile hearth and surround were added in 2007 after a wood burning stove was installed. The wood floors have been refurbished. In 2006, the damaged threshold between the living room and kitchen was replaced with a single piece of wood. The opening is larger than normal door size, but the date of the opening is unknown.

The door between the living room and the guest bedroom to the west was replaced with a half-stained-glass two-panel door in the 1990s. The guest bedroom has finishes similar to the living room.

The kitchen is located in the north wing. The room underwent a major rehabilitation in the 1990s. The current cabinets, vinyl flooring and appliances date from this period. The window and door casings are original and have been painted white. The kitchen walls were repainted in 2004. The main floor bathroom and back bedroom are located in the lean-to addition and were added to the house around 1900. The plank door to the cellar is original. Other finishes and fixtures date from the 1990s renovation with the cabinets added circa 2005. Space for a stacked washer & dryer and a closet in the bedroom have curtains instead of doors. The enclosed staircase is narrow and probably dates from the construction of the south wing. The wood staircase is currently painted white and hooked carpets have been installed on each tread and on the landing (circa 2005). The door at the top is similar to the plank door to the cellar (circa 1900).

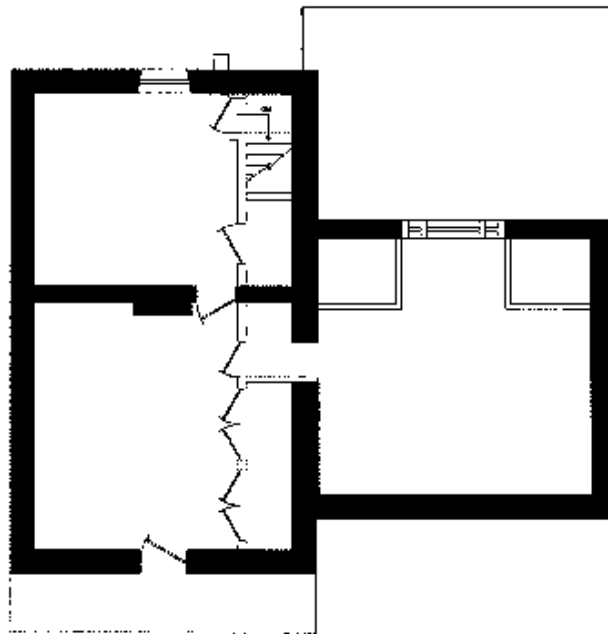
Second Floor Plan

SECOND FLOOR PLAN
SCALE APPROXIMATE

The upper floor is divided into three spaces: two bedrooms over the south wing and the unfinished attic space over the north wing. The wood casings, flooring, and plank doors on the upper floors are original, but other finishes on the second floor date from the 1990s to 2006. The flooring in the upstairs bedrooms was refinished circa 2006. The closets with multiple doors (under the eaves on the north side) were installed in 2006. A door was cut from the finished spaces over the south wing to the unfinished attic space above the north wing at an unknown date. The exterior stone and wood shingles are visible on the interior of the north attic.⁶ In the 1990s, a dormer was built to the west over the addition. The dormer is not visible from the front of the house. The space was never finished and is currently used for storage. The cellar is unfinished with visible foundation stone walls and some shelving. It is used for storage and the mechanical systems.

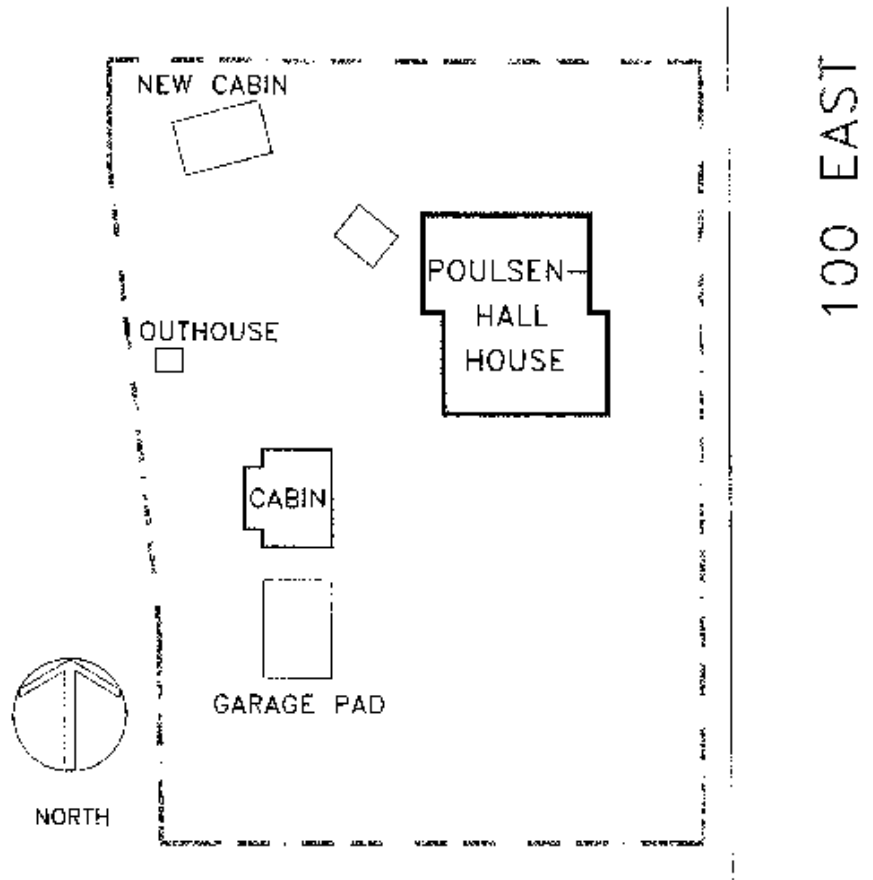
Site Plan

SKETCH SITE PLAN

The Poulsen-Hall House is located in the northeast quadrant of a roughly rectangular parcel of 0.44 acres. The house is located in the northeast quadrant of the parcel and faces east. The landscaping is mostly lawn with mature trees near the house. There is a white picket fence built in a zigzag pattern in front of the house to the east. A gravel parking area is along the east property line. A brick paved sidewalk extends from the street to the front porch. A straight picket fence is on the north side. There is a chain link fence along the west property line. The west property line is slightly angled due to the presence of a millrace from the settlement period (filled-in circa 1900). The backyard includes four outbuildings and a picnic pavilion. Two of the outbuildings, a log cabin and an outhouse, are historic, but are considered non-contributing because they were moved to the site after the historic period.⁷ The historic cabin has been restored. The newer false-front wood cabin, was built on the site in the 1990s, and is also a non-contributing outbuilding. A non-contributing garage in the nouveau barn-style was built in 2010 at the southwest corner of the property. Although the garage is the largest outbuildings, it is at the opposite corner of the property and does not visually impact the historic house.
